Report on Damage to Infrastructures by the Mid Niigata Prefecture Earthquake in 2004

NILIM-PWRI Joint Reconnaissance Team for the Mid Niigata Prefecture Earthquake in 2004

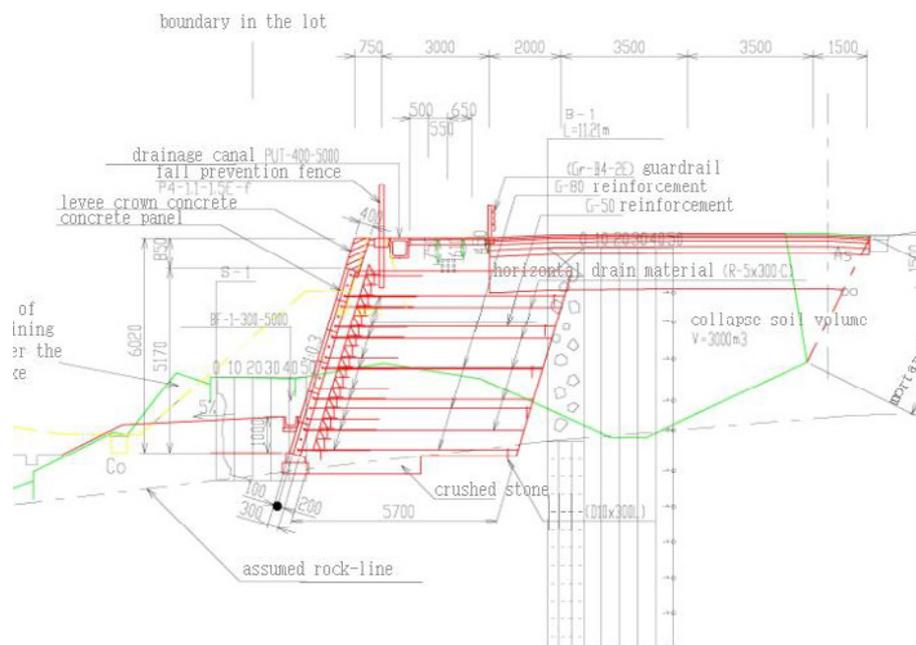
Fig. 16: Cross section of restoration work at Ten-noh in National Road No.17

Photo 9 shows the sliding failure at Ten-noh, Route No. 17. An aerial picture of the same site is also shown in Photo 10. The road and railway run along the edge of river terrace of Shinano River. The river runs in the right-hand side of Photo 9 and Photo 10, and the height of the terrace relative to the riverbed is about 40 meters. The average inclination of the terrace slope is about 25 degrees. As can be seen in Photo 6.3, road fill slope and the neighbouring railway fill slope are sliding down as a soil mass. The width of the failure was 56 meters measured at the road shoulder. The base of the sliding was alternation of tertiary sandstone and mudstone overlain by terrace sand gravel. Observation of the scarp immediately after the earthquake showed that the road fill soil composed of gravel and sand was rather dry. However, the bottom layer of the railway fill was wet. Original topography of the damaged site corresponded to a valley, which suggests that underground seepage water tend to accumulate. The mechanism of the failure has not been made clear, but the possible reasons are (1) inertial force acting on the fill on the steep slope caused loss of stability, or (2) the bottom saturated soil of the railway fill liquefied due to the earthquake, triggering slope failure associating with the upside road fill.

Restoration work was performed by using the geosynthetic reinforced soil method for the road and railway fills within the end of 2004. The cross section of the restoration work for the road fill is given in Fig. 16.

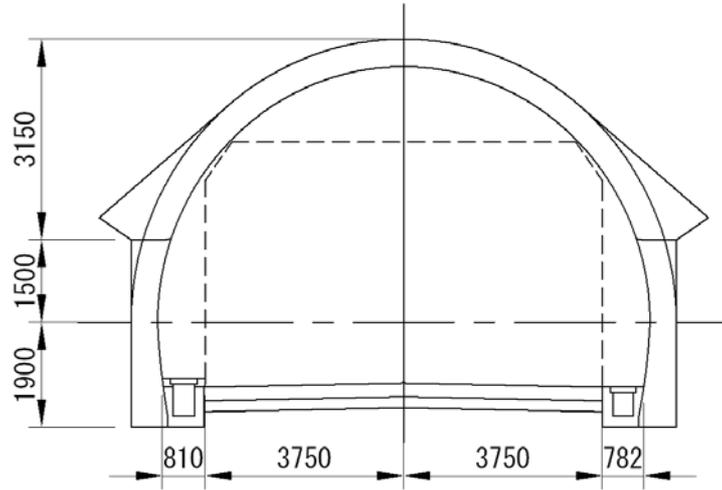
Fig. 17: Cross section of Wanatsu Tunnel (Unit: mm)

Severe damage was found in Wanatsu Tunnel on Route No.17. The tunnel is 300m long and accommodates two-way road. It was constructed by the bottom drift method and construction was completed in 1965. Cross section of the tunnel is shown in Fig. 17. Plan view and longitudinal section of the tunnel with geological formation are drawn in Fig. 18. The tunnel mainly passes through silty sandstone.

Locations of crack in the tunnel lining are indicated by gray areas in the tunnel expansion plan (Fig. 19). Spalling of concrete lining from the tunnel crown was observed throughout the length of 100m from the Nagaoka-side portal and large mass of lining (2m wide and 20m long) fell off from the crown at a distance of 100m from the Nagaoka-side portal as shown in Photo 14. Inward movement of side walls, compression failure of the concrete lin-
