Effects of the Mid Niigata Prefecture Earthquake in 2004 on dams

ABSTRUCT

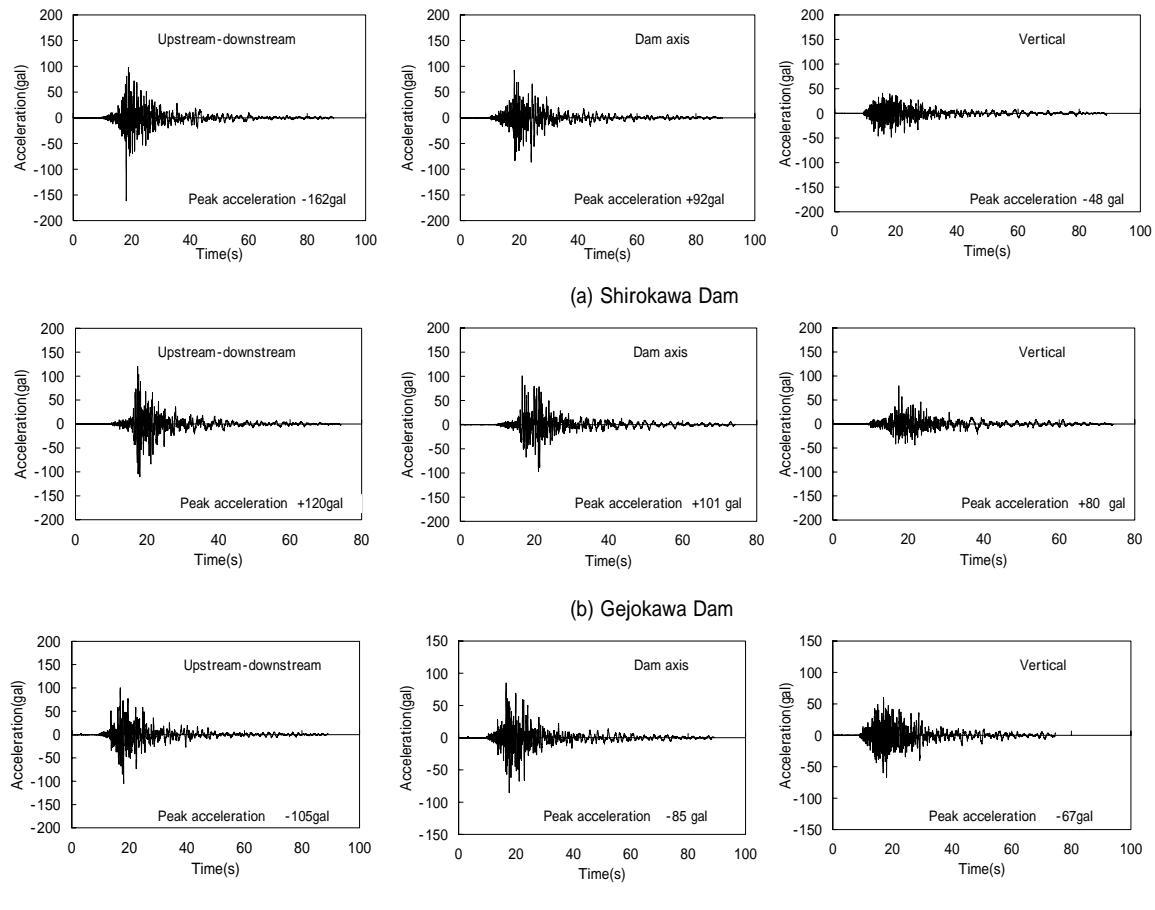
Fig. 10 Acceleration time-history waveform (main shock, at dam foundation)

Fig. 10 shows the acceleration time-history waveforms during the main shock at the foundations of Shirokawa Dam (distance to focal fault plane: about 14 km), Gejogawa Dam (about 28 km) and Sabaishigawa Dam (about 21 km), all of which are among the dams at which acceleration were recorded during the main shock. One characteristic of the Mid Niigata Prefecture Earthquake is that at some dams, higher accelerations were recorded during aftershocks than during the main shock. At Shirokawa Dam and Sabaishigawa Dam, accelerations higher than those recorded during the main shock were recorded during the greatest aftershock (18:34, October 23). Fig. 11 shows the acceleration time-history during the greatest aftershock.

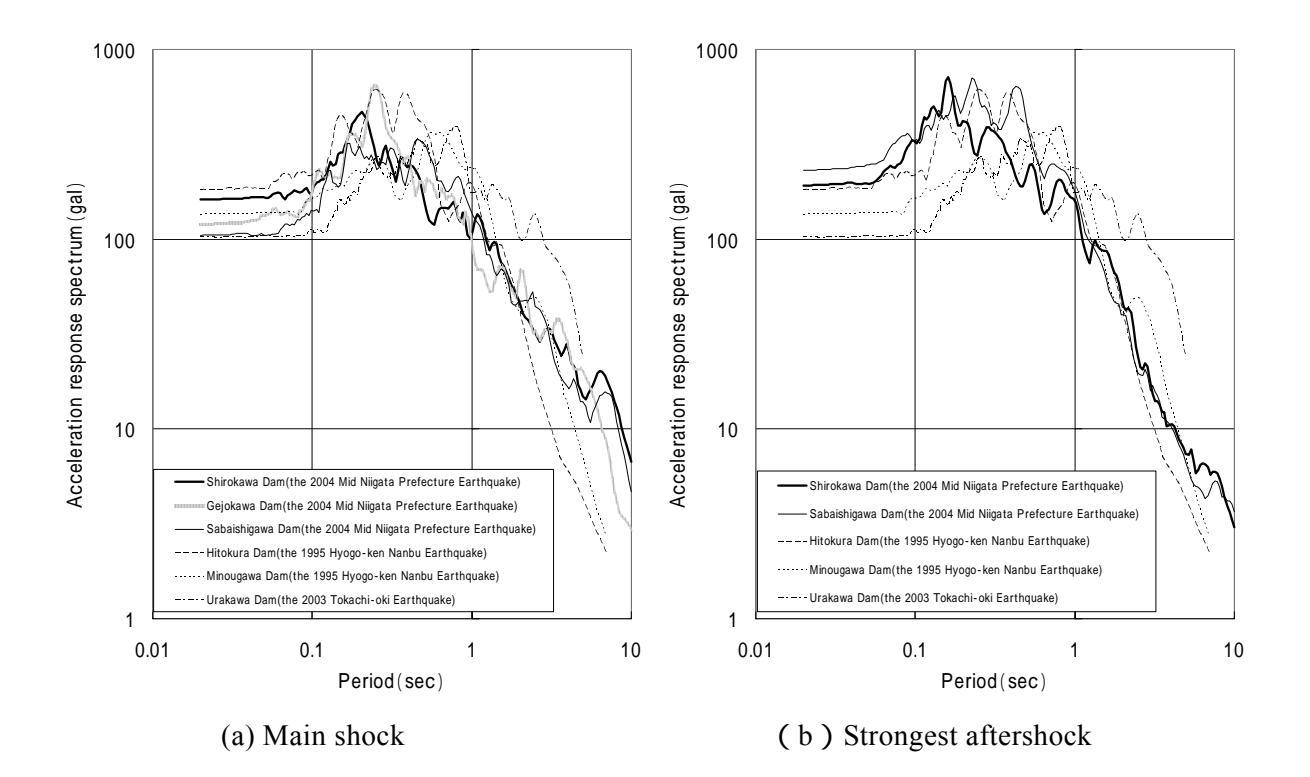
Fig. 12 Acceleration response spectrum (component in the upstream–downstream direction; damping ratio=5%)

Fig. 12 shows acceleration response spectra determined from the acceleration time-history waveforms shown in Figs. 10 and 11. For comparison, Fig. 12 also shows the acceleration response spectra measured at dam foundations near the hypocenter during the 1995 Hyogo-ken Nanbu Earthquake [9], which was an earthquake caused by active fault, and the 2003 Tokachi-oki Earthquake [3], which was a plate boundary earthquake.
