High Wind Damage to Buildings Caused by Typhoon in 2004

Yasuo Okuda¹, Yukio Tamura², Hiroaki Nishimura³, Hitomitsu Kikitsu¹ and Hisashi Okada¹

ABSTRACT

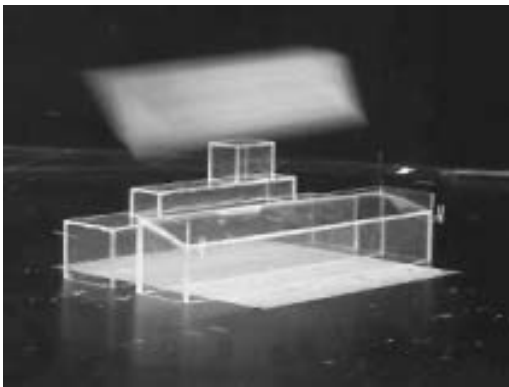
The size of the roofing material is 9 meter-by-41 meter and its weight is 7 ton. The Shinkansen service was suspended during 7 hours. The maximum 10 minutes mean wind speed of 16.0m/s and the maximum instantaneous speed of 36.4m/s were observed at the local meteorological observatory. The roof jumped upward and surprisingly passed over the signboard and the antenna on board apart and 10m in height 4m from the roof. Matsui *et al.*⁴⁾ carried out wind tunnel experiment to confirm the phenomenon as shown in Fig.9.

Fig.9 Experiment of Flying Roof Model by Matsui *et al.*⁴⁾
