# Damage Investigation and the Preliminary Analyses of Bridge Damage caused by the 2004 Indian Ocean Tsunami

Shigeki Unjoh<sup>1</sup> and Kazuo Endoh<sup>2</sup>

## ABSTRACT

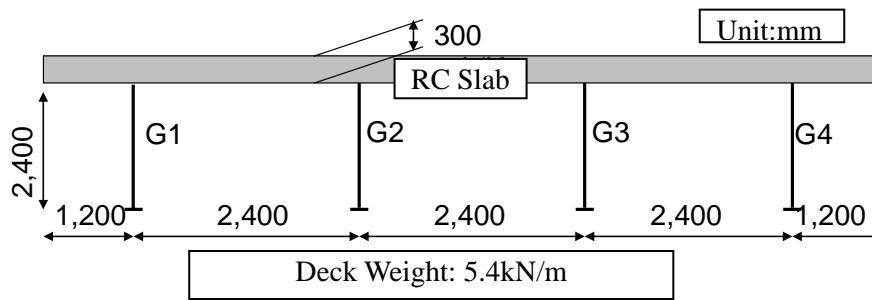
Figure 2 Assumed Deck Structure Analyzed

Figure 2 shows the section of the bridge superstructure analyzed. A steel I girder and the RC Slab with bridge length of 40m was assumed. The girder weight is assumed as about 5.4kN/m/girder. The deck is assumed to be supported by bearings. Deck height is assumed as 5m at the bearing level.

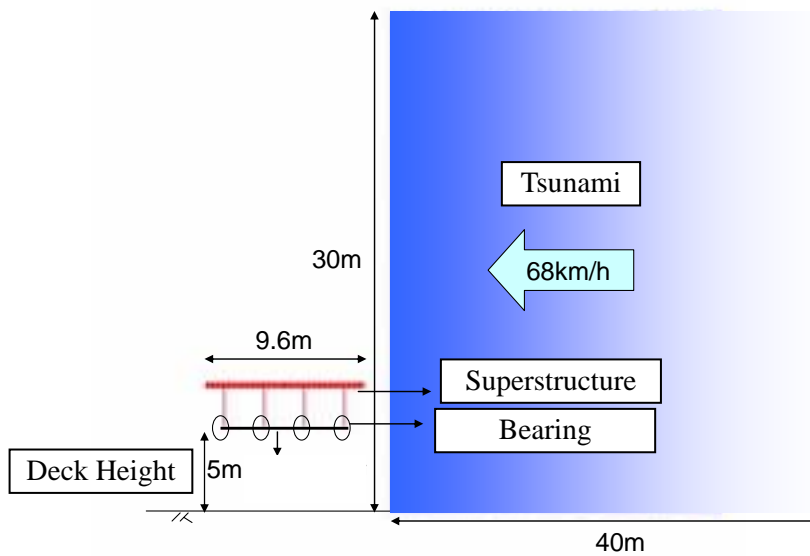
Figure 3 Assumed Effect of Tsunami

Figure 3 shows the assumed effect of Tsunami. Tsunami height is assumed as 30m considering the west coast at North Sumatra Island. And the velocity is assumed as 68km/h (about 20m/s) considering the observation and empirical equation. The analysis was made using the discrete element method assuming the particle of 10cm diameter. The flow was loaded from the right to left sides.

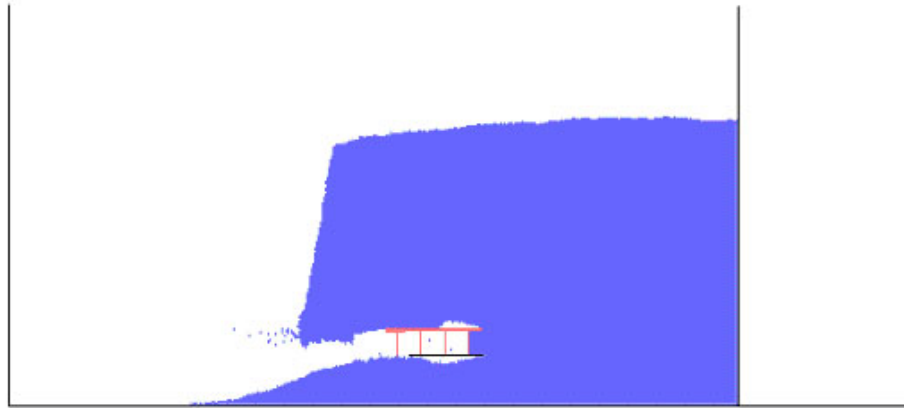
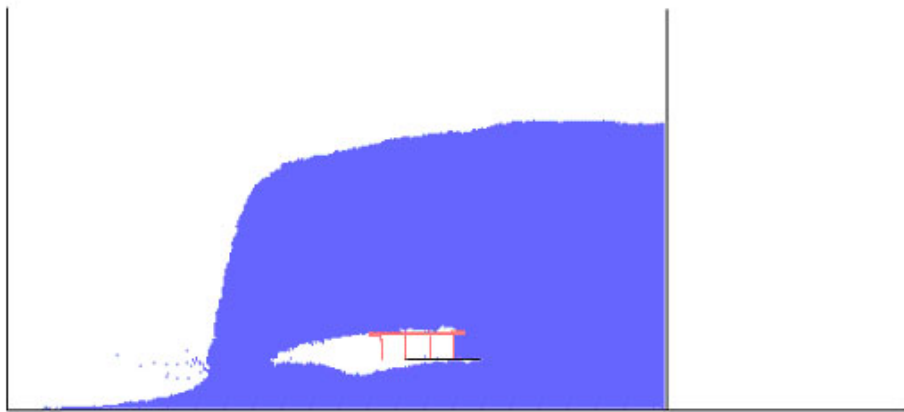
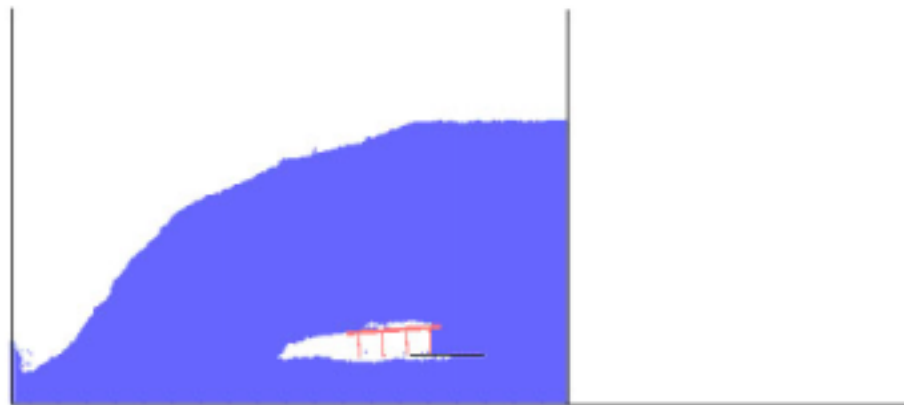
Figure 4 Examples of Time History Behavior

Figure 4 shows the time history behavior of the deck. It is found that the numerical analysis can roughly simulate that superstructure moves laterally by the effect of Tsunami. From this kind of analyses, forces which affect the bridge superstructures can be evaluated.
