# Outline of the Damage of Transportation Facilities and Geotechnical Structures by the 2009 L'Aquila, Italy Earthquake

## ABSTRACT

This is a reconnaissance report on the damage to transportation facility and geotechnical structures caused by the 2009 L'Aquila, Italy earthquake. Site investigation was conducted by the authors during the period of April 18-21, 2009. Presented is a discussion on the damage of transportation facilities. Geotechnical damage and ground motions are also presented.

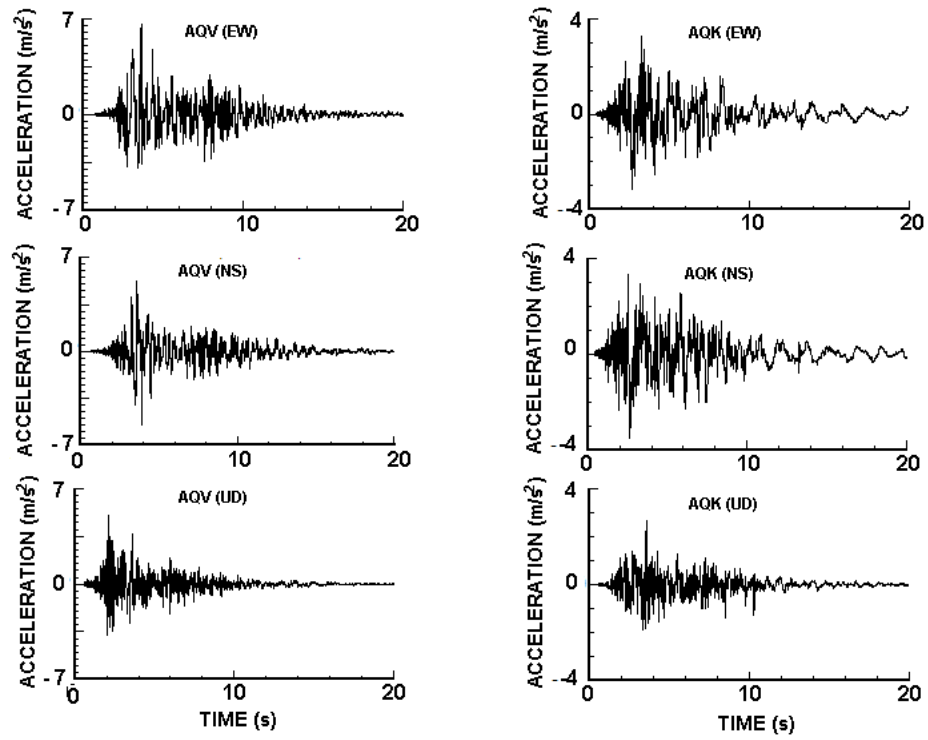
Fig. 4 Acceleration records at AQV and AQK stations

[Fig. 4](#) shows the acceleration records at AQV and AQK stations. It is of great interest that the amplitude of ground accelerations are not symmetric and their forms are different each other although the epicentral distances and the equivalent shear wave velocity  $V_{s30}$  of ground are almost the same.

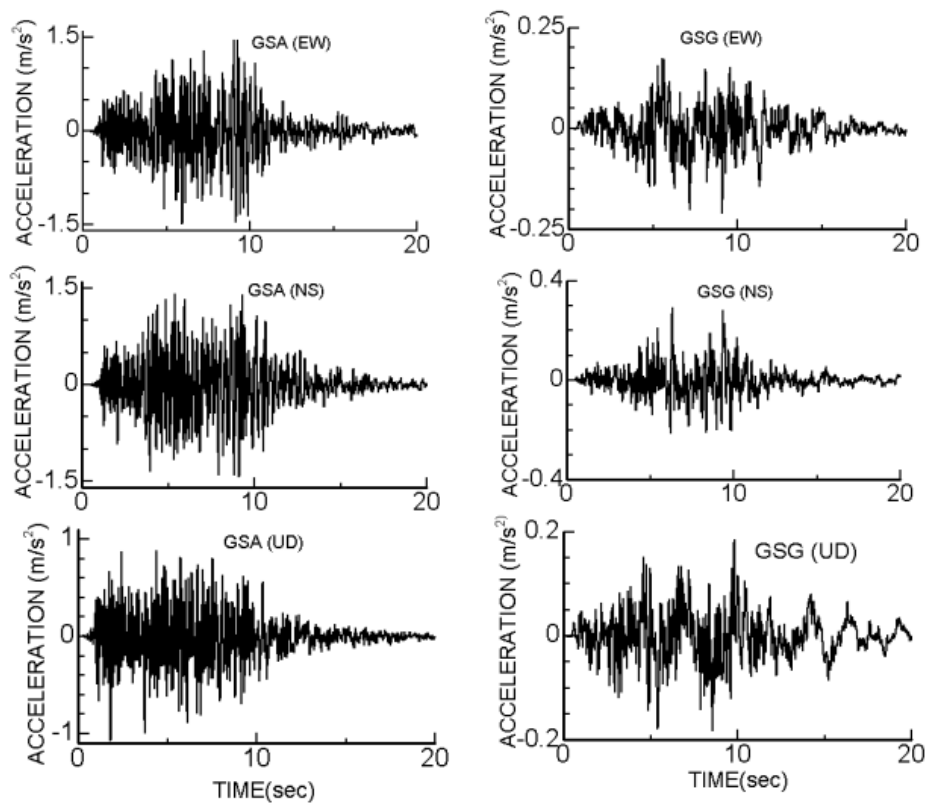
Fig. 5 Acceleration records at GSA and GSG strong motion stations

[Fig. 5](#) shows the acceleration records at GSA and GSG stations, which are reportedly founded on Eocene limestone with a shear wave velocity of 1 km/s. The GSA station is at Assergi and the GSG station is located in an underground gallery. Although the epicentral distances and ground conditions are the same, the acceleration at ground surface is amplified almost 15 times that in the underground gallery.

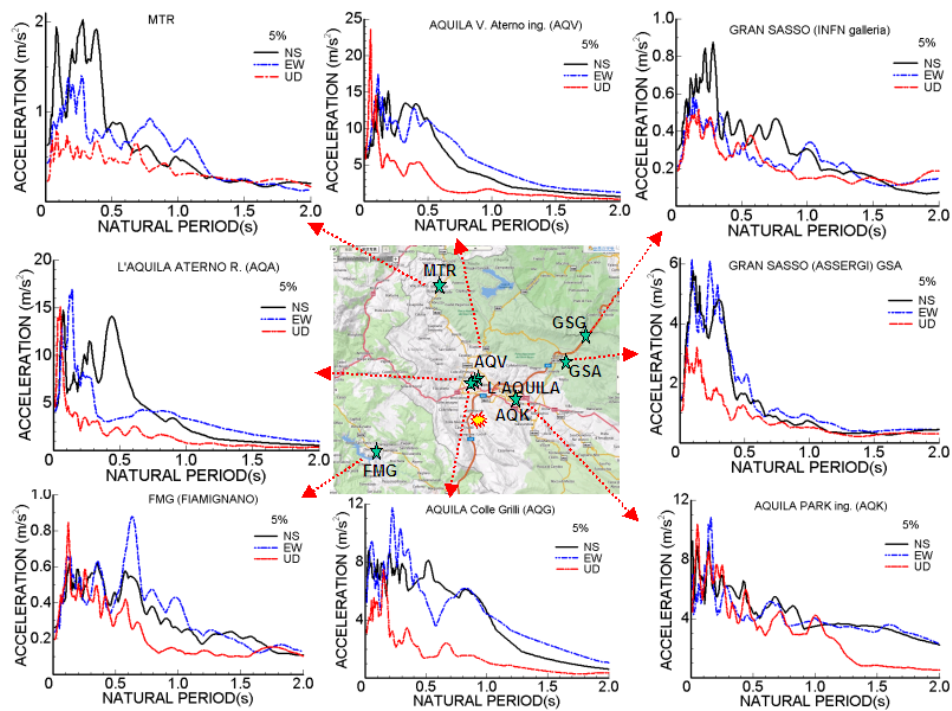
Fig. 6 Acceleration response spectra of selected strong motion stations

Acceleration spectra at some selected strong motion stations (AQV, AQK, AQA, AQG, MTR, FMG, GSA and GSG) are shown in [Fig. 6](#). The predominant periods of the recorded accelerations range between 0.05s and 0.4s in the lateral components. The predominant period of about 0.8 s at AQG station is noted as was pointed out by Luca et al. (2005). The spectral accelerations of vertical component are high at natural periods ranging between 0.05s and 0.1s.

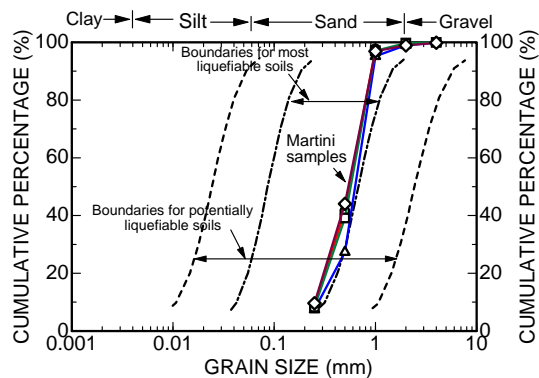
Fig. 9 Grain size distribution and comparison of liquefaction bounds

investigations, the authors found sand boils along Aterno River in the area called Martini, which is just south of the hill on which the old downtown of L'Aquila City is located. The river meanders in the area and it is likely to have resulted in sandy deposits at those meanders. At Martini district liquefaction created many NE-SW trending fractures parallel to the river embankment and they opened up as shown in Photo 10. Sand boiling as thick as 150 mm was observed in various locations. The movement of ground was towards SE direction. Table 2 and Fig. 9 show some physical properties and grain size distribution of sand boils, respectively, based on laboratory tests at Tokai University, Japan and Pamukkale University, Turkey. Boiled sand is almost homogenous and its grain size distribution falls within the easily-liquefiable bounds according to Japan Port and Harbour Research Institute classification (1997).
