# Damage to Dams due to the Iwate-Miyagi Nairiku Earthquake in 2008

## ABSTRACT

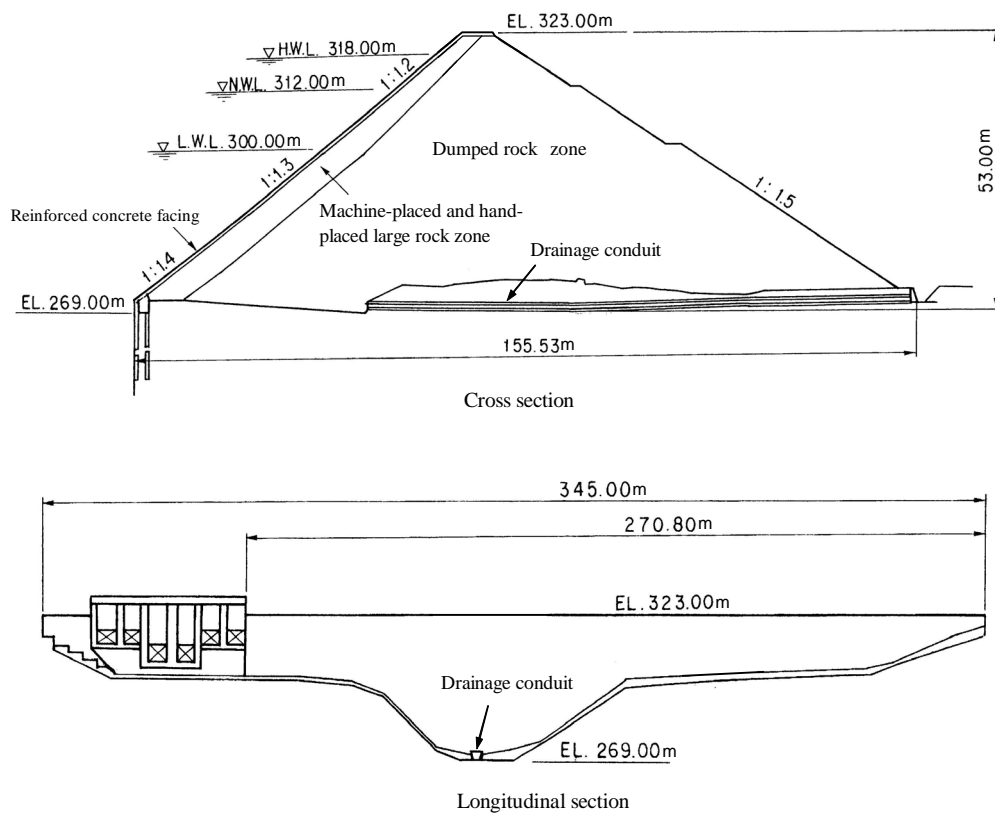
Fig. 3 Cross section and longitudinal section of Ishibuchi Dam

Ishibuchi Dam is a concrete faced rockfill dam (CFRD) with a dam height of 53m completed in 1953, and managed by Tohoku Regional Bureau, MLIT. Figure 3 is the cross section and longitudinal section of the dam. The upstream concrete face maintains the watertightness of dam body of this type of dam. No severe damage was found in the concrete face and its joints shown in Photo. 1.

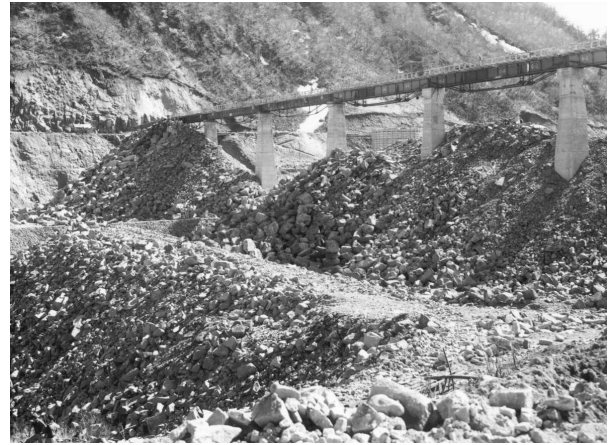
railing and pavement on the shoulder of the slope at the crest. On the downstream slope surface of the dam, projections were observed on the rock materials at the protruding parts of the wave on the crest pavement shown in Photos. 4 and 5, but damage of this kind was limited to high elevations. This dam was constructed by the dumped rock construction method as shown in Photo. 6 taken during construction. The piers for the railroad from where trucks dropped rock materials were left buried in the dam body. It is hypothesized that the whole dam body settled due to the earthquake, while the areas near the buried piers only settled a little. The maximum differential settlement is supposed to be about 50cm.

Photo.6 Ishibuchi Dam under construction by the dumped rock method in 1950's (The piers of tramway were buried.) (Courtesy by Kitakami River Integrated Dam Management Office, MLIT)
