# Damage to Buildings by EF5 Tornado in Iowa, U.S. on May 25, 2008

Hitomitsu Kikitsu<sup>1</sup> and Partha P Sarkar<sup>2</sup>

## ABSTRACT

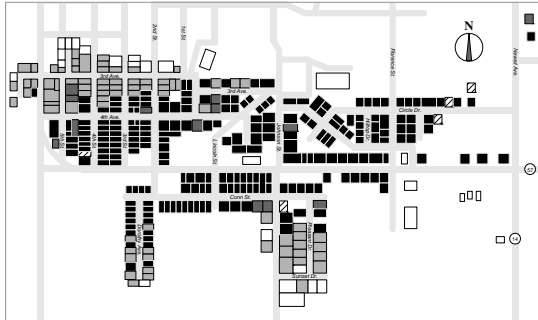
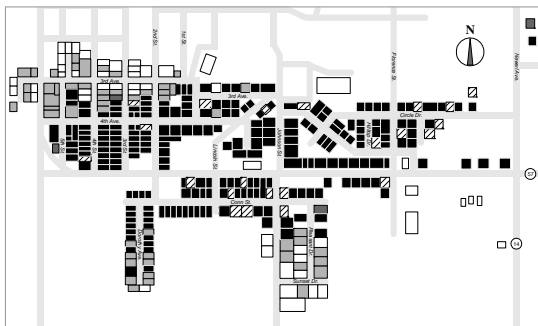
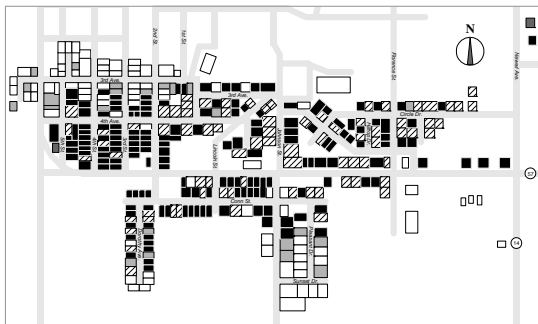
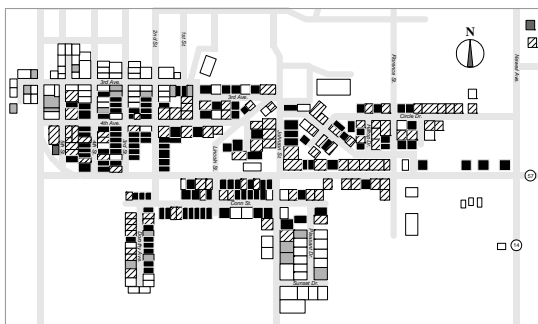
Figure 4 Progress in recovery of houses damaged by the tornado

These figures show that the recovery of damaged houses did not occur in the first month since the disaster struck, and that new construction has not started since two months after the disaster struck. At the elapsed time of four months, new construction of approximately half of the seriously damaged houses has been in progress, but construction of just only 10% of those has been completed.

Progress in recovery of houses damaged by the tornado is shown in Figure 4. Figure 5 shows the recovery progress of houses which suffered serious damage. Vertical axis in this figure indicates the ratio of recovery or completion, calculated as follows:

This post disaster survey also revealed that new construction method in all the seriously damaged houses chose continuous footing made from reinforced concrete as shown in Photo 35, because continuous footing that were damage and exposed, as shown in Photo 28, showed inadequate reinforcement.

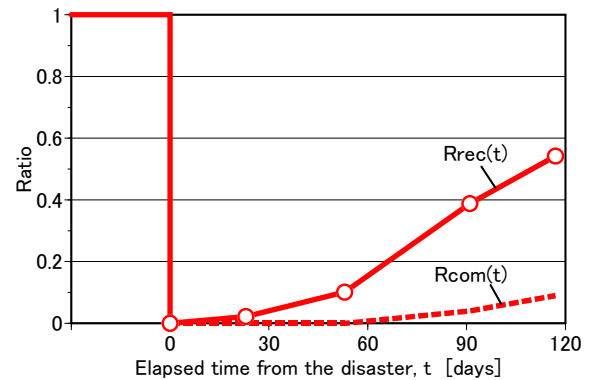
Figure 5 Ratio of recovery or completion of seriously damaged house vs. elapsed time

where  $R_{rec}(t)$ : ratio of recovery,  $R_{com}(t)$ : ratio of completion,  $t$ : elapsed time from the date of disaster,  $N(DOD \geq 5)$ : number of damaged houses with DOD of five or more,  $N_{rec}(DOD \geq 5, t)$ : number of damaged houses with DOD of five or more whose recovery has been already in progress at  $t$ ,  $N_{com}(DOD \geq 5, t)$ : number of damaged houses with DOD of five or more which has been replaced by new construction at  $t$ , respectively.
