Damage Investigation of Maturube Bridge during the 2008 Iwate-Miyagi-Nairiku Earthquake

ABSTRACT

2. DAMAEG INVESTIGATION OF MATSURUBE BRIDGE

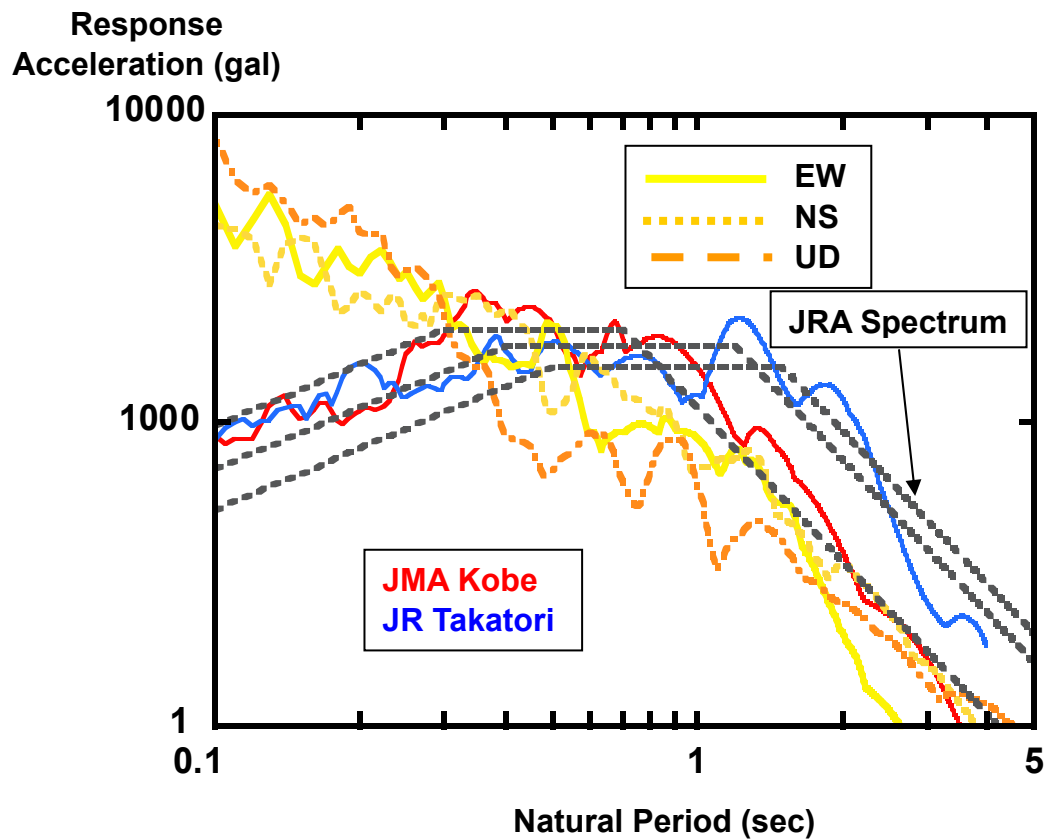
The National Research Institute for Earth Science and Disaster Prevention (NIED) reported the strong motion observation data. The strongest ground motion was observed at the IWTH25 station which was located by just a distance of 1.3 km from the collapsed bridge site. The maximum PGA was 1,143gal in NS, 1,433gal in EW, 3,866gal in UD, and 4,022gal as a combined value of these 3 components. It should be noted here that very strong UD acceleration with a very short period, which has not yet observed in the past earthquakes, was recorded. **Fig.1** shows the response acceleration spectrum of the IWTH25 record. It is found that the ground motion was very strong in the short natural period range less than 0.3s, but the shaking intensity decreases in longer natural period range than 0.3s. That means that the earthquake seriously affected on the short natural period structures but not so much on the longer natural period structures. For example, typical bridge structures with general spans and general height of substructures have the natural period of 0.5 to 1.0s, therefore, it was estimated that the shaking was not so strong effect on such bridge structures.

Fig. 1 Response Acceleration Spectrum of IWTH25 Station (NIED, KiK-Net)

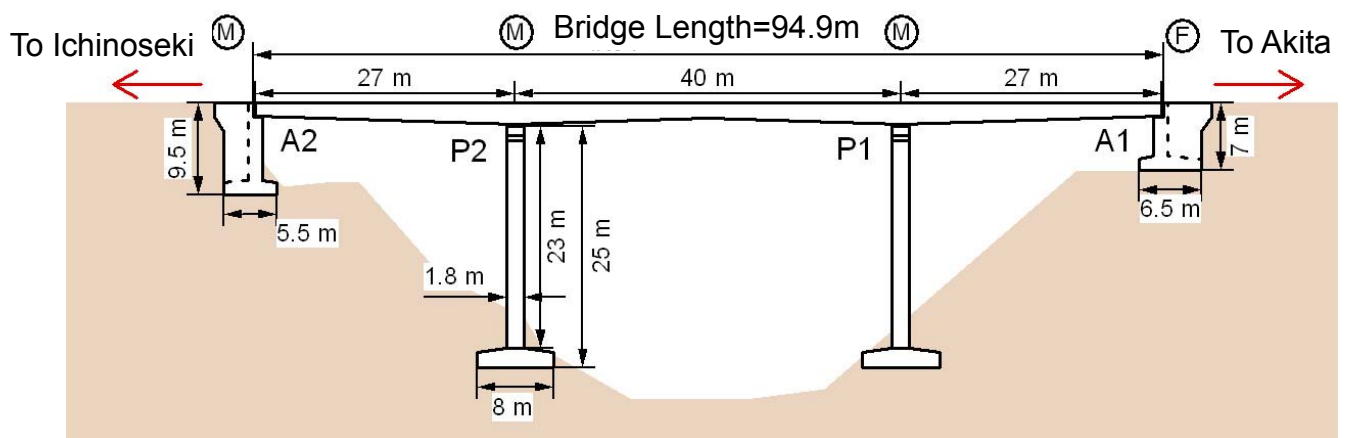
The Maturube Bridge was constructed in 1978 and managed by the Iwate prefectural government. It was 3-span continuous steel girder bridge with length of 94.9m (27m+40m+27m) as shown in **Fig.2**. The width of deck is about 10m. Two piers in the middle spans were RC wall type piers with height of 25m, and both abutments were an inverted T-shaped RC wall type. Ground condition is Type I (Stiff) according to the JRA highway bridge design specifications and therefore all foundations of piers and abutments were a spread type. Seismic coefficient

Fig. 2 Side View of the Maturube Bridge

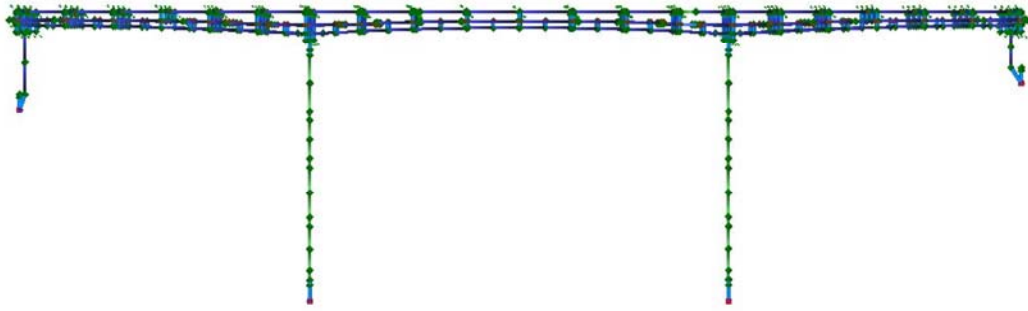
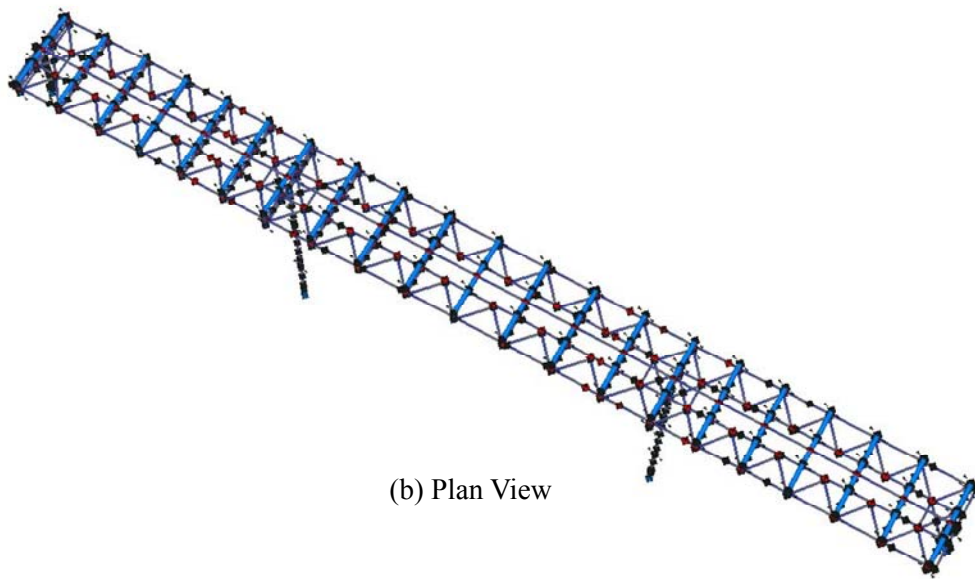
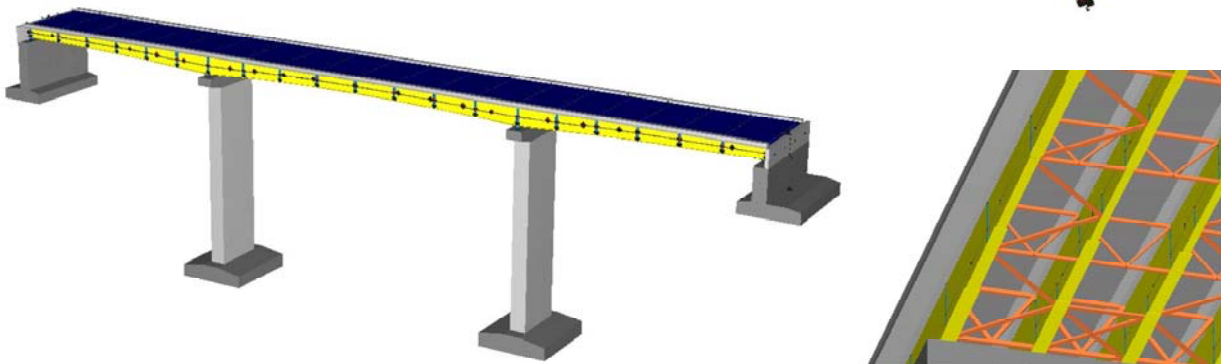
Fig. 5 Mathematical Model to Simulate Bridge Collapse

Fig.5 shows the mathematical model of the bridge. The superstructure was modeled as concrete slab and 4 steel girders considering the nonlinear behavior of materials. Movable bearing was modeled as nonlinear spring element considering the strength and fail of side stoppers. RC columns were modeled using fiber element model. The termination sections of the longitudinal re-bars were also considered. Abutments were modeled as linear element but the parapet walls were modeled as nonlinear fiber element model. Also to simulate the push-out failure of the parapet wall, the nonlinear shear spring element was provided at the bottom of the parapet wall. Backfill soil was model as spring element and the general soil stiffness was assumed because of the lack of the accurate soil data. Since foundations were spread type on the stiff ground, they are model as fixed to the ground.
