The Lessons Learned from Wenchuan Earthquake on Highway Bridges

W. Phillip Yen¹, Genda Chen², Mark Yashinski³,

ABSTRACT

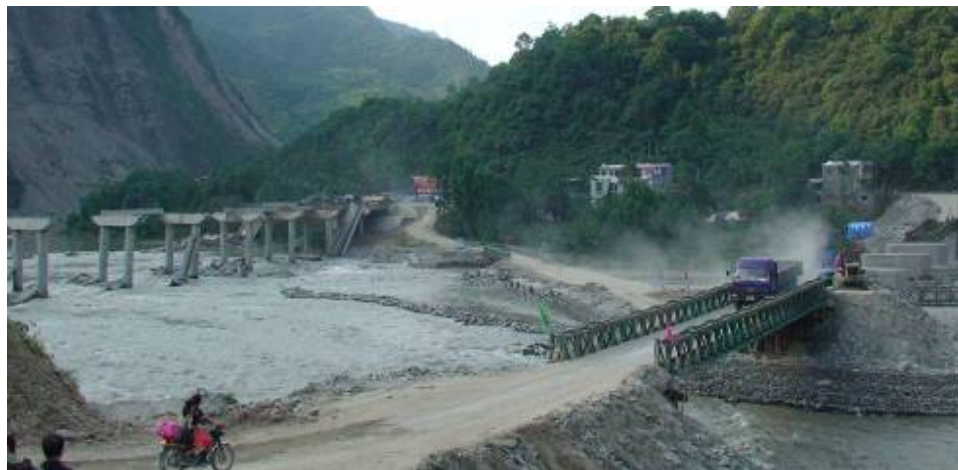
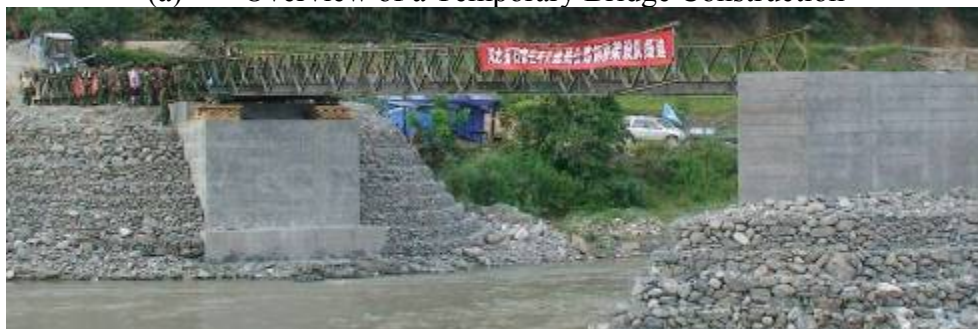
Figure 9: Construction of a Temporary Bridge

On the east side of the old and new bridges is a temporary structure that was being constructed by launching Bailey Bridges onto new RC pier walls at the time of field reconnaissance. As shown in Figure 9, vehicles were driving across the river on fill material laid over culverts in the meantime.

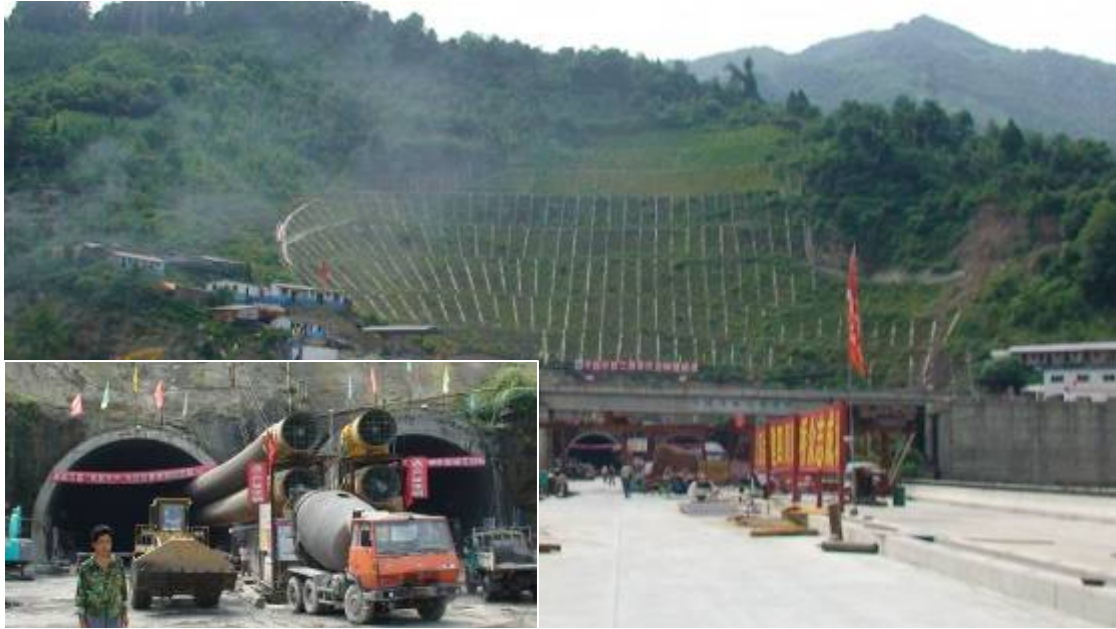
Figure 11: Miaozihiping Tunnel

Miaozhiping Highway from Dujiangyan to Wenchuan was under construction during the earthquake. It consists of a tunnel at Zhipingpu and a bridge over the Ming River as schematically shown in Figure 10. The Tunnel is shown in Figure 11 and experienced little damage during the earthquake. The highway was scheduled to open in October, 2008. Near the highway is the well-known Dujiangyan Dam. The bridge of approximately 1.4 km long consists of three parts: a main span and two approach spans as shown in Figure 12.

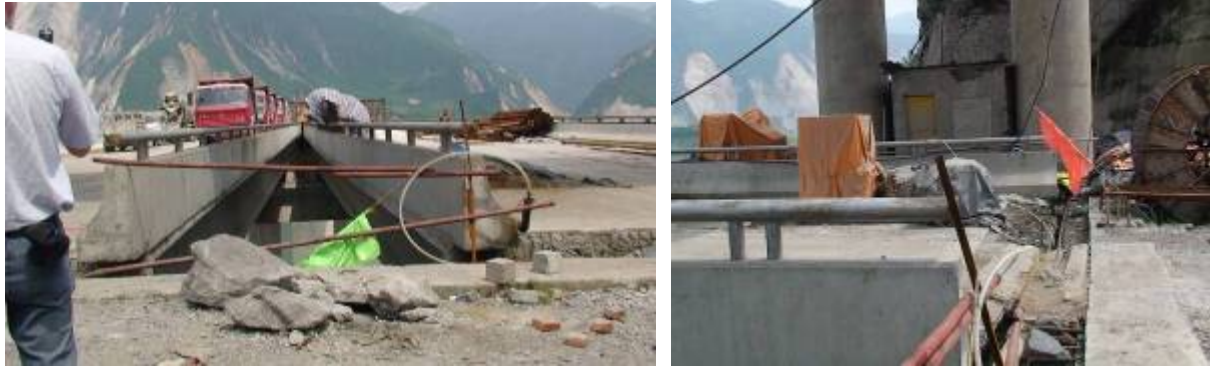
Figure 16: End of the Miaozhiping Bridge and its Overpass for the Old Highway

The end of the Miaozhiping Bridge near the tunnel is divided into two parallel elevated structures in order to guide two ways of traffic in alignment with the twin tunnels as indicated in Figure 16. Over the southeast approach is a four-span RC girder bridge built in 2004. The bridge supports the old highway from Dujiangyan to Wenchuan and Juzhaigou. The old highway was built along the mountain terrain, perpendicular to the Zhipingpu Highway at Zhipingpu Town. The bridge showed shear key failures and embankment cracking as shown in Figure 17.

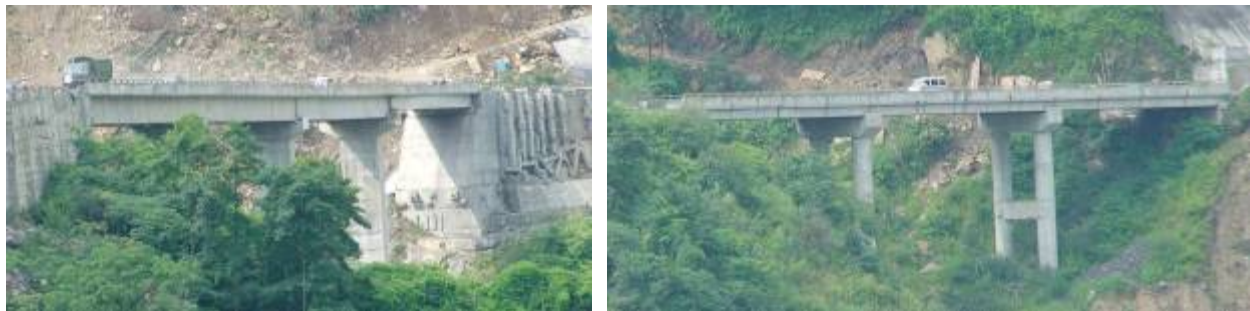
Figure 18: Bridges in the Vicinity of Miaozhiping Bridge

In the vicinity of Miaozhiping Bridge there are several RC girder bridges as shown in Figure 18.
