## Damage of Bridges during 2011 Great East Japan Earthquake

### ABSTRACT

This paper presents damage of road and railway bridges during the Great East Japan earthquake and tsunami on March 11, 2011 based on a JSCE damage investigation. Ground motion induced damage and tsunami induced damage of both road and railways bridges are presented.

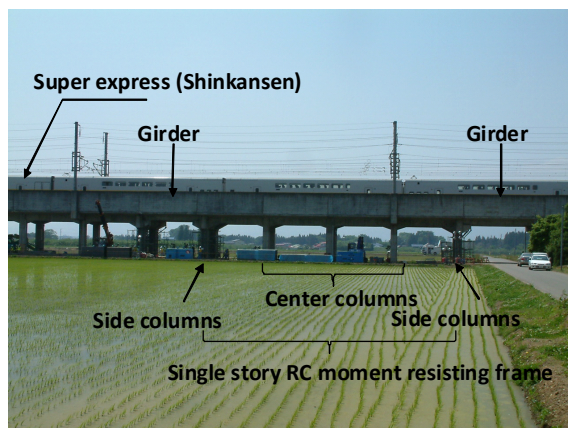
Photo 13 Single story RC moment resisting frame pier with a Gerber girder at both sides

It should be noted that all viaducts which suffered damage during 2011 Great East Japan earthquake had not yet been retrofitted. Most viaducts in Iwate-ken were single story RC moment resisting frame with a Gerber girder at both sides. Damage concentrated at the side columns during 2003 Sanriku-Minami earthquake as shown in Photo 13. Since the side columns were shorter than the center column, a parameter  $\alpha$  defined as a ratio of the shear capacity to the flexural capacity was smaller in the side columns than the center columns, which

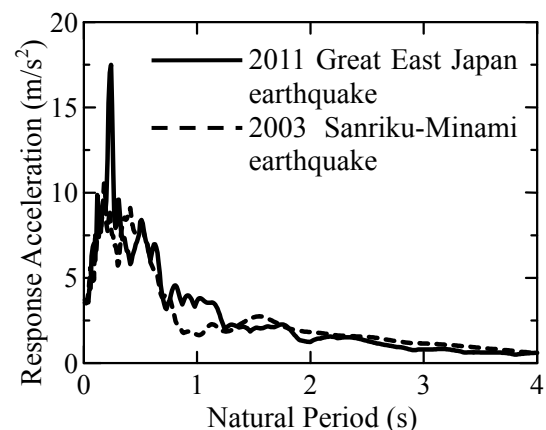
Fig. 5 Response accelerations in 2003 Sanriku-Minami earthquake and 2011 Great East Japan earthquake

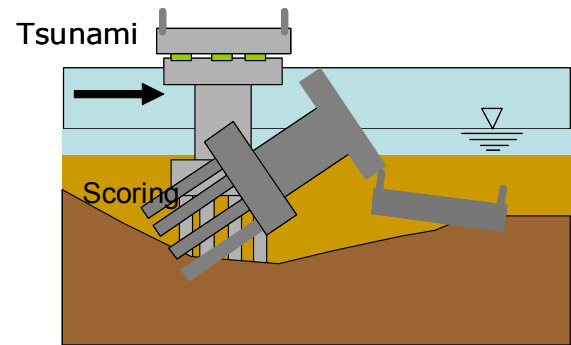
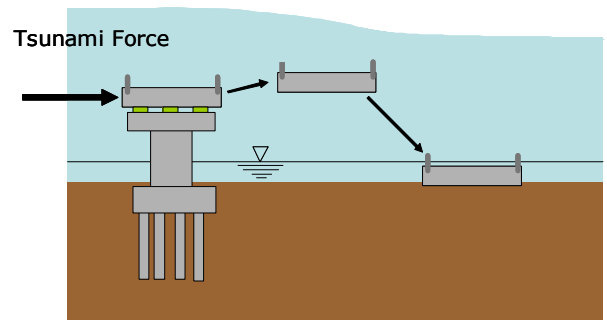
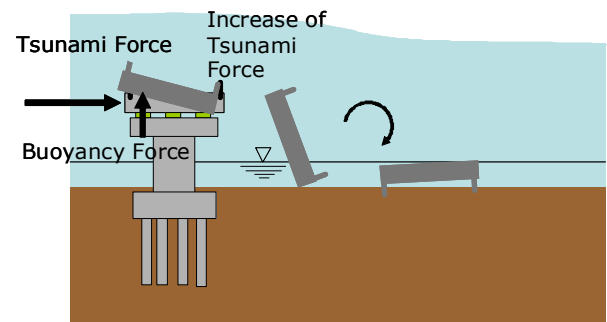
(a) Scoring

(b) Transverse offset

(c) Offset after overturning

Fig. 8 Possible mechanism of bridge damage by tsunami

for preventing excessive deck displacement in the longitudinal direction. It is important to know that none of those devices tilted or were detached from the pier which must have happened if the decks were simply washed away laterally. It is likely that the decks were uplifted by tsunami buoyancy force and then they were washed away. Steel plate bearings used in this bridge was very simple as shown in Photo 22 such that both uplift and lateral force capacities were limited.

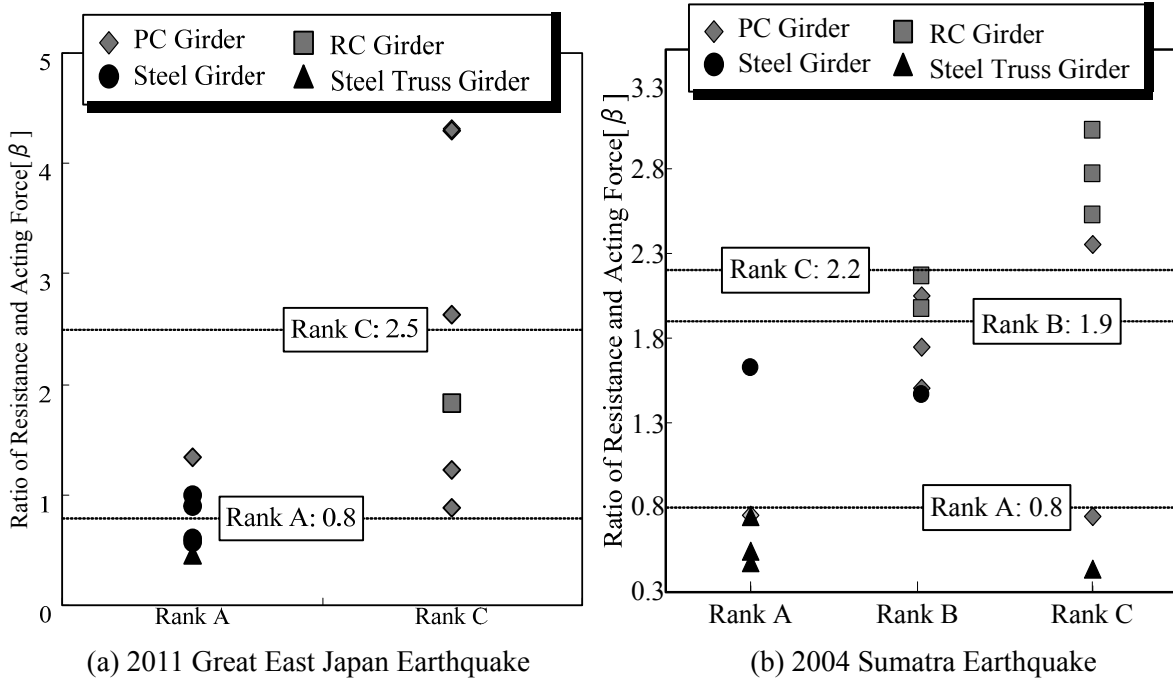
Fig. 9 Correlation of  $\beta$  value with damage ranks
