# Port Damage from Tsunami of the Great East Japan Earthquake

Takashi Tomita<sup>1</sup>, Gyeong-Seon Yeom<sup>2</sup>, Daisuke Tatsumi<sup>2</sup>, Osamu Okamoto<sup>3</sup> and Hiroyasu Kawai<sup>4</sup>

This paper presents tsunami damage in ports caused by a tsunami of the Great East Japan Earthquake. The tsunami higher than tsunamis for plan and design of tsunami disaster mitigation structures such as tsunami breakwaters, seawalls and etc. caused destruction in some structures. Furthermore, the tsunami higher than the expected tsunamis for tsunami disaster mitigation plan in communities overflowed the tsunami disaster mitigation structures, and therefore caused devastating inundation in the communities. The tsunami whose inundation was deep on land changed big vessels and oil tanks into tsunami debris.

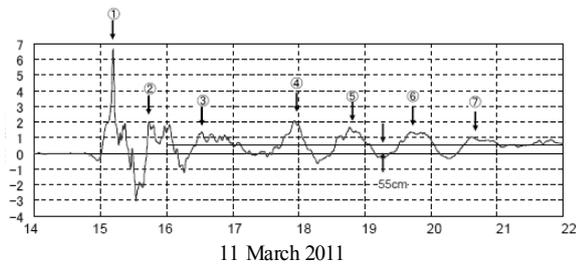
Buoys with a GPS sensor which have been installed offshore a coast in the Tohoku region [1] measured the tsunami propagating in the Pacific Ocean [2]. Figure 1 indicates a tsunami profile measured off Kamaishi Port as an example. Although the water depth is 204 m at the measurement point, the maximum tsunami height is 6.5 m. This high tsunami in the offshore region is enlarged due to wave transformation in shallower water depth region. The tsunami 0.5 m high was still measured 6 hours later after the

earthquake shock. Uplift 0.55 m of the mean water level after the quake may indicate subsidence of land where a reference point was set to improve accuracy of vertical measurement with GPS.

Fig. 1 Tsunami measured with GPS Buoy off Kamaishi Port.

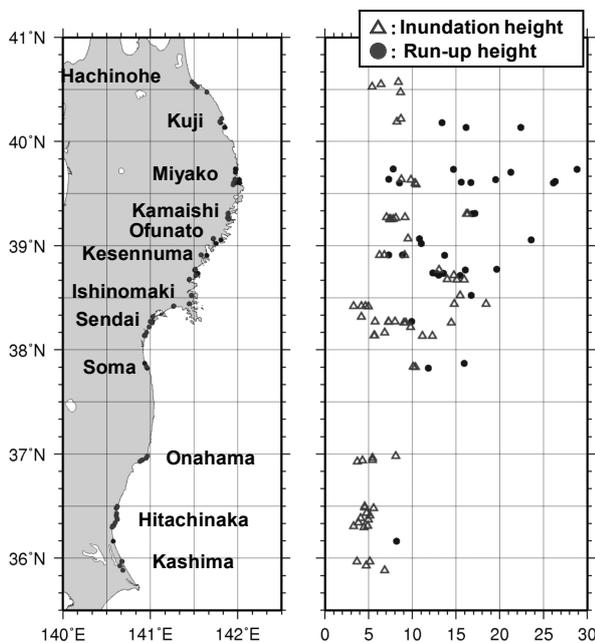
Fig. 2 Tsunami trace heights measured in major ports

Figure 2 indicates heights of tsunami trace measured by teams dispatched to major devastated ports by the Port and Airport Research Institute [3~5]. In the figure, (I) and (R) indicate inundation height and runup height, respectively. These values are height above the estimated tide level at the time of tsunami arrival.

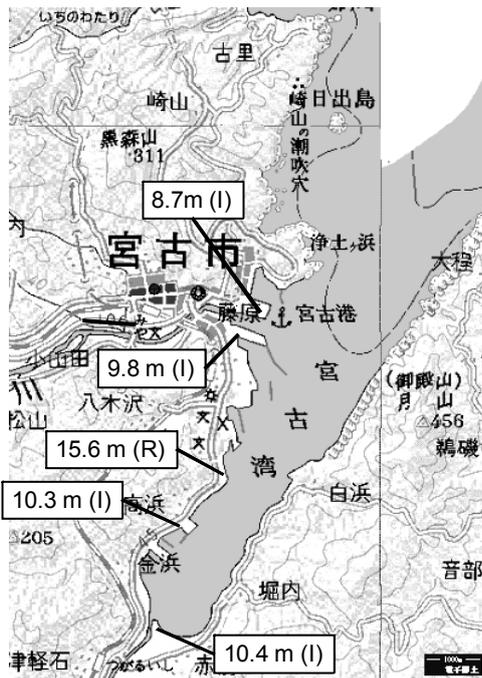
In the Miyako bay including Miyako Port, almost same tsunami inundation heights were measured, as shown in Figure 10. The tsunami of 10 m overtopped a protection dike and inundated residential areas as shown in Figure 11. Vessels were landed on wharfs in the port. Logs and cars were also floated and impacted houses, as shown in Figure 12.

Fig. 10 Tsunami trace heights in Miyako Bay
