## ASCE/JSCE Tohoku Tsunami Investigation of Structural Damage and Development of the ASCE 7 Tsunami Design Code for Buildings and Other Structures

by Gary Chock<sup>1</sup>

#### ABSTRACT

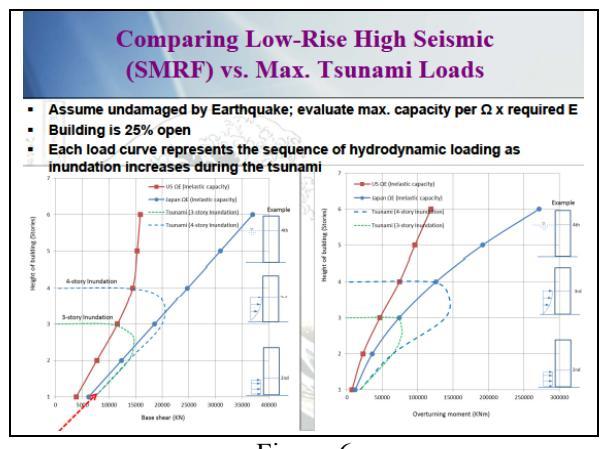
Figure 6 Figure 7 shows a comparison of a prototypical low-rise reinforced concrete building.

Structures of all material types can be subject to general and progressive collapse during tsunami. Figure 6 shows a comparison using a prototypical low-rise steel building of various heights.
