Nondestructive Inspection of the Suspender Ropes in a Suspension Bridge

Hiroaki HOASHI¹⁾, Takeshi SUGIMOTO²⁾

Two suspender ropes at Innoshima Bridge which elapsed 16 years after completion were removed and inspected to verify the state of interior corrosion. As the result, corrosion was found to be progressing inside the suspenders comparing with its surface, and the circumstances associated with the corrosion could be elucidated.

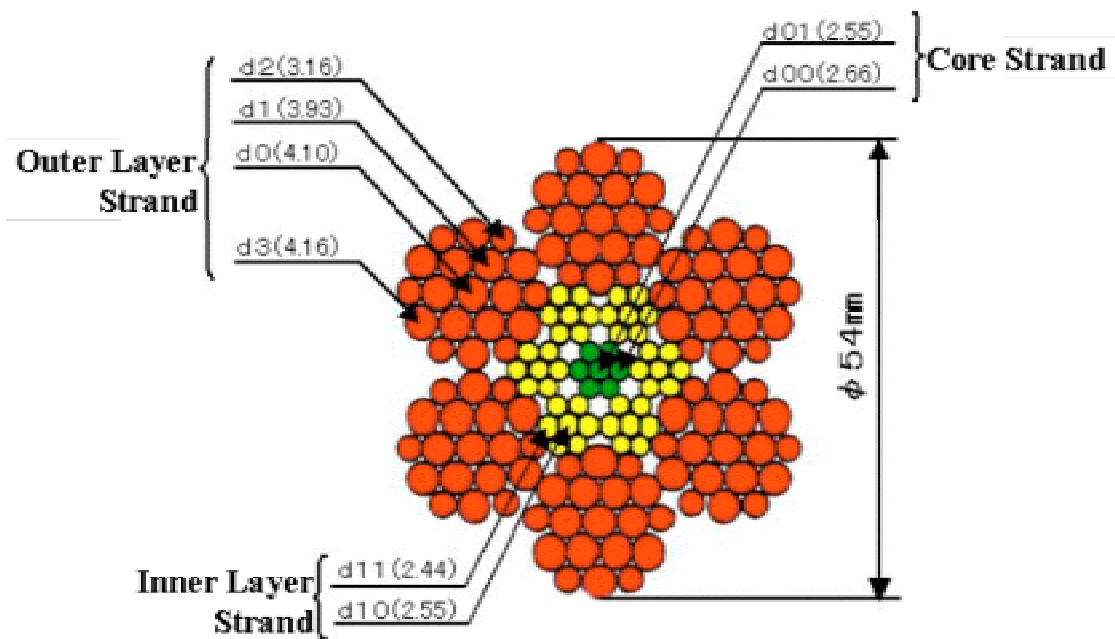
Fig 1 Cross Section of Suspender Rope

Suspender ropes from the Innoshima Bridge are CFRC cables with 54 mm in diameter. **Fig 1** shows a cross-section of the rope. The rope is composed of galvanized steel wires and painted on its outer surface as specified in **Table 1**.

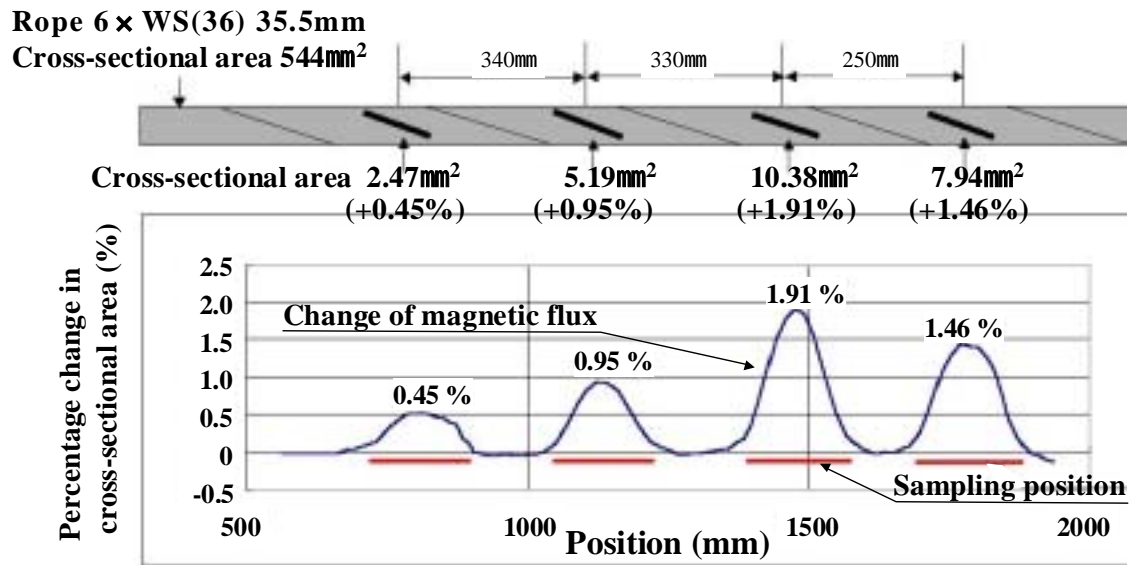
Fig 5 Result of Continuous Measurement Test by Main Flux Method in Laboratory

Prior to on-site inspection, laboratory testing was carried out using the continuous-measurement main flux method to evaluate changes in magnetic flux and magnetic field intensity. The measuring apparatus was moved along a 35.5-diameter rope with artificially created defects (four different patterns of changes in cross-sectional area at intervals of approximately 300 mm) to measure changes in magnetic flux and field intensity. **Fig 5** shows the results. The measured change of magnetic flux resembles the change in cross-sectional area caused by the artificial defects. The magnetic field intensity also changes at each artificial defect. These results indicate that the continuous-measurement of main flux method is effective in evaluating the extent of corrosion in suspender ropes.
