Anti-subsidence Measure Using King-post Cables against Subsidence in A PC Box Girder with Central Hinge

Takeshi SUZUKI¹⁾, Shigeru MATSUMOTO²⁾, Kousuke WAKATSUKI³⁾,
Hideki MANABE⁴⁾

Abstract: Four dyvidag bridges with hinge on the Hanshin Expressway Network were found subsiding in the central hinge region. Displacement was most significant in the Kireuriwari Viaduct of the Osaka Matsubara Route which exhibited a subsidence of more than 30 cm from the initial level. Anti-subsidence measure was investigated as a part of the major repair work on this route in fiscal 2003. Through comparative studies between a composite truss, external cables installed inside the box girder and other proposals, a king post cable structure was chosen because of its advantages in terms of local and structural conditions of the bridge. This method was to install new struts to the underside of the main girder and lay external cables eccentrically. This report covers detailed design of the king post cable reinforcement technique.

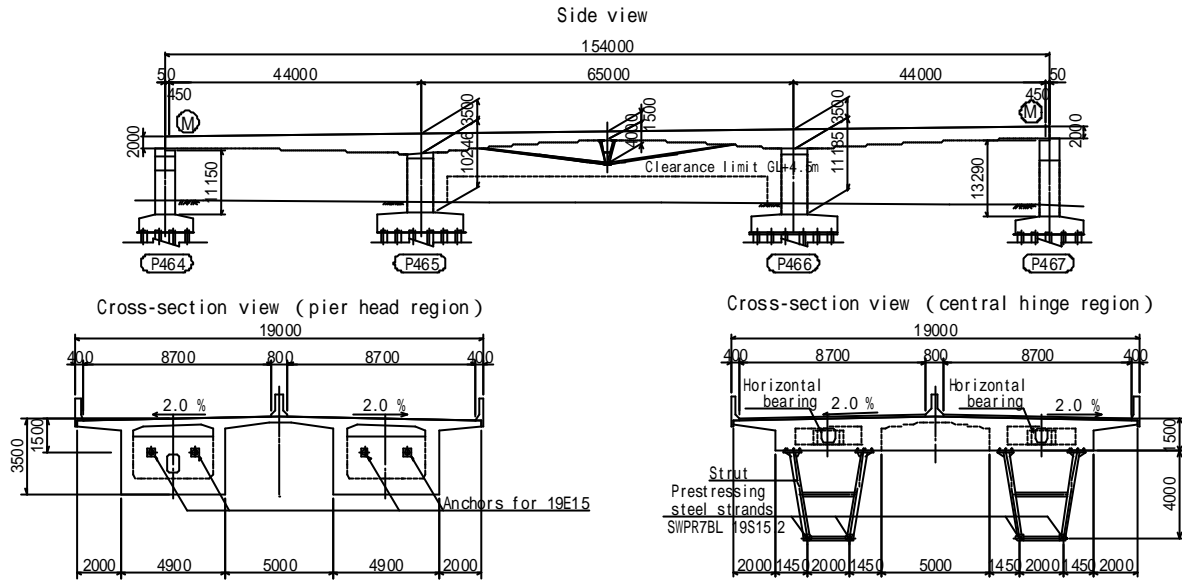
Fig. 2 General structural views of the Kireuriwari Viaduct

Structure	continuous 3-span prestressed concrete rigid frame twin main girder bridge with hinge
Bridge length	154.0 m (span lengths: 44.450 + 65.000 + 44.450 m)
Width	0.400 + 8.700 + 0.800 + 8.700 + 0.400 = 19.000 m
Live load	B live load (TL-20 at construction)
Gradient	incline: 1.167%; crossfall: 2.0% (upward gradient)
Bearings	8 roller bearings, 162 tf (overall)
Central hinged shoes	4 Gelenk shoes + 2 horizontal rubber bearings (overall)
Concrete strength	superstructure: 40 N/mm ² ; substructure: 24 N/mm ²
Prestressing steel	internal cable: SBPR 930/1180 (dia. 26 mm; existing) external cable: SWPR7BL 19S15.2
