# Detailed Investigation of PC Cable-stayed Bridge Damaged in the 1999 Taiwan Earthquake

Kenji KOSA<sup>1)</sup> and Kenji TASAKI<sup>2)</sup>

## ABSTRACT

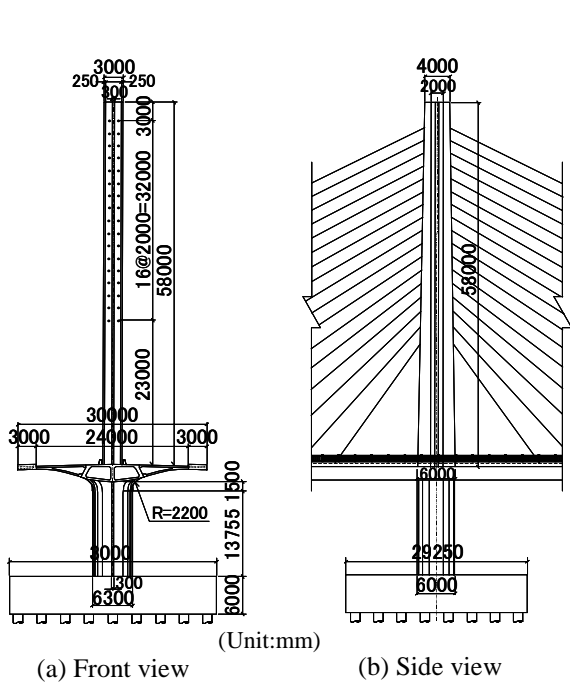
Fig. 3 Structure of the main pylon

The main girder of this bridge consists of arc-curved one box girder with two cells. The girder height is 2.75 m, the girder width is 24.0 m and the span length is @  $120 \times 2 = 240$  m. The main pylon is an RC column, 58 m in height, having a deformed diamond shaped cross section with a hollow, measuring 3.0 m x 4.0-6.0m, as shown in Figs. 3 and 4. The cables are arranged in two rows. In one row, 17 cables are arranged on each side of the main pylon. The pier below the main pylon is an oval-shaped RC column measuring 6.0 x 6.3 m, as seen in Fig. 5. The Foundation below the main pylon is the cast-in-place pile type ( 1500). The concrete strength (  $f_{ck}$ ) is  $34.3 \text{ N/mm}^2$  for all of the main girder, the main pylon, and the pier.

As to the progress of retrofit as of November 2002, Ji-Ji-Da Bridge was already open for service, but the pullout cable was still left as it was and a bent support was still in place. However, the bottom of the main pylon had been repaired with concrete jacketing and the bottom of the pier with steel jacketing.

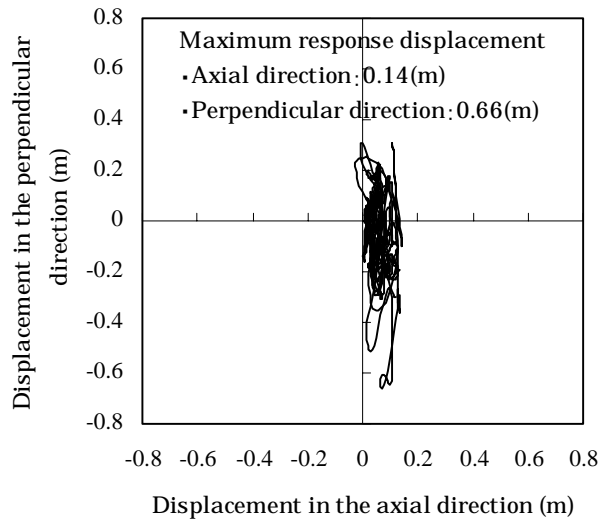
Fig. 13 Response-displacement hysteresis at the top of the main pylon

From the above results, it is considered that the seismic motion acted at the bridge area was probably much stronger than that given by the TCU078 original waveforms. Hence, we then used the seismic motion having approximately the same scale of maximum acceleration with that estimated by the NCREE as the input waveforms (Corrected TCU078) which are shown in Fig. 11. Figure 13 shows the response history in the axial and perpendicular directions taken at the top of the main pylon when the corrected TCU078 was input. It is seen in this figure that the maximum response displacements in the axial and perpendicular directions at the top of the main pylon are 0.14 m and 0.66 m, respectively, which means that the response in the perpendicular direction is predominant.

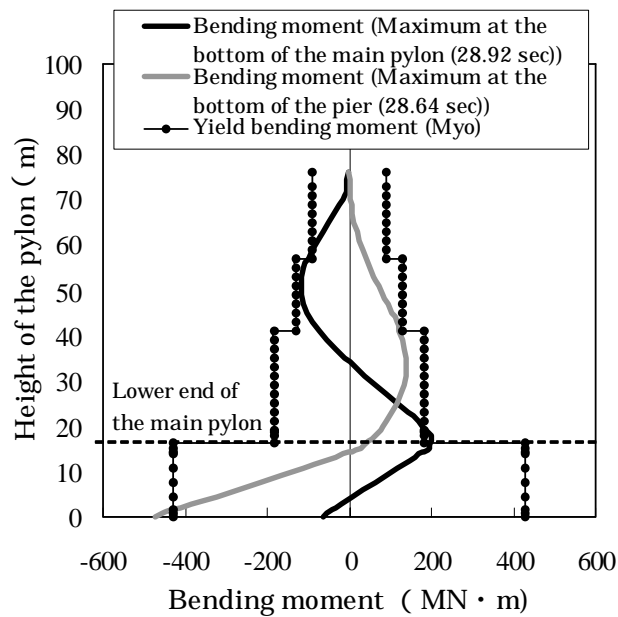
Fig. 16 Flexural strength at the main pylon and the pier and the distribution of bending moment

As seen, the pier bottom failed by the deformation of the 5<sup>th</sup> mode and the pylon bottom by that of the 9<sup>th</sup> mode, and then the nonlinear response advanced.

- (3) With regard to the cause of damage to the perpendicular direction of the main pylon, it was found from the nonlinear time history response analysis that the pier bottom reached yielding by the predominance of the 5<sup>th</sup> deformation mode and the pylon bottom reached yielding by the predominance of the 9<sup>th</sup> deformation mode, and then the nonlinear response advanced.
