The Collapse Mechanism and the Temporary Restoration of Omori Bridge Damaged by the Storm Surge of Typhoon No.18 in 2004

Shinya OKADA*, Hiroshi MITAMURA**, Hiroyuki ISHIKAWA***

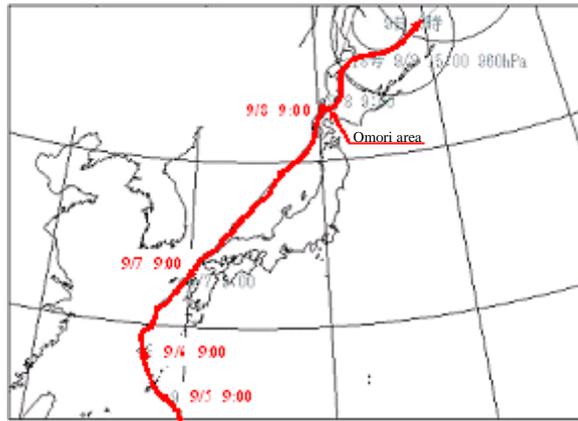
Typhoon Songda formed in the South Pacific near the Marshall Islands on August 28, 2004, and approached the west coast of the Oshima Peninsula (Hokkaido, Japan) at around 1 a.m. on September 8. The typhoon headed north along the coast, arriving at Omori Bridge shortly after 5 a.m. The forward speed then decreased to 35 km/h, and the typhoon slowly started to leave Hokkaido from 2 p.m. (Figure 1).

Figure 1: Course of Typhoon Songda

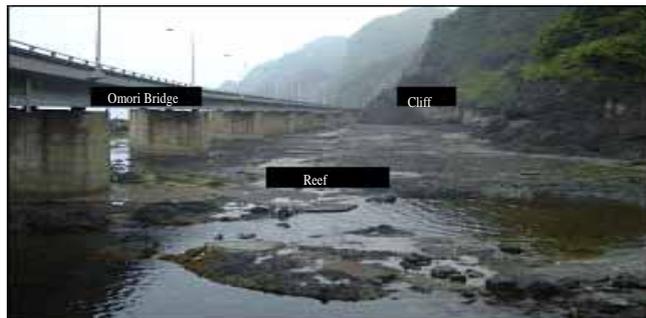
Omori Bridge is built on a rocky reef (Photo 1), whose elevation is about +0.5 m. The elevation drops abruptly to -10 m beyond the offshore end of the reef, where wave dissipating concrete blocks are installed. On the mountain side of the bridge, there is a sheer cliff that embays the reef (Figure 2 and Photo 4).

Photo 1: Local topography (reef and cliff) at Omori Bridge

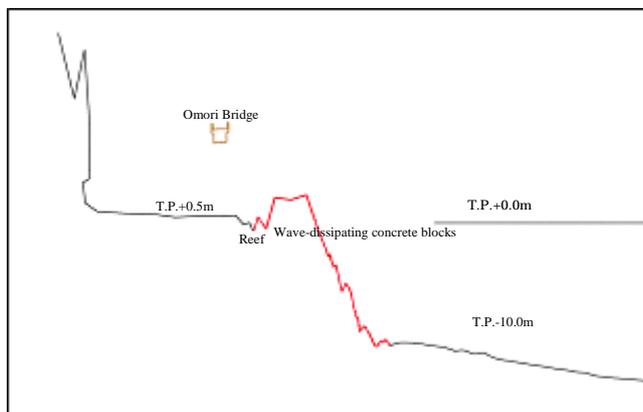
Figure 2: Topographic profile of Omori Bridge site

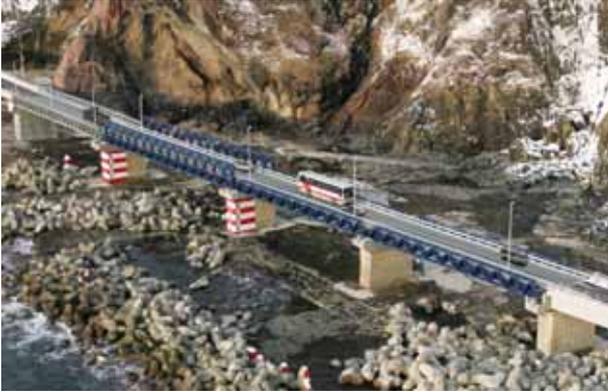
After the collapse, Omori Bridge was quickly restored and was returned to service on December 8, 2004 (Photos 8 and 9).

Photo 8: Restored bridge in service (1)

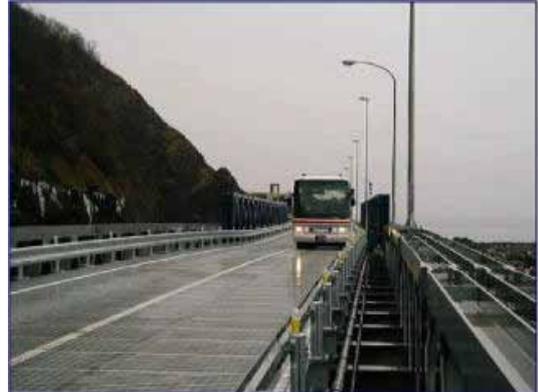
Photo 9: Restored bridge in service (2)
