# **Introduction of A Methodology to Mitigate Tsunami Disaster by The Pre-evaluation of Tsunami Damage Considering Damage Investigation of 2004 Tsunami Disaster in the Indian Ocean**

## **1. Damage Investigation of 2004 Tsunami Disaster in the Indian Ocean**

### **1.2 Road Damage in Sri Lanka**

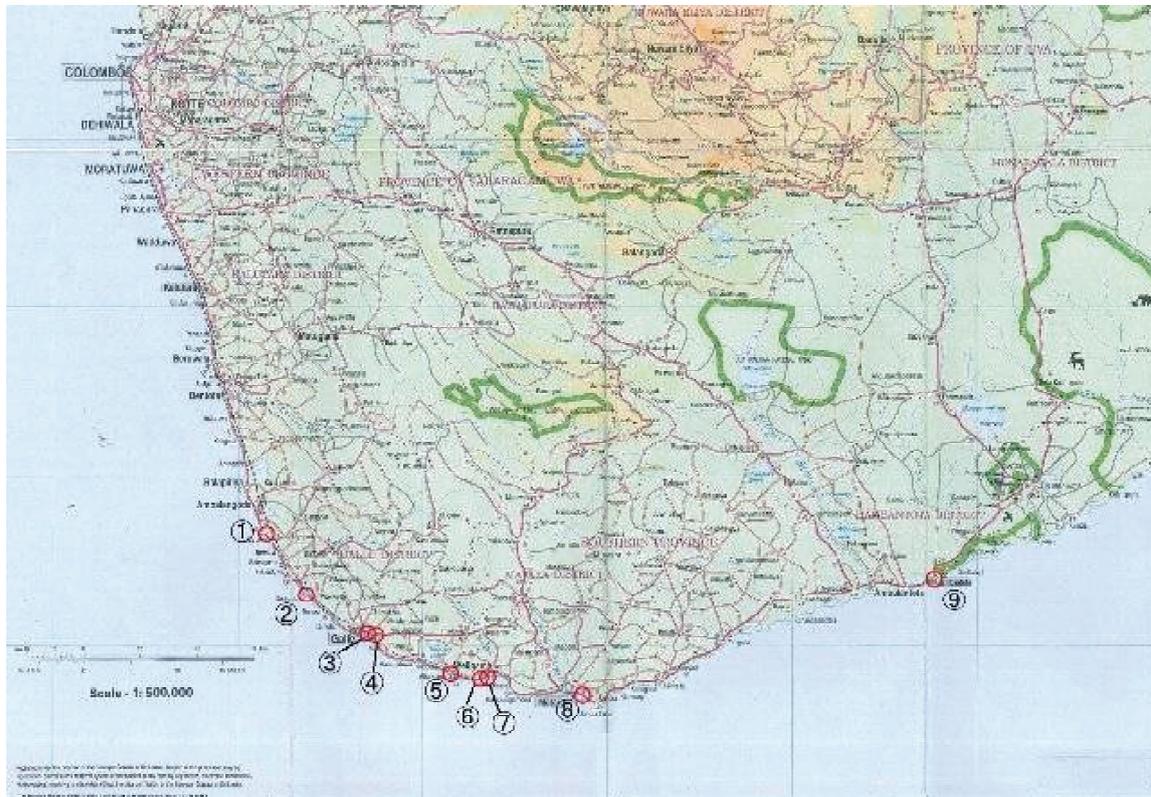
Figure-1. Locations of the Photos Taken (The South Coast of Sri Lanka)

With regard to collapsed bridges, Erosion at the piers were observed. It is considered that bridge collapse was caused by erosion of pier, but direct impact of wave force is not cause of collapse. In addition, generally the damage to the roads was small even though damage along the road was serious. For example, in Kahawa where a train was washed away, the damage was enormous; however, there were some roads and a bridge in the area that went undamaged.

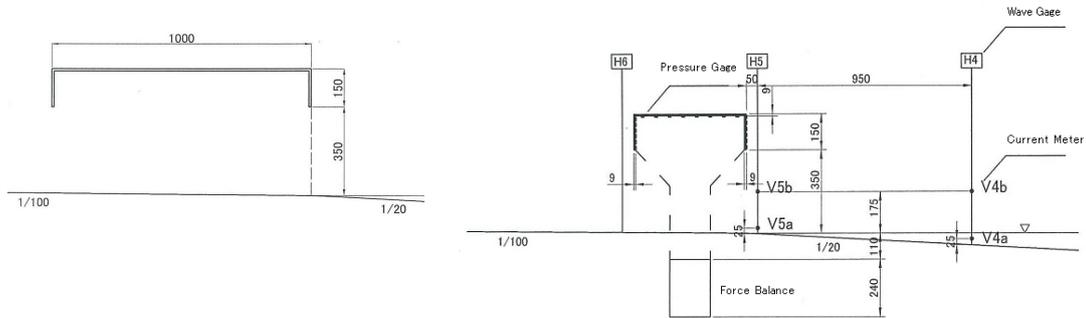
Figure-2. A Cross Sections of Bridge Girder and the Setting of Experiment

A series of wave force measurement was conducted by using a wave channel in the NILIM. We consider that bridge girder itself is not broken by wave force. Bridge will be washed away by the damaged at the support. We measured total drag force and lift force act on girder by a force balance. We have no plan to use pressure distribution that is measured by pressure tap. Figure-2 shows cross sections of bridge girder tested, and the setting of experiment. Photo-2 shows the process of tsunami attacking bridge girder. The analysis of measurement has not yet completed. Figure-3 shows an example of measured time history of drag force acted on bridge girder. The wave impact force has quite steep peak at the moment of attacking. Since bridge girder and peers are elastic, the effective force acts on support of bridge is considered smaller than the peak value. Numerical analysis using model shown in Figure-4 is on going to evaluate effective impact force acts on support of bridges.

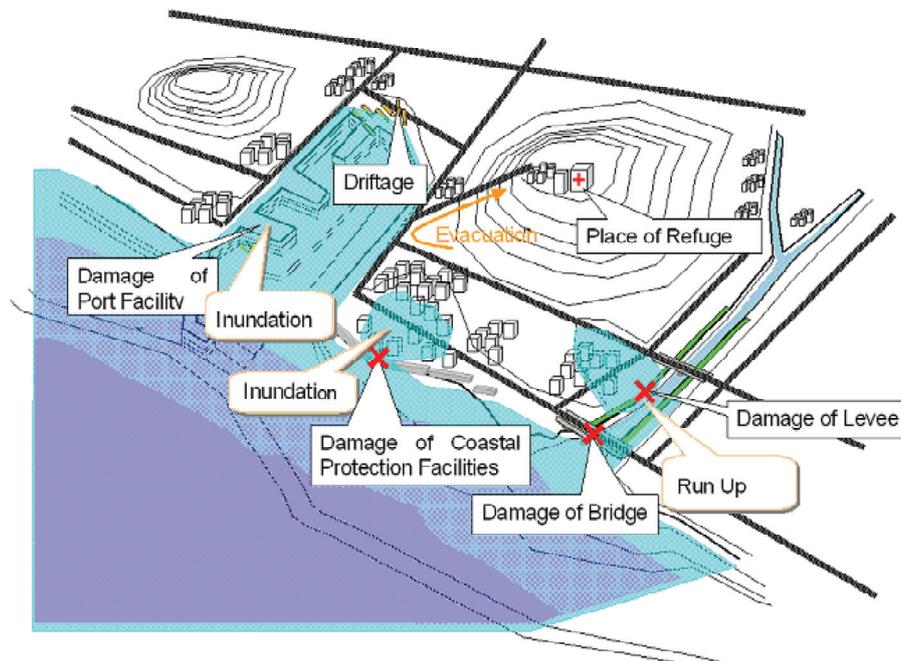
Figure-5. Image of Tsunami Disaster

A target of this study is to draw Figure-5 that shows inundation, damaged facility by tsunami, influence of driftage, and so on. It is quite common to discuss tsunami disaster mitigation plan by using map of estimated inundated area. The difference between the map illustrated in Figure-5 and the common method is to consider damage of facility. In this study damage of dike, bridges port are evaluated. Operation of water gate is also considered.

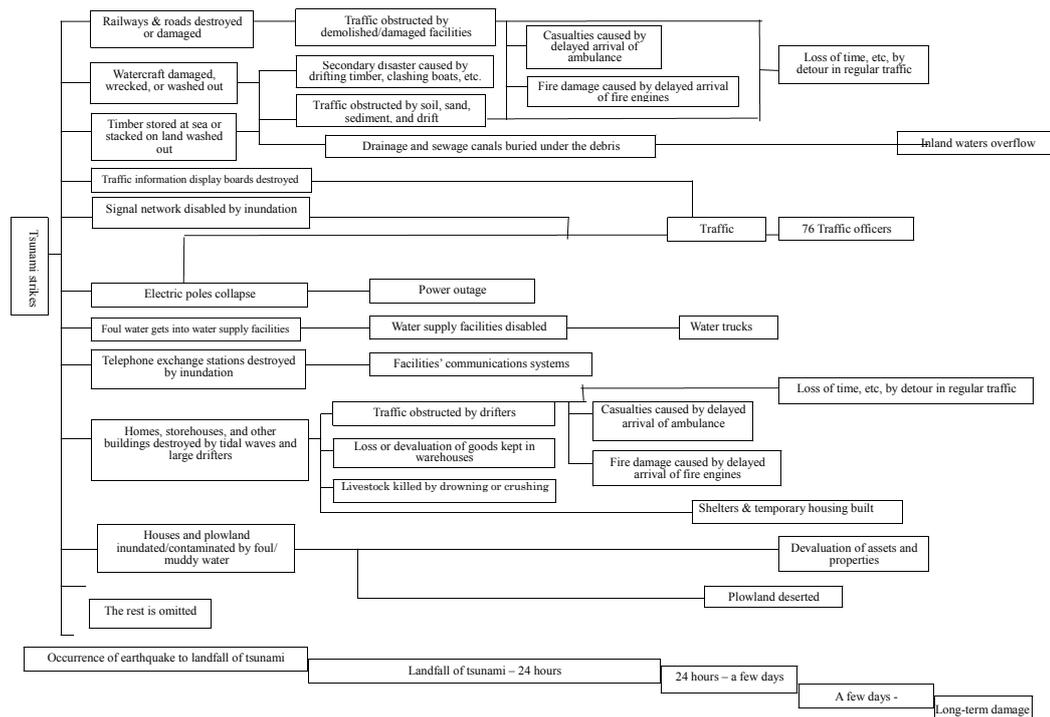
Figure-6. A Part of Event Tree (An Tentative Image)

The challenge in the ongoing study is not finished by drawing Figure-5. The tsunami disaster is series of events. It is quite important for mitigation planning to understand structure of event tree. Figure-6 is a part of event tree, that is concerning road, developed in this study. The methodology that will be proposed is how to draw Figure-5 and how to find and evaluate serious event pass from the event tree.
