POST-EARTHQUAKE EVALUATION OF THE ALASKAN WAY VIADUCT

Jugesh Kapur¹, David Goodyear², Tim J. Ingham³

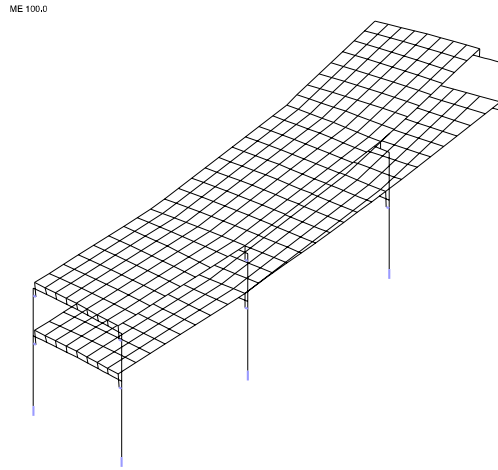
Figure 4, ADINA Model of the Structure

A three-dimensional model of the structure was made using the ADINA general purpose finite element program [1]. This program performs geometrically nonlinear analysis and it has nonlinear elements able to model the flexural hinging of beams and other elements. The ADINA model of the structure is shown in Figure 4. The curvature of the structure is faithfully reproduced in the model. The model includes the widening of the lower deck at Bent 97, and the outrigger bent from the upper deck.

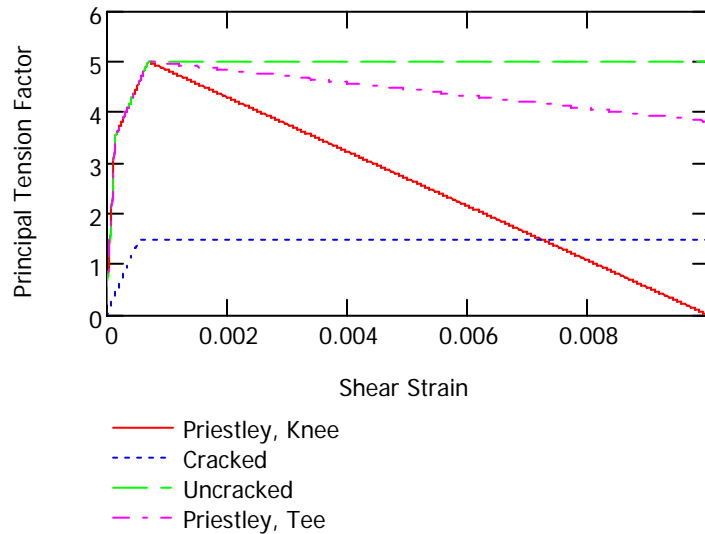
Figure 5, Degradation of Joint Principal Tensile Strength vs. Shear Strain, Priestley, et al. [5]

The modeling of the joints was motivated by a relationship between joint principal tensile stress and shear strain developed by Priestley, et al. [5] for the seismic assessment of bridges. This relationship is shown in Figure 5. The relationship models the initial stiffness of a joint, the cracking of the joint at a shear strain of 0.00015, the consequent reduction of stiffness, and the deterioration of the strength of the joint beyond a strain of 0.0007.

Joints which are uncracked were modeled with this relationship, except that because ADINA cannot model degradation of stiffness, the modeling assumed the strength to be constant beyond a shear strain of 0.0007. This is the model labeled “uncracked” in Figure 5. Of course, the model is only realistic if the strain is not much larger than 0.0007. The “uncracked” model was only used for joints that were observed to be uncracked, and the analysis was monitored to verify that the joint shear strains were indeed small.

Joints which were observed to be cracked were modeled with the relationship labeled “cracked” in Figure 5. The initial part of this relationship reproduces the stiffness of a cracked joint from the Priestley model. Because ADINA cannot model degradation of stiffness, the model assumes that the joint shear strength is constant beyond a certain strain. The plateau strength must be assigned based on the peak shear strain occurring in a joint, e.g., to intersect the Priestley model at the peak shear strain. An iterative analysis was required to obtain meaningful

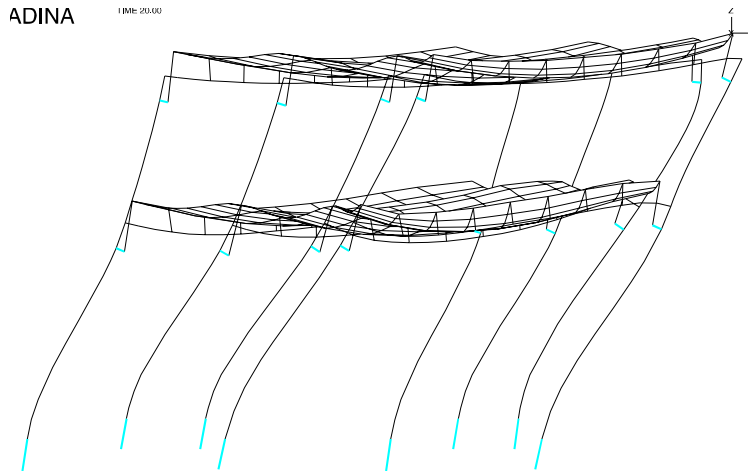
Figure 6, Deflected Shape under Mass-Proportional Lateral Load (100 times scale)

The first step in the analysis was to apply the dead load and solve for the corresponding deformed position. Then a mass-proportional lateral load was applied to the model in order to reproduce the damage observed in the field, specifically the eastward lean of the structure. Figure 6 shows the deflected shape of the model under a mass-proportional lateral load corresponding to an acceleration of 100 inch/sec/sec = 0.26g. This was the maximum lateral load that the model could support without collapse. When the lateral load was removed the structure sprang back to the residual deflections shown in Table 3:
