## **DAMAGE CHARACTERISTIC OF BRIDGES DUE TO 2010 CHILE EARTHQUAKE**

Kazuhiko KAWASHIMA<sup>1</sup>, Shigeki UNJOH<sup>2</sup>, Jun-ichi HOSHIKUMA<sup>3</sup> and Kenji KOSA<sup>4</sup>

This paper presents damage of bridges during the 2010 Chile earthquake based on site investigations. Damage feature of bridges including the effect of in-plane rotation of bridges, insufficient seat length, absence of anchor between superstructure and substructures at bearings and lack of bearing capacity of foundations is presented. Design practice of bridges in Chile is also introduced.

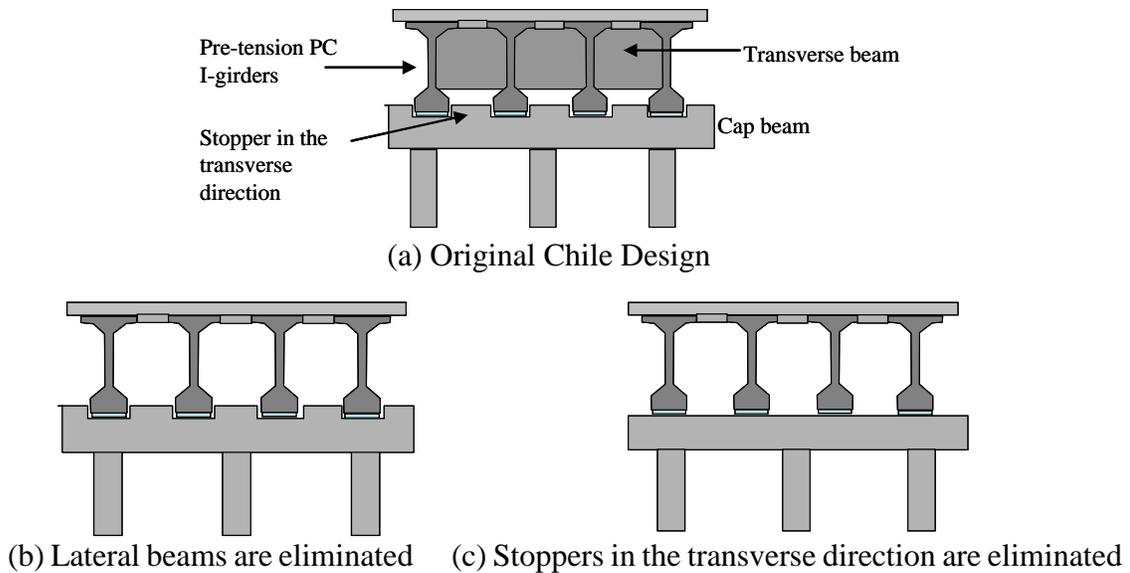
Assuming a straight bridge with  $l=30$  m and  $h=10$ m, the seat length  $S_E$  becomes 0.48 m under category c and d based on Eq. (3). For reference, the minimum seat length  $S_E$  is 850 mm based on the Japanese practice under the same condition [JRA 2002]. Note that concession has been introduced for construction and operation of transportation facility in Chile since the mid 1990s. It seems that a different concept of seismic countermeasures has been introduced for bridges built in the concession regime. For example, in prestressed concrete (PC) I-girder bridges which are dominant in Chile, transverse beams have been generally set for connecting PC girders at mid span as well as at both ends based on the original Chilean practice. However they are eliminated in the bridges in the concession as shown in Fig. 3. Furthermore side blocks for limiting excessive offset in the transverse

Fig. 3 Type of PC I-girder bridges

direction, which are generally set in the Chilean practice, are also removed in the bridges in the concession. These modifications were most likely introduced for reduction of construction cost and period, which had resulted in extensive damage to bridges as shown below.

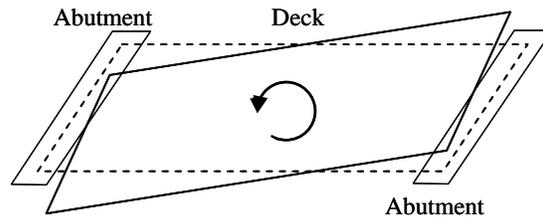
Fig. 4 Unseating resulted from rotation of skewed bridge

It is well known that skewed bridges tend to rotate in-plane directing from its obtuse corner to the acute corner under a strong ground motion. The rotation can result in unseating of a skewed bridge at the acute corners as shown in Fig. 4. To distinguish the direction of skewness from the bridge axis (longitudinal direction) and the direction perpendicular to the longitudinal direction (transverse direction), the direction parallel to the ends of a skewed bridge and the direction perpendicular to this direction are called herein skewed transverse direction and skewed longitudinal direction, respectively. Rotation of a skewed bridge is developed by various seismic actions such as pounding between a bridge and an abutment or between two adjacent bridges, and incoherent response of substructures.

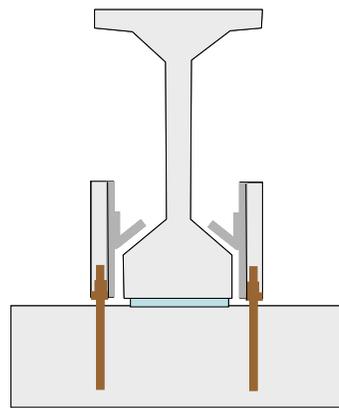
Fig. 6 Side stopper for restricting deck uplift and transverse drift

The inner bound of Lo Echeveres Overcrossing collapsed while the outer bound bridge did not collapse but it was shored due to damage of supports. They were 26.5 m +34m+26.5m long bridges with skew angle of about 60 degree. The deck slab was continuous at the joints between adjacent decks. Photo 7 shows damage of supports as well as two side stoppers of the outer bound bridge. The side stoppers were weak to limit offset of the I-girders in the transverse direction.

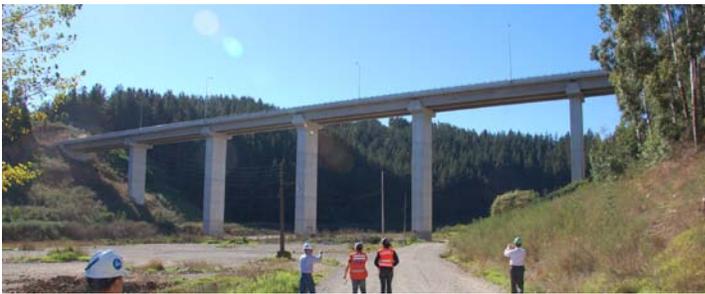
Photo 20 A new bridge constructed based on the original Chile seismic design

There were a number of bridges which did not suffer extensive damage in the region under strong excitation. For example, Lirquen Bridge was a six span simply supported PC I-girder bridge, as shown in Photo 20, along No. 150 road in the suburbs of Concepcion City. It was recently built based on original Chile seismic design. Although the bridge was supported by five columns with different height, it suffered essentially no damage. As shown in Photo 21, transverse beams connecting three PC I-girders and side blocks for limiting excessive transverse offset are provided. Although PC I-girders were only supported by neoplane pads without anchor, no transverse offset developed.

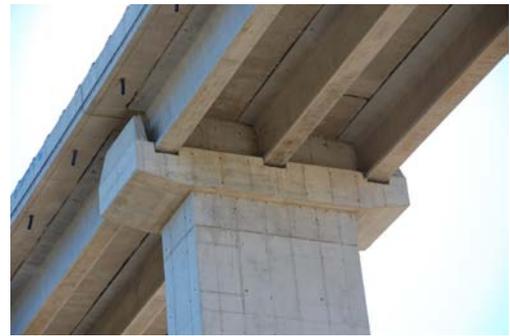
Photo 21 Transverse end beam and side blocks for limiting excessive transverse offset
