# GROUND MOTION AND TSUNAMI INDUCED DAMAGE OF BRIDGES DURING 2011 GREAT EAST JAPAN EARTHQUAKE

This paper presents damage of road and railway bridges during the Great East Japan earthquake and tsunami on March 11, 2011 based on a JSCE damage investigation. Ground motion induced damage and tsunami induced damage of both road and railways bridges are presented.

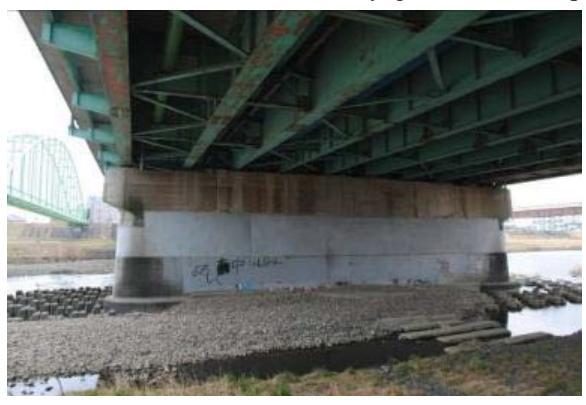
Photo 7 Retrofitted pier of Sendai Bridge which did not suffer damage during 2011 Great East Japan earthquake

On the other hand, damage of bridges which were already retrofitted suffered virtually no damage. For example, Sendai Bridge which is a symbolic bridge in Sendai suffered extensive damage at columns and bearings as shown in Photo 6 during 1978 Miyagi-ken-oki earthquake. However this bridge suffered no damage during this earthquake, because columns were retrofitted as shown in Photo 7 and steel bearings were replaced with elastomeric bearings.

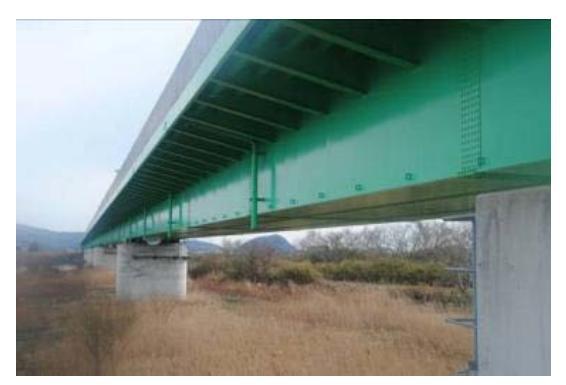
Photo 8 Shin-Tenno Bridge

For example, Photo 8 shows Shin-Tenno Bridge which was constructed in 2002 suffered no damage. This bridge was located 150 m upstream of Tenno Bridge which suffered damage during 1978 Miyagi-ken-oki earthquake and suffered damage again at almost the same components. Photo 9 shows an end of girder at the left bank where it was supported by elastomeric bearings. New cable restrainers which satisfy the requirements by the post-1990 design code are set. No damage occurred in this bridge.

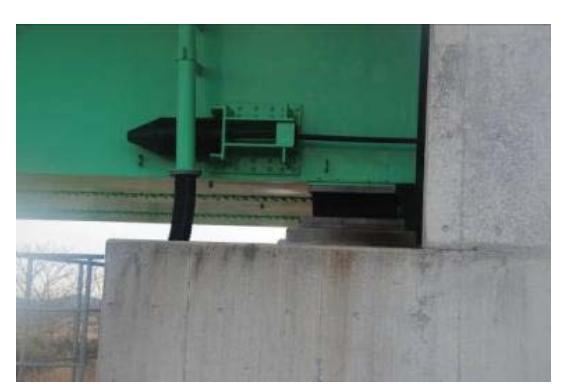
Photo 9 An end of deck supported by elastomeric bearings and unseating prevention devices

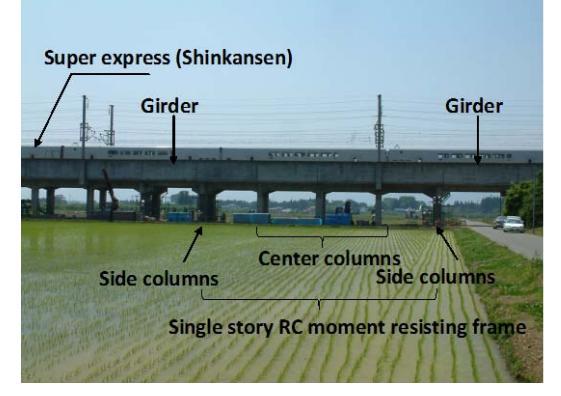
It should be noted that all viaducts which suffered damage during 2011 Great East Japan earthquake had not yet been retrofitted. Most viaducts in Iwate-ken were single story RC moment resisting frame with a Gerber girder at both sides. Damage concentrated at the side columns during 2003 Sanriku-Minami earthquake as shown in Photo 13. Since the side columns were shorter than the center column, a parameter defined as a ratio of the shear capacity to the flexural capacity was smaller in the side columns than the center columns, which led shear failure in the side columns.

Photo 13 Single story RC moment resisting frame pier with a Gerber girder at both sides

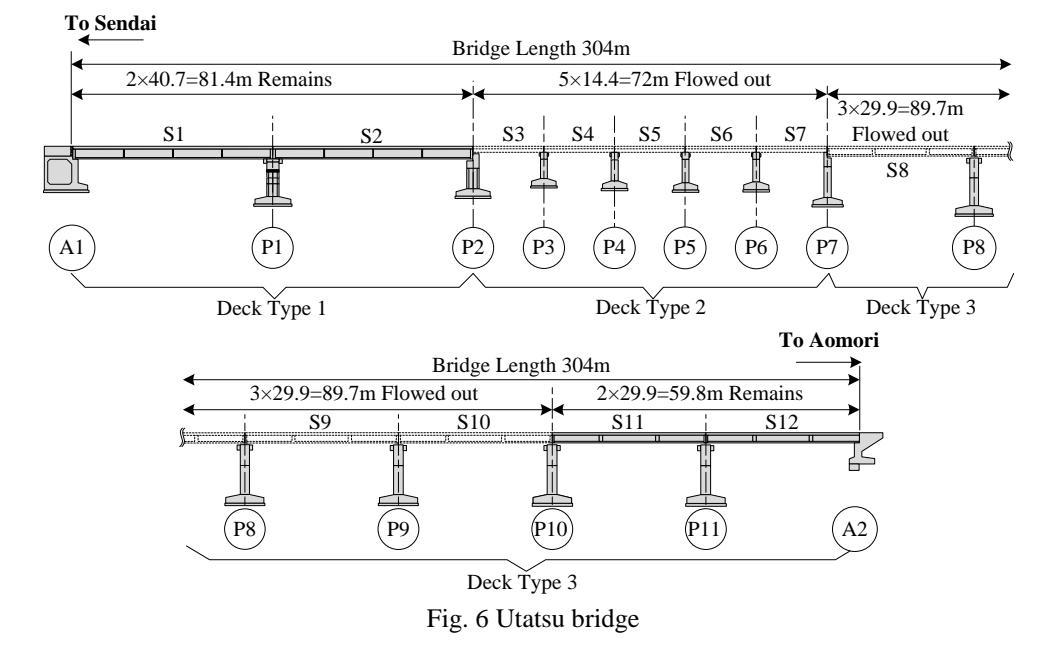
Photo 18 Damage of Utatsu Bridge

Utatsu Bridge at Minami-sanriku Town over Irimae Bay suffered extensive damage by tsunami as shown in Photo 18. It consisted of 3 types of superstructures with spans ranging from 14.4m to 40.7m, as shown in Fig. 6. The superstructures from S3 to S10 were completely washed away from their supports in the transverse direction due to tsunami while the superstructures S1, S2, S11 and S12 were not washed away. The

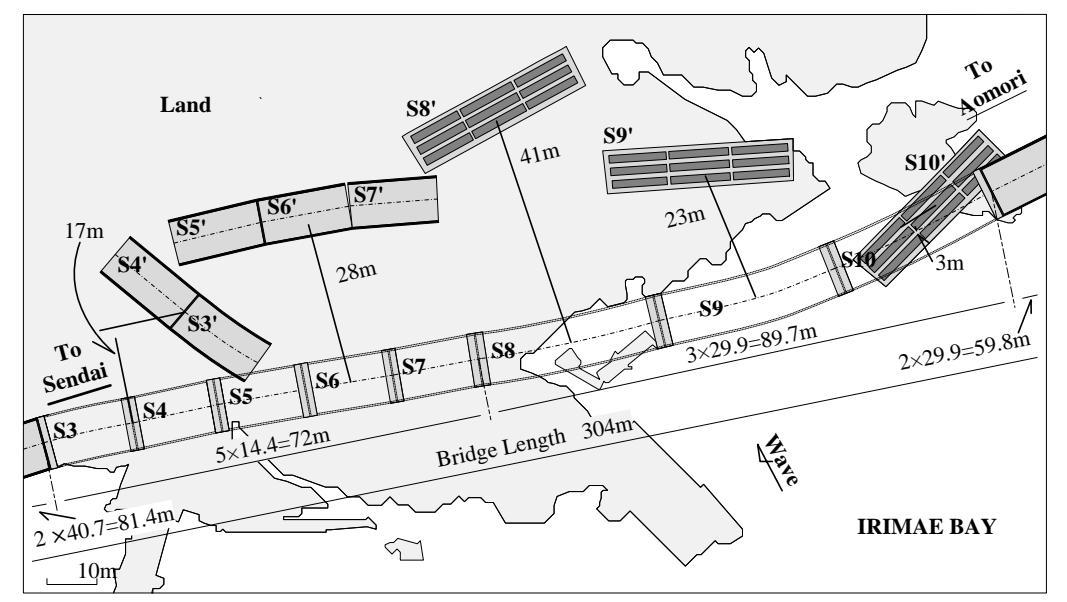
Fig. 7 Outflow of superstructure

outflow displacements of S3~S10 are shown in Fig. 7. It should be noted that the spans located at the center such as S5-S7 and S8 were flowed 28 m and 41 m away from the original position, while the spans located at the sides such as S1, S2, S11 and S12 were

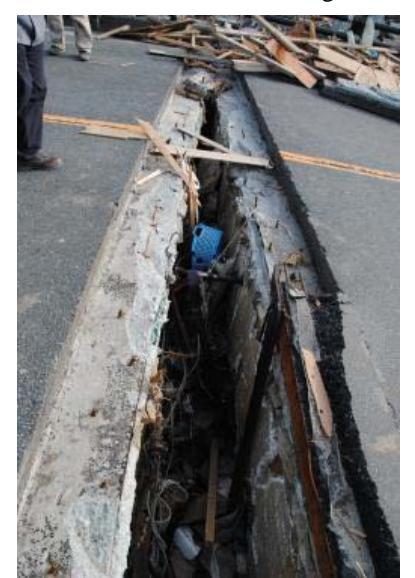
Photo 19 Effective restrainers to tie together adjacent decks

not washed away. It is noted that S3, S4 and S4, and S5, S6 and S7 which flowed out together because they were tied by cable restrainers for preventing excessive superstructure response under a large seismic excitation as shown in Photo 19. S8, S9 and S10 overturned during being floated as shown in Photo 20.

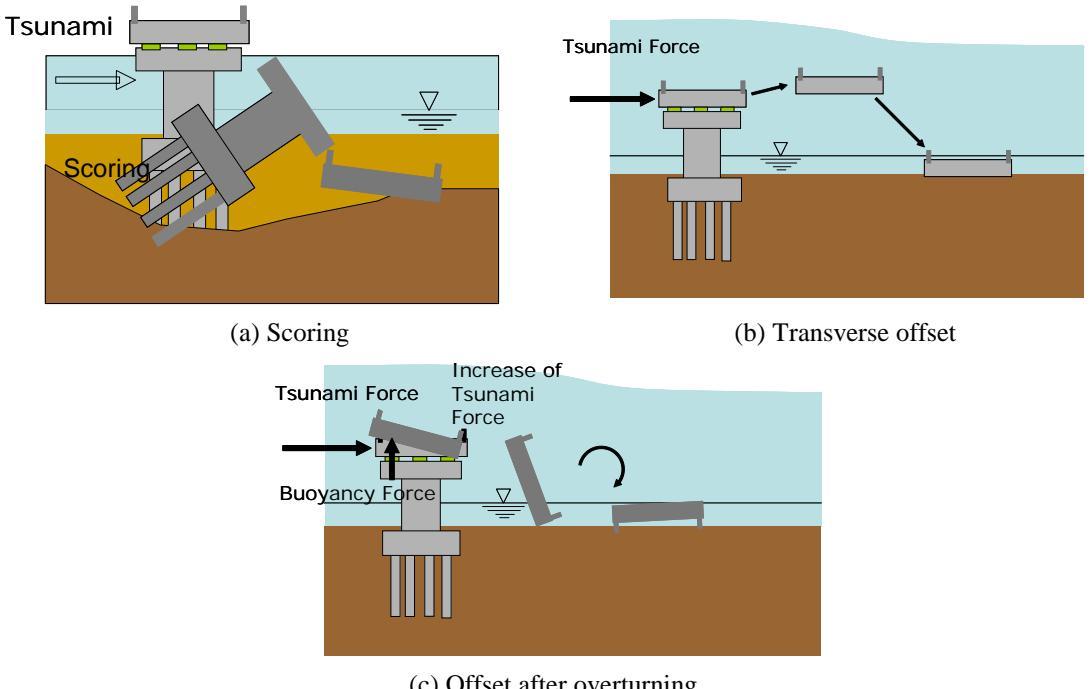
(c) Offset after overturning Fig. 8 Possible mechanism of bridge damage by tsunami

Fig. 8 shows possible mechanism of damage of bridges due to tsunami. As mentioned earlier, overturning of foundation due to scouring did not occur in road bridges. It is likely that damage of decks in Photos 20 and 21 occurred due to mechanism shown in Fig. 8 (b) and (c), respectively.
