# DAMAGE ANALYSIS OF BRIDGES AFFECTED BY TSUNAMI DUE TO GREAT EAST JAPAN EARTHQUAKE

Kenji Kosa<sup>1</sup>

Many bridges were washed away by Tsunami caused by the 2011 Great East Earthquake. We carried out the field survey and investigate the detailed damage to a lot of bridges in Tohoku Region. Utatsu Bridge, a prestressed concrete bridge, suffered enormous damage from the destructive tsunami. The detailed damage and the possible mechanisms of Utatsu Bridge have been conducted. Furthermore, from the study of the relation between  $\beta$  values (ratio between girder resistance and wave lateral load) and bridge damage extents of bridges in Tohoku Region and Sumatra Island, it is noted that ratio  $\beta$  is a significant indicator to judge the damage extent of bridge girders.

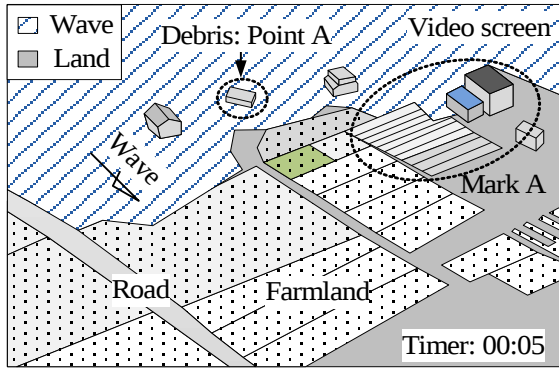
**Fig. 4** Starting point for timing

A velocity measurement of the debris at location B is described as an example. The time span for the debris flowed from one point to the other was obtained from the video. **Fig. 4** is drawn based on the video screen which shows the starting point for timing. When the debris passed Point A, from the timer of video, the time point was observed as 5sec. **Fig. 5** is drawn based on the video screen which shows the terminal point for timing. When the debris passed Point B, the time point was observed as 51sec. After that, the time span for the debris flowed from Point A to Point B was computed as  $51 - 5 = 46$ sec.

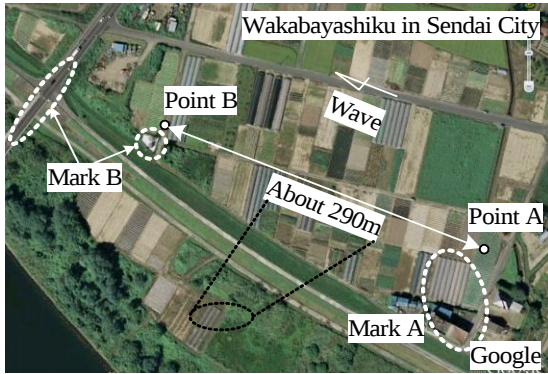
**Fig. 6** Distance between 2 points

Google Earth, with the use of Mark A and B, refer to **Fig. 6**. By the use of the distance measuring function of Google Earth, the distance between Point A and B was estimated around 290m. In the end, the Eq. (1) was applied to compute the velocity of the debris as 6.3m/s, refer to the velocity of B-2 in **Fig. 7**. By the same method, the wave velocity at location B was measured by 3 times with different debris. And the average velocity of the debris at location B was 6.4m/s. In the same way, the average wave velocities at the other 4 locations were computed as well. At last the average wave velocity of the 5 locations was computed as 5.1m/s, as shown in **Fig. 7**, and this velocity can be regarded as the average wave velocity in Tohoku Region.

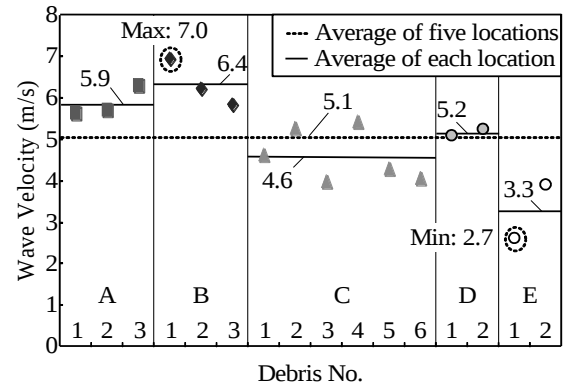
**Fig. 7** Velocity result

Among the 16 velocity data, only the velocity of debris B-1 reached 7.0m/s, so it should be considered as an isolated phenomenon and the wave velocity at Utatsu Bridge should not exceed 7.0m/s. Besides that, since the Utatsu Bridge is located at location A (average: 5.9m/s) and the wave velocity is slightly larger than the velocity

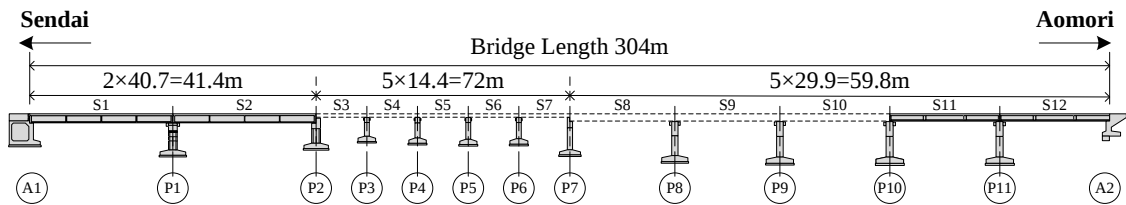
**Fig. 8** Side view of Utatsu Bridge (before damaged, view from seaside)

In the following content, the Utatsu Bridge which belongs to Line 45 of national road is analyzed as an example. The Utatsu Bridge, located at Minamisanriku Town over Irimae Bay, is composed of 3 types of superstructures varying in length from 14.4m to 40.7m, as shown in **Fig. 8**. For simplicity, the authors assigned numbers for the superstructures and piers from Sendai side to Aomori side. The 12 superstructures were numbered from S1 to S12 while the 11 piers were numbered from P1 to P11.

Based on the detailed survey, superstructures S3~S10 moved off their supports under the wave-induced lateral load while the superstructures of S1, S2, S11 and S12 did not flow out. In the flowed spans, S3~S7 and S8~S10 have different types and the details of them are shown in **Fig. 9** and **Fig. 10**. The displacements of S3~S10 have been illustrated in **Fig. 11**. The directions of displacements are transverse to the bridge axis. The characteristic of outflow condition is that the central spans such S5~S7 and S8 experienced long displacements (28m and 41m).
