INVESTIGATION INTO CAUSES OF RUPTURES OF ELASTOMERIC BEARINGS DUE TO THE GREAT EAST JAPAN EARTHQUAKE

Takeshi Hirose¹, Kaneyoshi Yamada²

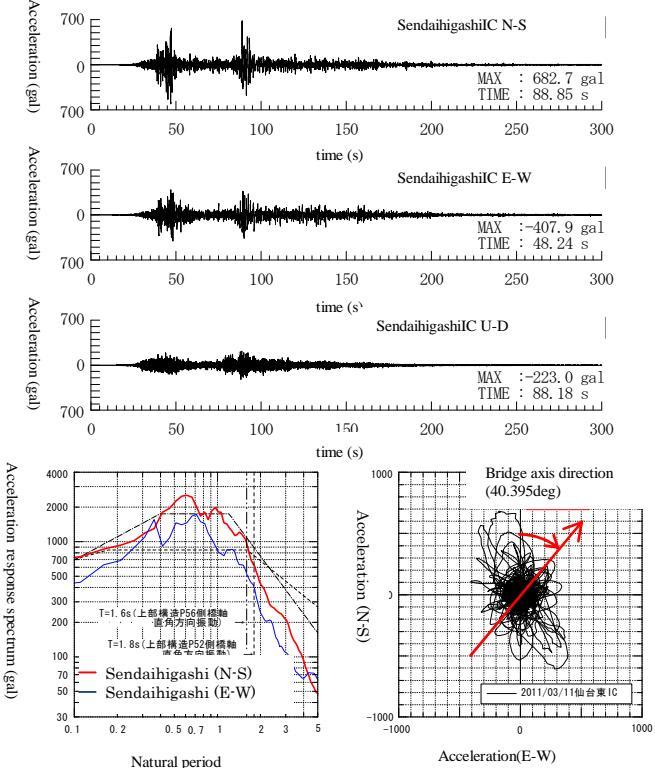
Fig.14 The acceleration wave form / acceleration response spectrum and main direction of observed wave

Figure 14 shows the acceleration wave form, the acceleration response spectrum, and the observed wave horizontal component at Sendai-higashi IC on March 11. 2011.
