# STUDY ON GROUT CONDITIONS OF EXISTING PRESTRESSED CONCRETE BRIDGES

Yoshinori WADA<sup>1</sup>, Yoshitomi KIMURA<sup>1</sup>, Taku HANAI<sup>2</sup>

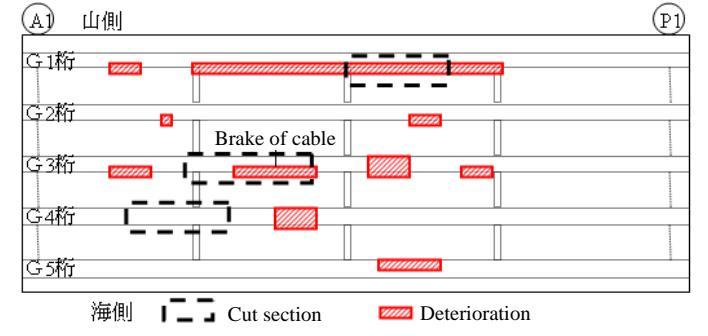
In demolition work, each girder was cut into six or seven pieces and grout condition survey was conducted using the cut sections. Also corrosion investigation of cables was conducted focusing on external damage level of lower flange. Girder 1 at A1-P1 (Almost half the wire's cross section had decreased from corrosion), girder 3 at A1-P1 (Each cable decreased a part of the cross section and some had broken by corrosion), girder 4 at A1-P1 (No history of remedial works. First deterioration was found after 40 years of service)

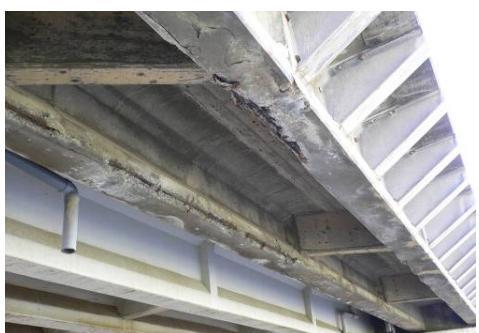
Figure 20. D Bridge in service

D Bridge was a 2-span simply-supported prestressed concrete girder bridge for bikes (Figure 20, 21). It was constructed in 1972, and demolished in 2011. This bridge was located in the northeastern coast of Japan.

By investigation, some deterioration such as crack, delamination, and spalling appeared over the whole of the girder and 2 in the total of 8 PC steel wires were broken (Figure 22).

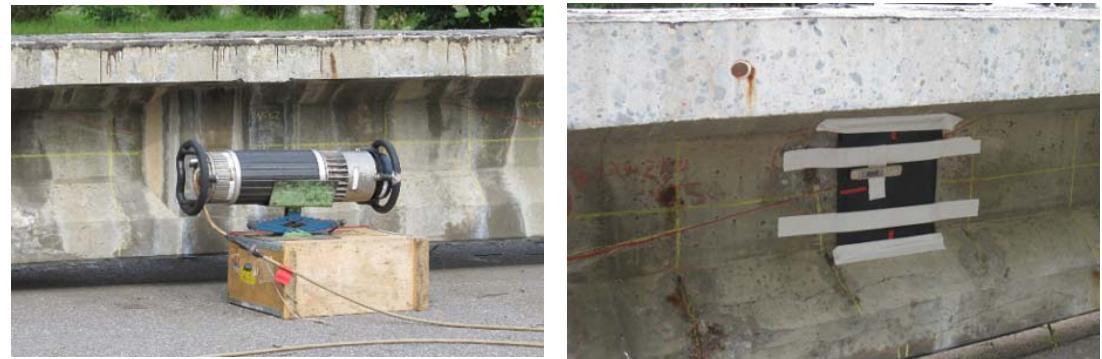
Figure 23 and 24 show X-ray inspection system and results of grout condition by the system, respectively. Although partial voids due to lack of "Consistency flow during grouting as the result of duct inclination" was confirmed, grouting is relatively well done throughout. While on the one hand, we were able to get a clear image by almost 3 minutes of X-ray irradiation if web thickness was around 160mm. On the other hand, it was not possible to get a desired clarity of images at the end of girders where web thickness was 400mm even if X-ray irradiation took place for more than 60 minutes.

a) X-ray generator (300kV)

b) Imaging plate
