# **Non-Destructive Bridge Deck Assessment using Image Processing and Infrared Thermography**

Masato Matsumoto<sup>1</sup>

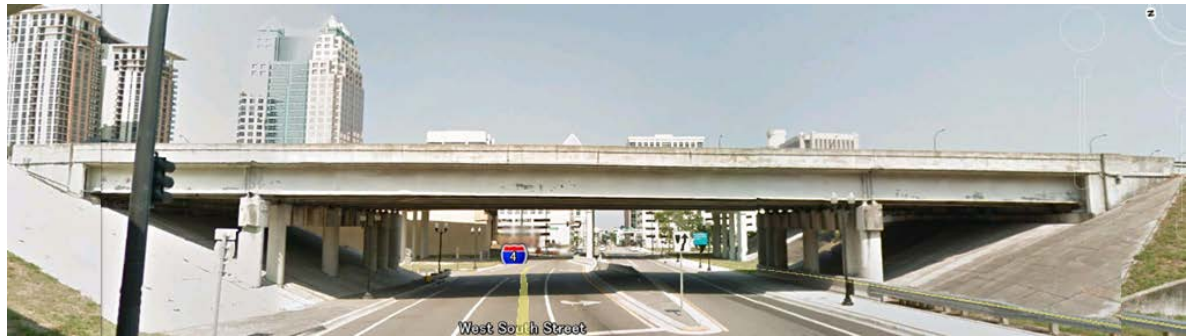
Fig.4: A Scanned Bridge in Downtown Orlando, FL

During the pilot application, 10 bridges carrying I-4 in Central Florida area were scanned by the system. Fig.4 is the photo of a scanned bridge located in downtown Orlando. The bridge includes 3 spans carrying 4 lanes of the traffic. The 4th (left) lane has been added to the existed three lanes during the recent bridge widening project. Fig.5 depicts the overall condition and defects on the deck surface. Small potholes with the size of 5"-10" and cracks with longitudinal and transversal direction were detected from the scanned visual images obtained by the line sensor camera system. Some of the cracks make hexagonal shape and causing delamination/potholes within the cracking areas. The detected cracks were typically 1/64" (0.3mm) in width. According to the Bridge Inspectors Field Guide (Florida Department of Transportation, 2008), cracks should be classified into three categories as shown in Table 1, and the NBI (National Bridge Inventory) specified "Distressed Area" is calculated for the rectangular area

including “Moderate,” or “Severe” cracks. Most of the detected cracks on this bridge deck shall be categorized as ‘Insignificant’, and these cracks could not be detected by the traditional visual inspection that is typically performed by the bridge inspectors overlooking the deck surface defects from the shoulder. The infrared thermography camera successfully detected the possible delamination in deck concrete as shown in Fig.5 (hatched in pink colour). In order to find such deck subsurface defects traditional technique using chain dragging method (Fig.1- left) requires lane closure during the inspection period.

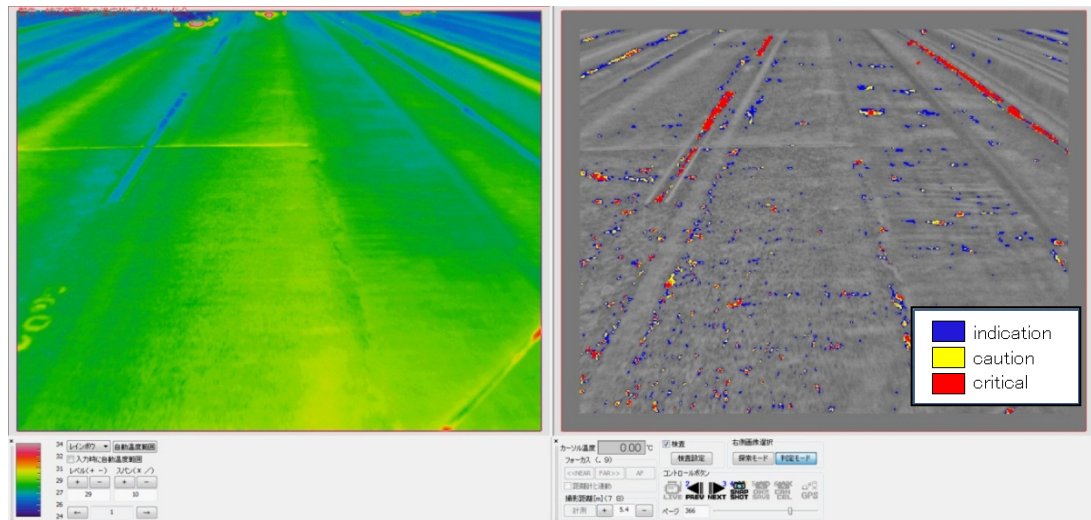
Fig.7: The Real Time IR Monitor (Thermal Image (left) and IR Software Output (right))

voltage or current when heated by infrared radiation, thus requiring longer exposure time to take the IR image. In this study, raw infrared images were further analyzed based on algorithm developed and tested in Japan on many bridges. The proprietary IR software applied in this project can classify the damage rate into three categories; the classification categories being “Critical” (crack caused by delamination reaches on concrete surface and immediate attention is required), “Caution” (crack exists within 2cm from the concrete surface and close monitoring is recommended) and “Indication” (Currently satisfactory) (see Fig.6). Raw infrared (IR) image data is filtered and rated into three categories by the software to indicate and evaluate the severity of the subsurface defects in concrete structures. The real time monitor shows the raw thermal image and filtered/rated images at the field (Fig.7). Fig.8 is an example of the thermal image and software output for a scanned bridge in downtown Orlando.
