Repair Works on a Composite Girder Cable-Stayed Bridge damaged by Ship Collision (Binh Bridge in Vietnam)

Tomonobu Tokuchi, Shinji Kaifuku, Satoshi Kawabata, Tatsuya Idani

The Binh Bridge, a 3-span cable-stayed bridge with composite girders and a center span of 260m, was opened to traffic in 2005. In 2010, 3 ships swept upstream by a typhoon collided with the bridge, resulting in serious damage to the main girder and several cables. Repair and rehabilitation works on the bridge were awarded to IHI Infrastructure Asia Co., Ltd.

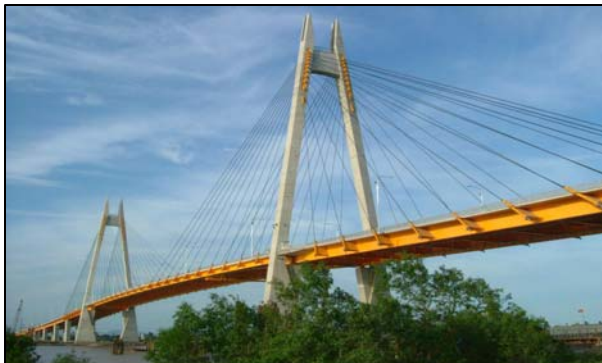
Figure 1 Binh Bridge at Completion

Binh Bridge, located in Haiphong City, Vietnam, is a 3-span cable-stayed bridge with composite girders and a center span of 260m that was completed in 2005. Figure 1 shows a complete view of the Binh Bridge at completion. In July 17th 2010, three cargo ships that had been moored for repair at a shipyard near the Port of Haiphong were carried approximately 600 m upstream by typhoon No. 1 and collided with the composite girder of the Binh Bridge. Fig. 2 shows a general view of one of the ship's bridge stuck onto the composite edge girder after collision.
