# NON-DESTRUCTIVE BRIDGE ASSESSMENT TECHNOLOGY BY INFRARED THERMOGRAPHY

Masato Matsumoto<sup>1</sup>, Koji Mitani<sup>2</sup> and Necati F. Catbas<sup>3</sup>

## The pilot Project

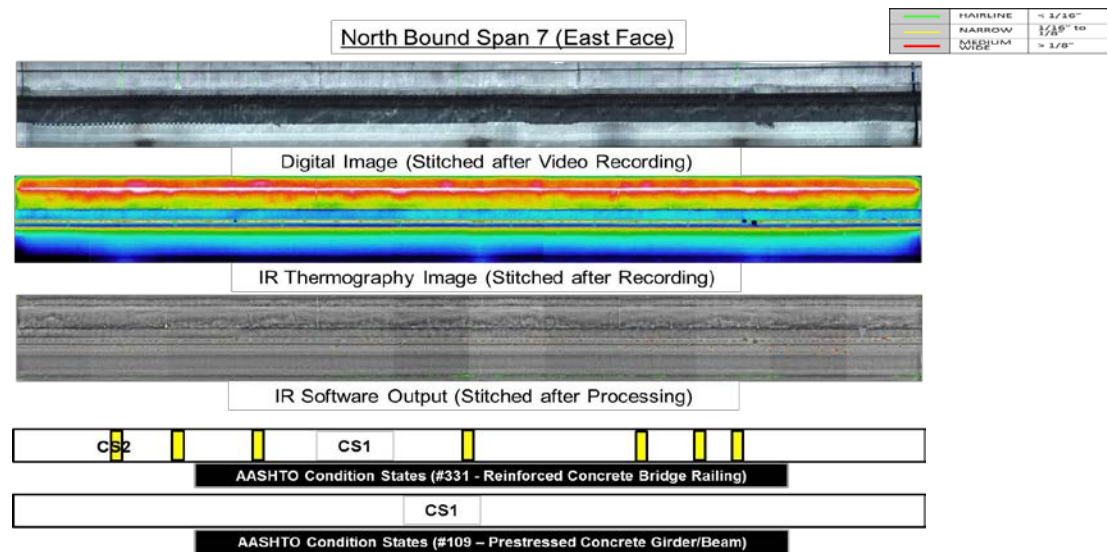
Fig.15: Example of Digital image, IR thermography image and software output

On the other hand, no significant cracks/delaminations were found in the outer faces of the prestressed concrete beams except for some minor spall and cracking at the end of the beam (Fig.13). Sections including minor cracks and delamination should be evaluated as ‘CS2’ based on the condition state criteria defined in the AASHTO Manual. Based on the information obtained by digital image and IR scanning, condition state for element ‘#109 Prestressed Concrete Girders/Beams’ for the Lake Jessup Bridge was summarized. Table 4 is an example of an element level inspection quantity summary for the prestressed concrete beam for the west face of the south bound bridge. The length of each condition state for prestressed concrete beams was also summarized for each span of the bridge. Fig.14 is a graphical presentation for element level condition state distributions for each span of the beam of the west face of the south bound bridge. The percentage of beams in ‘CS2’ (depicted in yellow color) varies for each span, and this information can be a quantitative parameter for the bridge owner to monitor the overall condition for prestressed concrete beams over time and to prioritize the repair /rehabilitation programs. Fig.15 is an example stitched image and IR scanning results for the west face of Span 7 (Bent 84- Bent 85) of the north bound bridge. AASHTO condition state distribution for reinforced concrete bridge railing and prestressed concrete beam are also shown in Fig.15.
