LANDSLIDE DETECTION, MONITORING, PREDICTION, EMERGENCY MEASURES AND TECHNICAL INSTRUCTION IN A BUSY CITY, ATAMI, JAPAN

K. Fujisawa¹, K. Higuchi¹, A. Koda¹ & T. Harada²

¹ Public Works Research Institute, Japan (e-mail: fujisawa@pwri.go.jp)

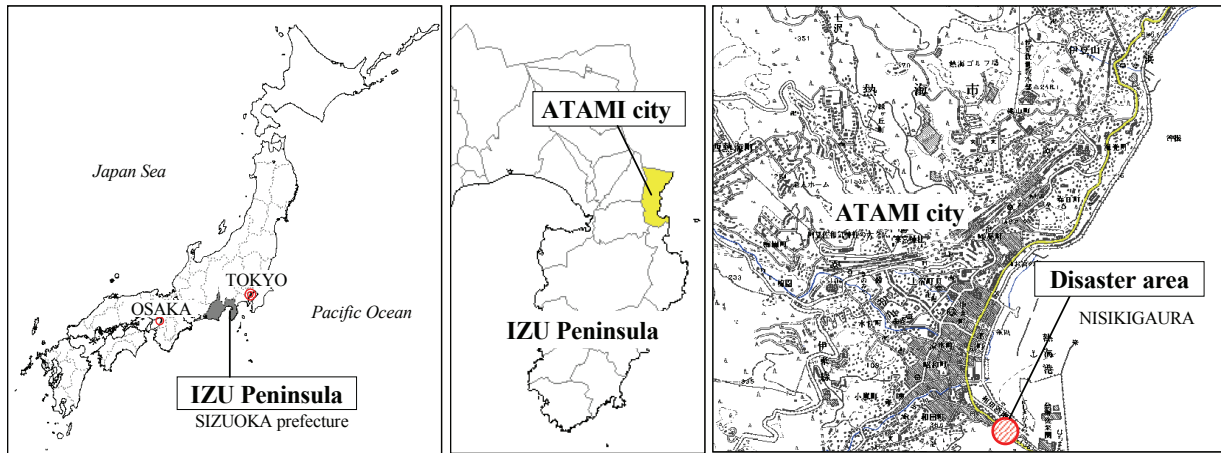
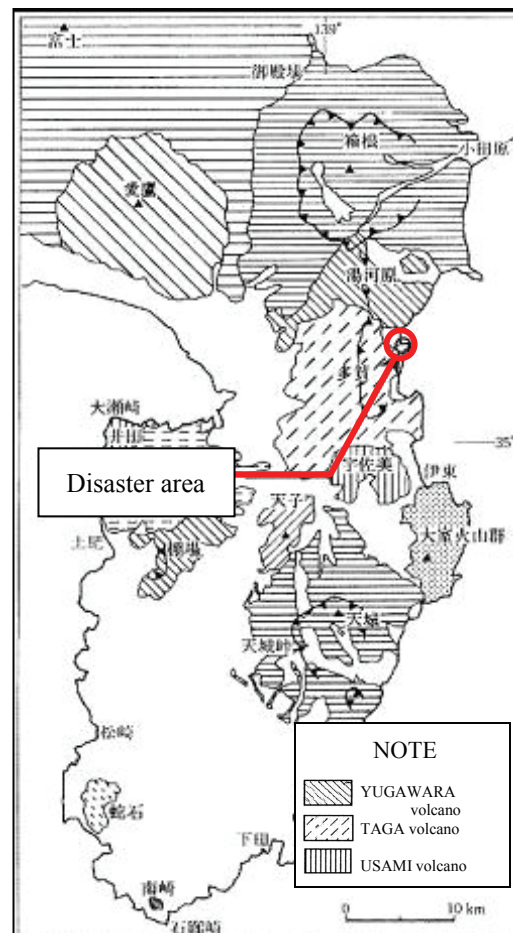
The geology of the area consists of Miocene tuff overlain by Pleistocene andesite lava. National highway No.135 is located by the scarp of the foot of a stratovolcano, which is heavily incised by coastal erosion. Rock fall and surface failure occur frequently on the neighboring slopes, although a large-scale landslide such as reported in this paper has never been observed in historic times (Figure 2).
