**Risk management for landslide disasters
– in the case of the Higashi-Yokoyama landslide, Japan –**

Kazunori FUJISAWA¹, Joko OHARA¹, Fujihiro OKADA², Masami SHICHI²,
Takao YOSHIDA³, Youichiro HAGIWARA³

¹Public Works Research Institute, Japan

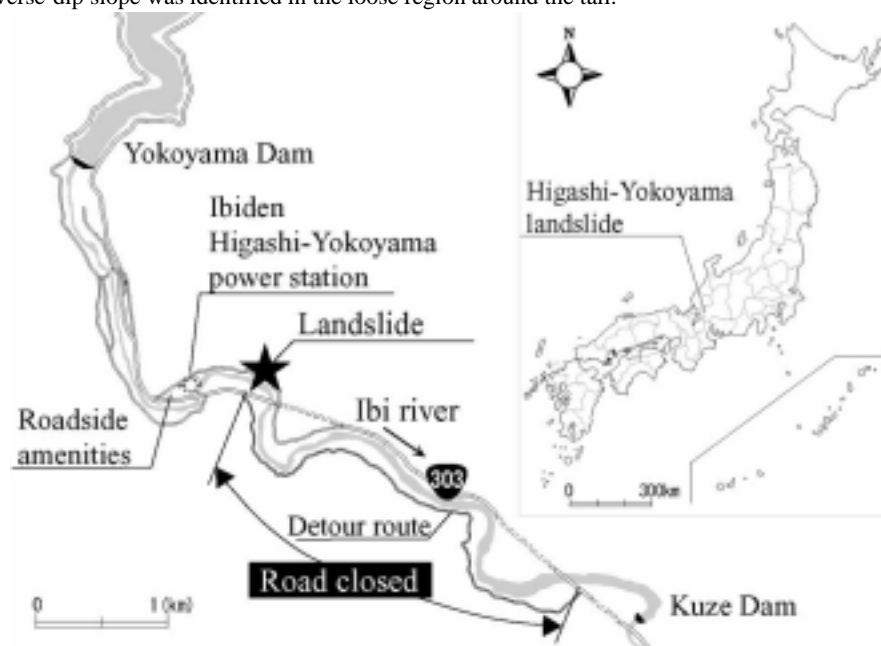
Figure 1 Higashi-Yokoyama landslide

The Higashi-Yokoyama landslide occurred on May 13, 2006 along the left bank of the Ibi river near the town of Ibigawa-cho in Gifu prefecture. Figure 1 shows the location of the landslide site, situated approximately two kilometers downstream of the Yokoyama Dam operated by the Ministry of Infrastructure, Land and Transport, and approximately 3.5 kilometers upstream of the Kuze Dam operated by the Chubu Electric Power Company. The landslide measured approximately 150 m in width by 135 m in height, with a volume of approximately 250,000 m³ (see Picture 1).

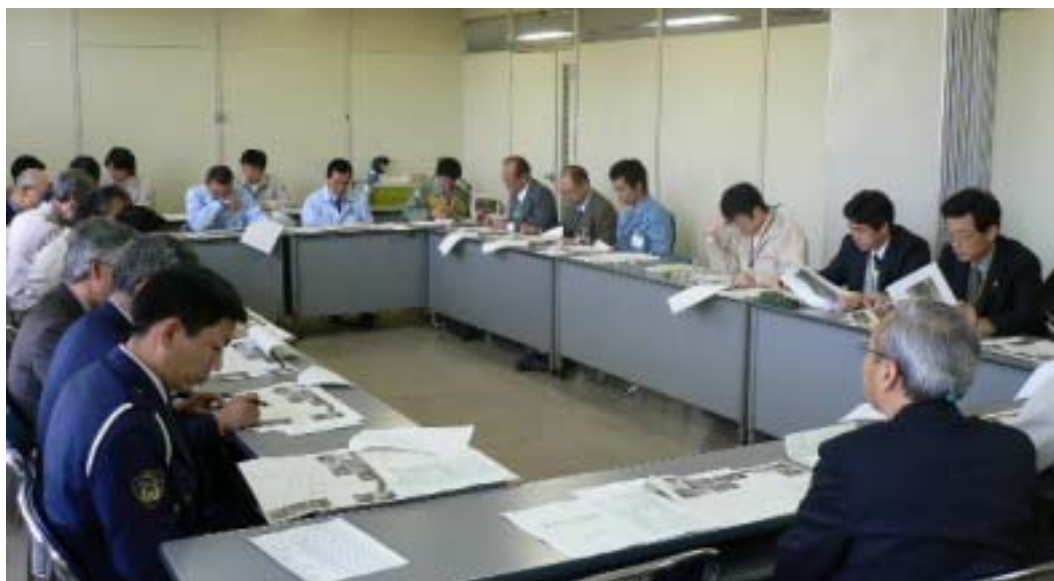
Picture 3 Meeting of interested parties

To this end, the local civil works office convened an initial meeting on April 28 to bring together representatives of the fishing co-op, the power company and power stations, the police and fire services, and relevant government agencies (see Picture 3). The meeting resolved to set up a liaison structure to maintain the flow of information, and also delegated responsibilities among the various parties, including closure of roads, walking trails and river access, and notification to residents.
