# SEISMIC PERFORMANCE AND RETROFIT OF BRIDGE FOOTINGS

David I. McLean<sup>1</sup>

## **Abstract**

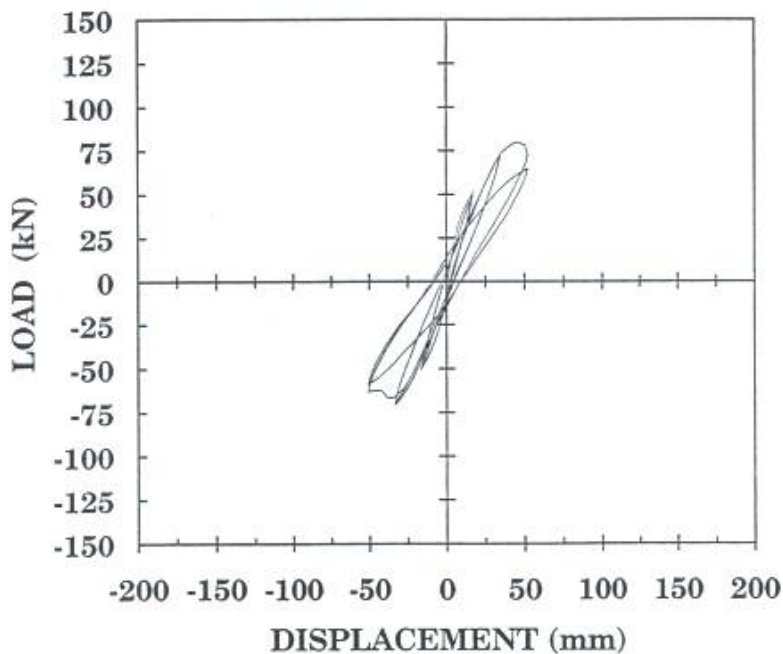
Failure in the as-built specimens occurred after cycling at low displacement levels. The resulting hysteresis curves for an as-built specimen with a pile-supported footing are shown in Figure 2 and indicate little energy dissipation. The column reached only 65% of its moment capacity before the specimen failed. The column showed only minimal signs of cracking. During testing, the top of the pile cap developed cracking radiating outward from the column. After removing the specimen from the testing setup, cracks were also observed on all four sides of the footing. Only minor cracking was observed on the bottom of the footing. The major cracks in the footing are shown in Figure 3. Testing of an as-built specimen with a spread footing produced similar results.

Figure 2 Hysteresees Curves For As-Built Specimen
