Development of exchange technology of deteriorated reinforced concrete slabs

Abstract

Replacement of floor slabs for heavily-trafficked roads such as highways generally requires large-scale construction because it involves closure to traffic at night and lane switching. The author reviewed the following to suggest a more effective construction method: whether replacement of floor slabs by half-sections is practical considering it requires only lane closure, and whether the joint section has enough fatigue endurance because half-section replacement involves a vertical joint.

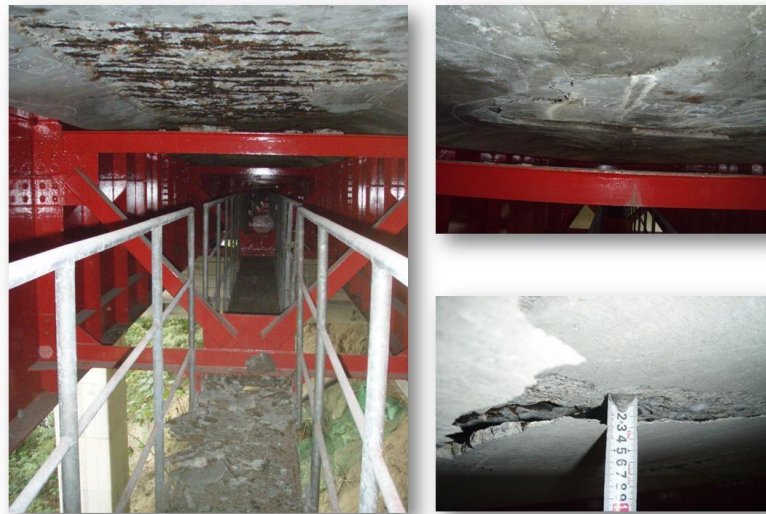
Pic. 1 Deck deterioration situation

The reinforced concrete (RC) floor slabs of highways are deteriorating because of the effect of anti-freezing agents in addition to fatigue caused by heavy vehicles. The replacement of RC floor slabs generally becomes a large-scale construction project requiring closure to traffic and lane switching at night. Therefore, in this research, the author reviewed whether replacement of floor slabs by half-sections is practical considering it requires only lane closure, and in addition, the author reviewed whether the joint section has enough fatigue endurance because half-section replacement involves a vertical joint. The author reviewed them to suggest a more effective construction method.

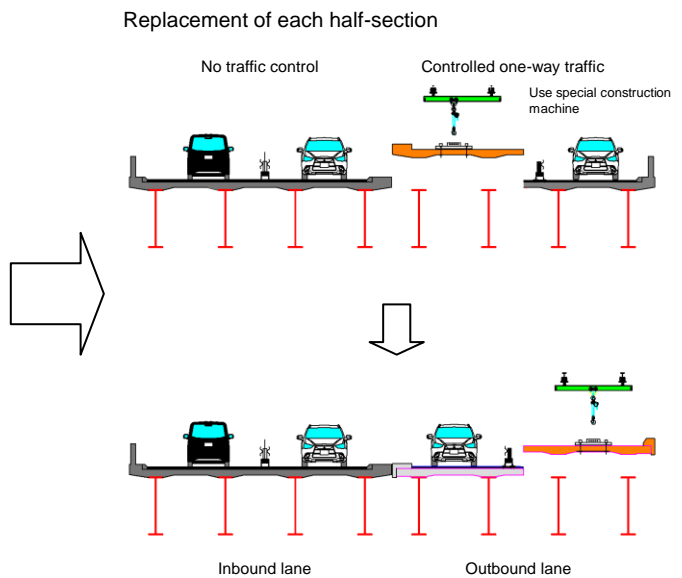
Fig. 2 Example of replacement of each half-section

Generally, the replacement of floor slabs is done by full-section replacement as shown in Fig. 1 after the road is closed and an alternative route is prepared. However, in the case of heavily trafficked roads, the option of road closure and an alternative route is not practical. Therefore, the option of replacement by half-sections only with lane closure as shown in Fig. 2 was reviewed.

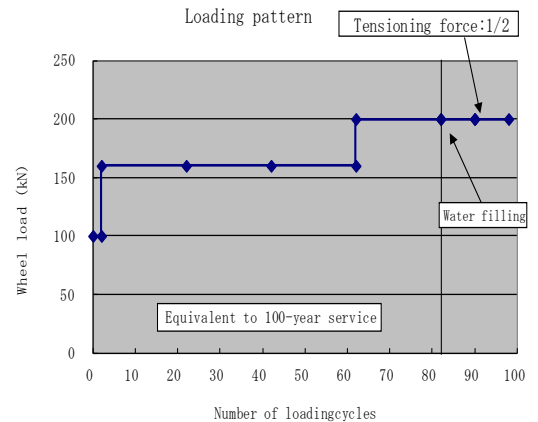
Step	Load		Number of loading cycles		Remark
			Between steps	Accumulated total	
	kN		10K cycles	10K cycles	
0N		Before test	0	0	
1N	100	Basic wheel loading	2	2	
2N	160	Excessive loading	60	62	
3N	200	Double wheel	20	82	Equivalent to 100-year service
4N	200	Same as the above + water filling	8	90	
※5N	200	Same as the above + water filling + 1/2 tensioning force	8	98

Fig. 8 Loading step and wheel load loading position

Three wheel loading steps, basic wheel loading (100kN), excessive loading (160kN) and double wheel loading (200kN) were set, and running stress tests were repeated for 820,000 cycles, which is equivalent to 100 years of service. Then, the tensioning force was reduced by half and the running stress test was repeated for 80,000 cycles.

Fig. 8 shows the loading steps and the patterns for the range of 3m. For the loads of 100kN and 160kN, constant loading was used. And for 200kN, the trapezoid loading pattern was used; 160kN was applied from the edge to 60cm and it was changed to 200kN and kept in the inner range of 1.8mm. The wheel load loading position was the middle point of the span.

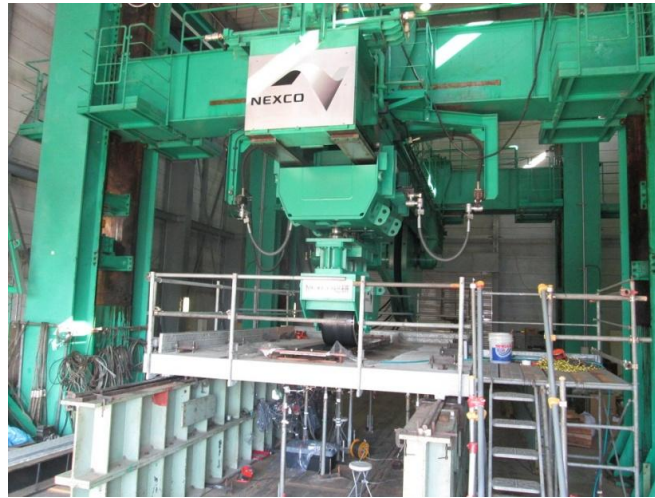
Pic. 3 Move loading test setting

It was determined to use the wheel load loading tester in the conventional way.

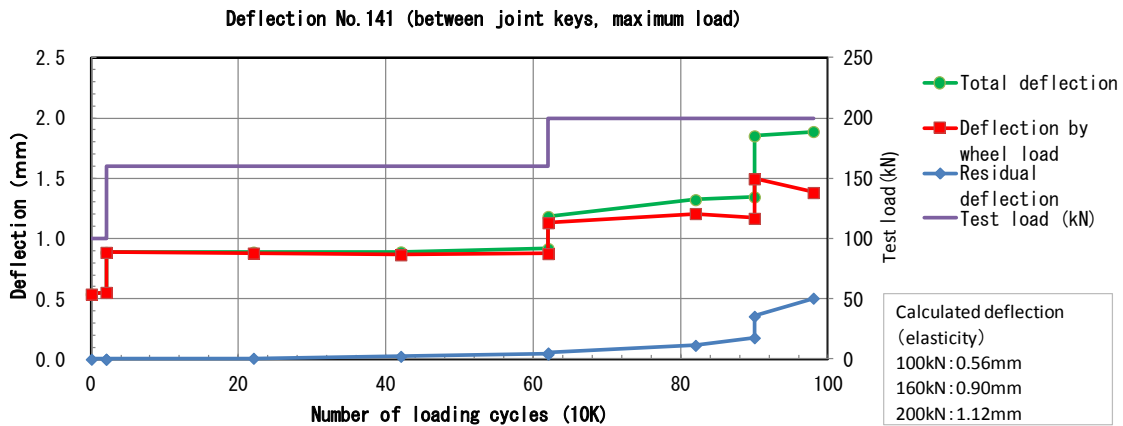
Fig. 9 Amount of deflection

- (1) At the steps 1N and 2N, we observed no cracks. And the measured deflection of the floor slab was equal to the calculated deflection with almost no residual deflection.

- (2) At the step 3N-0, two cracks extending in the longitudinal direction (RC material direction) were observed on the floor slab; then, as the number of cycles increased, the number of cracks increased in the same direction. In addition, cracks in the axial direction (PC direction) started at the step of 3N-100K.
The cracks in the axial direction were not so severe because they closed when the load was removed. The cracks were very minor, so they were hardly visible during the period without the load. The author assumed this was because pre-stress was working effectively. The width of a crack was 0.04mm at the step of 3N-200K (equivalent to 100 years of service) and the residual deflection was 0.1mm.

- (4) We performed static wheel loading tests between the joint keys and on the joint key. As a result, the measurement results were almost the same. The residual deflection was 0.2mm.
