Reparability Limit of Steel Structural Buildings Based on the Actual Data of the Hyogoken-Nanbu Earthquake

ABSTRACT

KEYWORDS: Hyogoken-Nanbu Earthquake, Performance-Based Design, Repair Cost, Reparability Limit, Residual Drift, Steel Structures

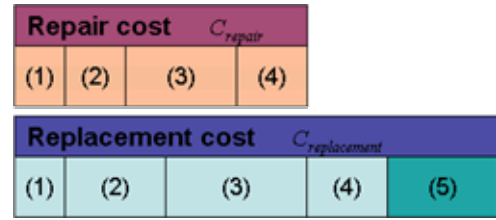
- Restoration cost -
- (1) Temporary work
- (2) Structural frame
- (3) Non-structural member
- (4) Architectural equipment
- (5) Demolishing

Fig. 1. Breakdown of repair and replacement cost.

When we discuss the reparability limit from an economic point of view, we can say that the ratio of repair cost to replacement cost (Fig. 1.) is one of the most useful factors of all cost-related indexes.

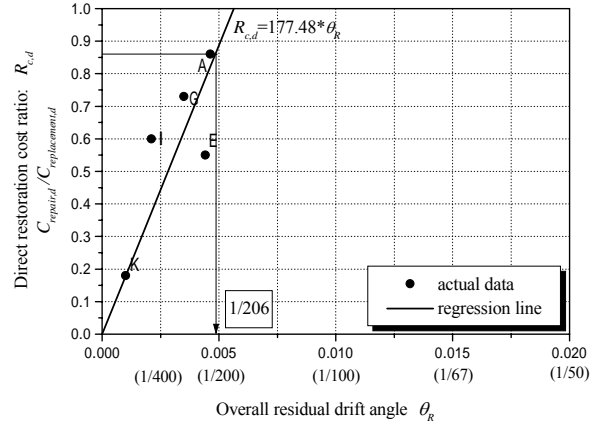
Fig. 2. Relationship between overall residual drift angle and direct restoration cost ratio.

Fig. 2 shows the relationship between overall residual drift angle and direct restoration cost ratio. Fig. 3 shows the relationship between overall residual drift angle and indirect restoration cost ratio. The data of building B, C, D, H and L are not plotted in the graphs because of the reasons mentioned in Chap. 2 and 3. The data of demolished buildings (building F and J) are not also plotted in the graphs. The lines in Fig. 2 and 3 show the regression lines. In both graphs, there are some scatters between the plots and the regression line, but from a broader perspective, this relationship can be regarded as linear. It is speculated that one of the reasons of these scatters is that residual drift can become the index to express structural damage to some extent, while it just shows the final damage of a building and does not always perfectly correspond to the damage of the entire building.

When we predict both direct restoration cost ratio and indirect restoration cost ratio from these regression lines, the predicted equations are defined as follows:

$$R_{c,d,p} = 177.48 \cdot \theta_R \quad (13)$$

limit of indirect restoration cost ratio (0.40) is defined as 1/189. From these two values, the smaller value 1/206 is adopted from a safety viewpoint. Eq.15 shows the definition of the reparability limit of overall residual drift angle recommended for design practices:

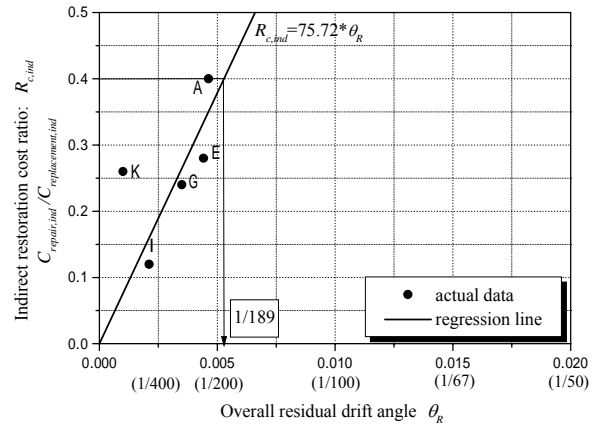
Fig. 3. Relationship between overall residual drift angle and indirect restoration cost ratio.

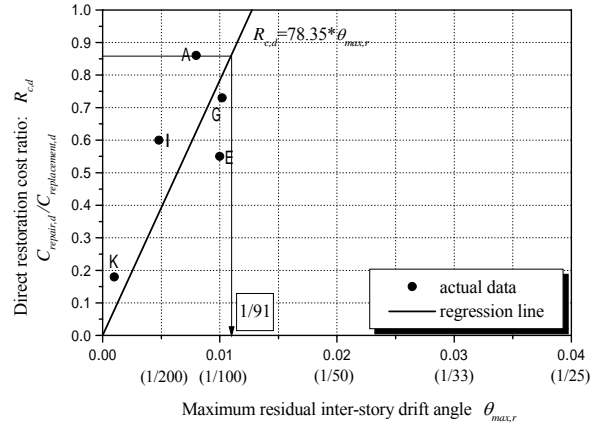
Fig. 4. Relationship between maximum residual inter-story drift angle and direct restoration cost ratio.

Fig. 4 shows the relationship between maximum residual inter-story drift angle and direct restoration cost ratio. Fig. 5 shows the relationship between maximum residual inter-story drift angle and indirect restoration cost ratio. The lines in Fig. 4 and 5 show the regression lines. When we predict both the direct restoration cost ratio and indirect restoration cost ratio from these regression lines, the predicted equations are defined as follows:

where $R_{c,d,p}$ is the predicted value of direct restoration cost ratio; $R_{c,ind,p}$ is the predicted value of indirect restoration cost ratio; $\theta_{max,r}$ is maximum residual inter-story drift angle.

From Eq.16, the value of maximum residual inter-story drift angle corresponding to the reparability limit of direct restoration cost ratio (0.86) is defined as 1/91. From Eq.17, the value of maximum residual inter-story drift angle corresponding to the reparability limit of indirect restoration cost ratio (0.40) is defined as 1/79. From these two values, the smaller value 1/90 is adopted from a safety viewpoint. Eq.18 shows the definition of the reparability limit of maximum residual inter-story drift angle recommended for design practices:

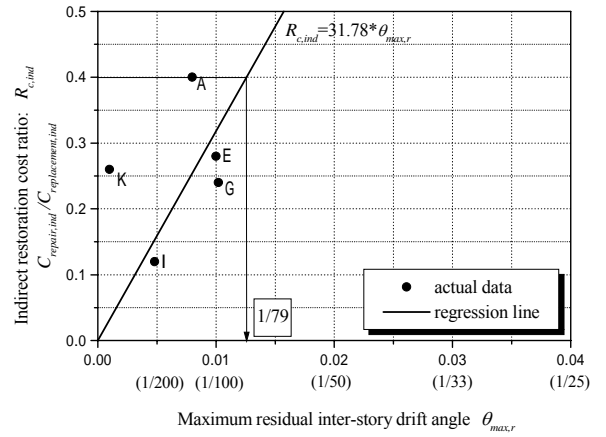
Fig. 5. Relationship between maximum residual inter-story drift angle and indirect restoration cost ratio.
