WASHINGTON STATE'S BRIDGE SEISMIC RETROFIT PROGRAM

Jugesh Kapur¹

Abstract

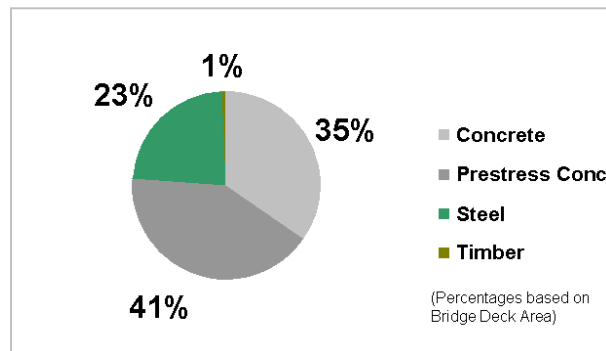
WSDOT is responsible for nearly 3,000 vehicular bridges on state owned highways. The bridges on state highways are made of either: concrete, prestressed concrete, steel or timber. Timber was generally used for bridges built prior to the 1950’s and represent 1% of the total. Steel has been used in both short and long span bridges and consists of 23% of the total. Concrete is the most common material used and represent 74% of the total number of state bridges. The average age of a state owned bridge is 39 years.

WSDOT BRIDGES – MATERIAL TYPES

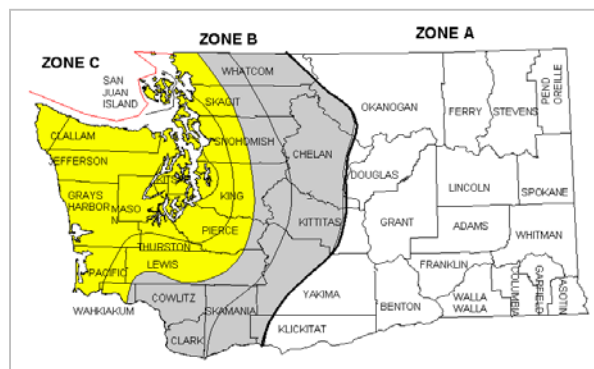
WSDOT uses a map to identify different seismic zones with peak ground accelerations (PGA) in Washington based on USGS information. "Zone C" is considered "High Risk" and covers the area with PGA greater than 0.20 times the force of gravity. "Zone B" is considered "Moderate Risk" and contains an area of PGA between 0.10 and 0.20 times the force of gravity. "Zone A" is considered "Low Risk" and contains an area of PGA less than 0.10 times the force of gravity.

WSDOT SEISMIC ZONE MAP

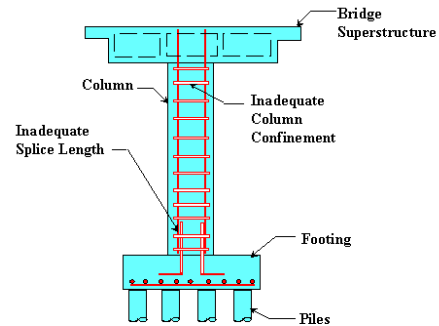
1. Inadequate confinement reinforcement for main longitudinal reinforcing steel in concrete columns.
2. Inadequate splice length of main longitudinal column reinforcing to footing dowels.
3. Inadequate development length of footing dowels (footing embedment).
4. Absence of reinforcement in the tops of footings.
5. Inadequate footing support capacity.

TYPICAL COLUMN DEFICIENCIES

The first three items were easily identified by a review of the bridge plans. Splice and confinement reinforcing, design, and detailing practices have changed so significantly that vulnerability is more of a yes or no determination rather than a degree of deficiency. The same is true of reinforcing in the tops of footings. Footing support adequacy is a function of the column retrofit scheme selected and existing footing's capacity to withstand the forces from a design earthquake. Footing retrofit techniques are expensive relative to the cost of retrofitting superstructures and columns.

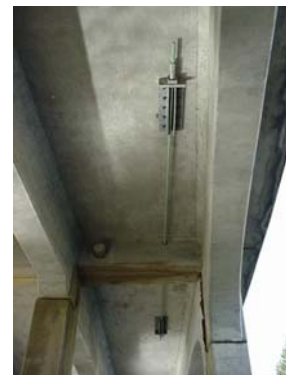
Techniques for restraining longitudinal and transverse movement of bridge superstructures typically include various combinations of restraining bars, hold downs, and reinforced concrete stops and thrust blocks. Replacement or modification of vulnerable bearing types have also been done. Bridges requiring this work are essentially done.

LONGITUDINAL RESTRAINER

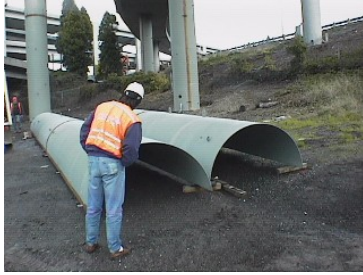
COLUMN RETROFIT STEEL

The primary material used by WSDOT to retrofit concrete columns is welded steel jackets. The process includes using two steel sections that are attached around a column and then welded together. Thickness of the steel jacket is determined by the size of the existing columns. Composite materials such as carbon fiber and fiber reinforced polymers (FRP) were installed on 9 bridges but was discontinued since the cost was 2 to 3 times more than steel.

Past earthquakes and experimental tests have shown that concrete columns on pre-1983 bridges are vulnerable to brittle failure if exposed to a significant seismic event. Column jacketing permits ductile behavior of the bridge during an earthquake by providing additional shear capacity and confinement thus allowing the formation of plastic hinges at one or both ends of the column.

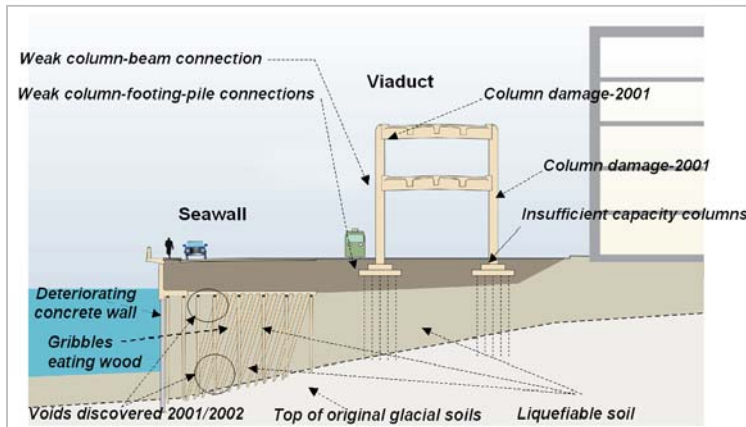
ALASKAN WAY VIADUCT – VULNERABILITY AREAS

Post-earthquake inspections of the viaduct revealed both good and bad news concerning its condition. The good news was that the viaduct survived the 6.8 magnitude earthquake. The bad news was the earthquake caused damage to the viaduct's joints and columns, further weakening the structure and revealing its severe vulnerability. The team of experts concluded that it was not cost-effective to fully retrofit the majority of the viaduct; rather, the viaduct would need to be rebuilt or replaced.

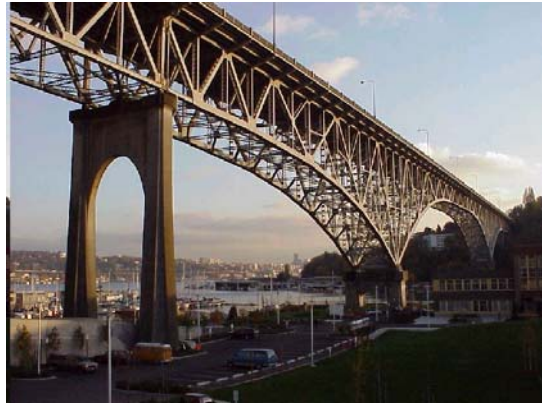
The George Washington Bridge is a long-span cantilever truss structure spanning the Lake Washington ship canal at the entrance to Lake Union in Seattle. The structure was designed and built between 1929 and 1931. The 800 ft. long main span is one of Seattle's longest and tallest spans and is currently registered as one of four Historic Bridges in King County. The bridge carries 6 lanes of arterial traffic averaging 73,836 vehicles a day. The Aurora Bridge has been designated as a critical emergency route and is considered an essential bridge by the Seattle Engineering Department Traffic Section.

GEORGE WASHINGTON BRIDGE

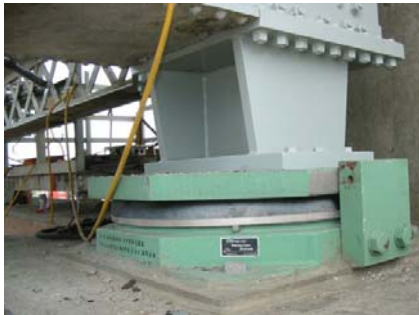
WSDOT decided to address the seismic deficiencies in three separate projects due to the total retrofit cost. The first stage project added restrainers to the bridge and was completed in 2000 at a cost of \$2.1 million. The second stage retrofit work included replacing 24 existing rocker bearings with friction pendulum base isolation bearings. These bearings are designed to mitigate the deficiencies of columns at piers S-3 to N-3 (inclusive) and deficient members in the main truss spans. The expansion joints were replaced to allow greater movement in a seismic event. A couple of the lower cord truss members were also replaced. The second stage project was completed in 2004 at a cost of \$7.3 million.

FRICITION PENDULUM BEARING

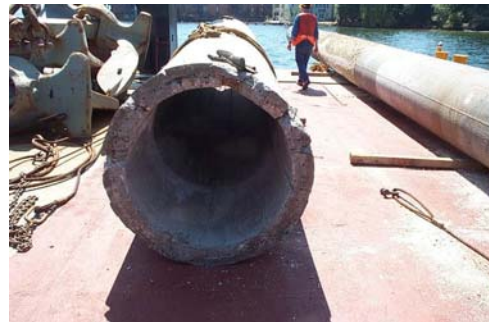
A second, and possibly more severe deficiency could result from spalling of the interior surface of the piles at fairly low lateral displacements and modest pile curvature (flexural rotation induced by lateral seismic loads). The concrete inner surface is unconfined and under compressive strains as low as 0.004, the concrete spalls. These thin walled piles (typically five inches thick on these circa 1960s bridges) rapidly lose vertical load capacity with any amount of spalling, unlike conventional solid columns which are indifferent to spalls so long as the concrete core and reinforcing that confines the main longitudinal steel are intact.

TYPICAL PRESTRESSED CONCRETE HOLLOW COLUMN

One of the primary problems (non-ductile performance) occurs in the top several feet of the piles (a length equivalent to the pile diameter) where plastic hinging develops in the pile-to-pile cap connection. Tests performed to verify effectiveness of retrofits in this area have shown that while providing addition confinement and longitudinal reinforcing in this area improves shear capacity, it actually reduces pile ductility by driving the plastic hinging region to the mid height of the pile.

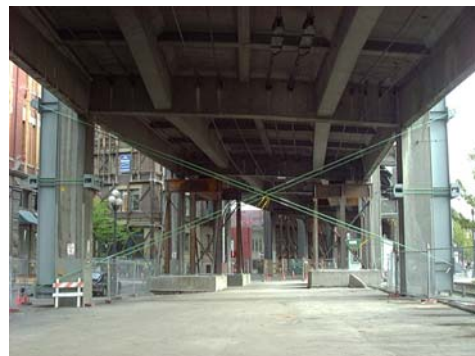
The numbers of bridges damaged based on their design type were: Reinforced concrete bridges (36); Prestressed concrete bridges (20); Steel bridges (16); Movable bridges (6). No damage was reported to timber or masonry bridges. The most common type of reported damage (48 bridges) consisted of concrete cracking and spalling. The Alaskan Way Viaduct sustained significant damage, which required temporary shoring. The total cost to repair the damage to state bridges was approximately \$5 million.

ALASKAN WAY VIADUCT SHORING
