Experimental study on application of damage detection and measurement technology of steel bridge

Abstract

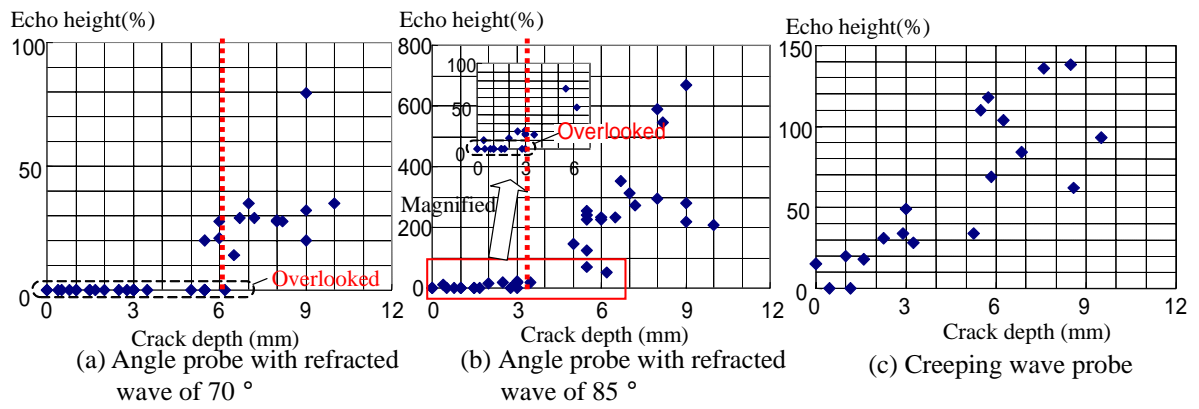
Figure 3 Results of Ultrasonic Testing by Specimen
(Relationship of crack depth with reflected echo)

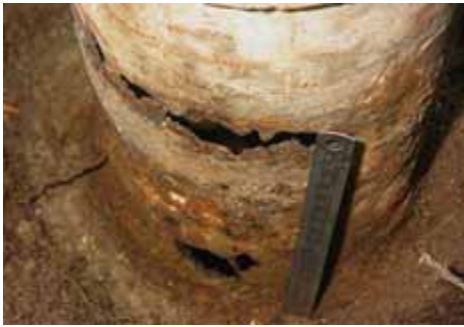
Photo 2 Light pole corrosion

During the 40 years since the light poles were installed, it has been reported that under the old standards, foundations have been corroded (Photo 2) and broken toppling the poles. Although only a few cases have been reported, this may lead to public injury and there needs some measures in inspection. This has occurred because the foundations of light poles are usually underground and even when corroded, this damage is not easy to observe. So technologies ranging from applied to basic technologies are now being studied.

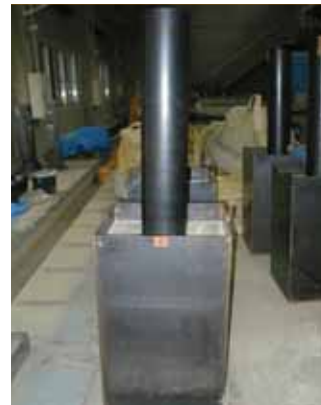
Photo 3 Specimen

This part of the report focuses on the electromagnetic ultrasonic testing method that is used in Europe for pipeline corrosion inspections. Because ultrasonic waves are input with a magnetic field in this method, it is a non-contact method that can apply waves deeply into the material, even from above a paint film. The equipment used had already been developed. The experiment was done using a specimen with artificial damage made to simulate corrosion (see Photo 3).

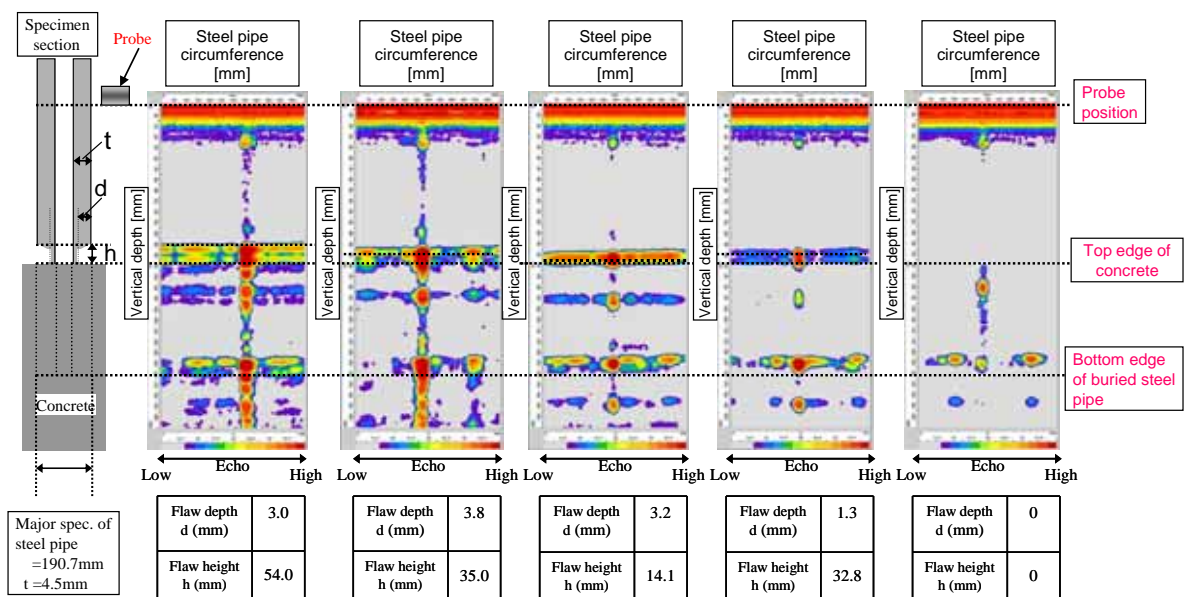
Figure 4 Defects and Results of Electromagnetic Ultrasonic Testing Method

This inspection was performed by installing the probes about 800mm from the end of a steel pipe. Figure 4 shows an example of a result of an inspection when 300 kHz ultrasonic waves were used.

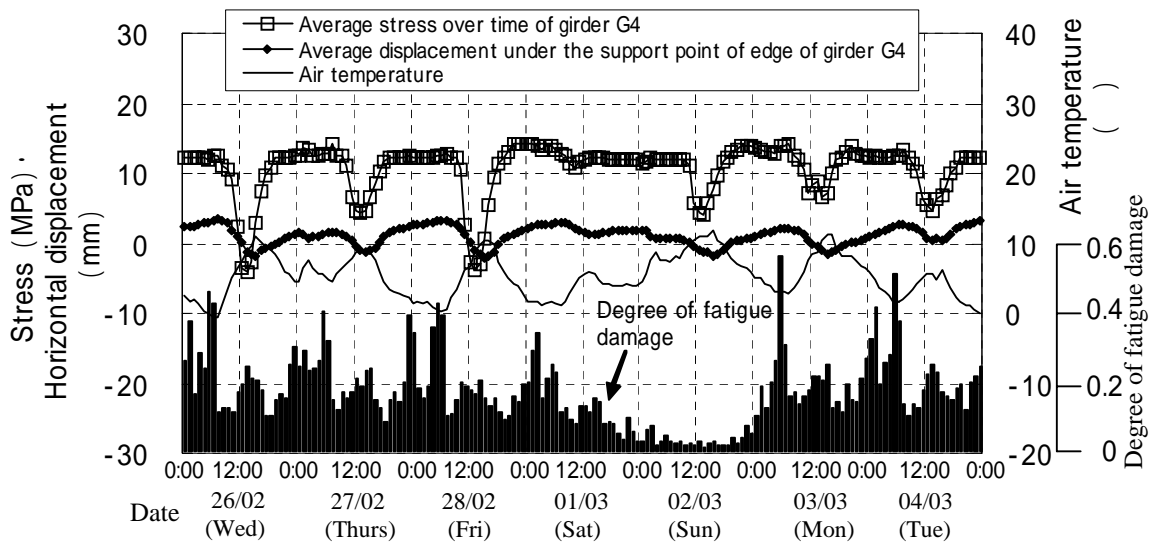
Figure 8 Weekly Fluctuation

. Results of degree of fatigue damage measurements in one hour units and in daily units of main girders confirmed tendencies for fluctuation by time of day and day of the week of the live load stress that is assumed to be a result of the impact of the large vehicle traffic volume (see Fig. 8). Figure 9 has confirmed that there is no specific fluctuation of properties related to stress other than thermal stress under weekly and annual fluctuations, so it appears that abnormal values can be monitored to a certain degree.

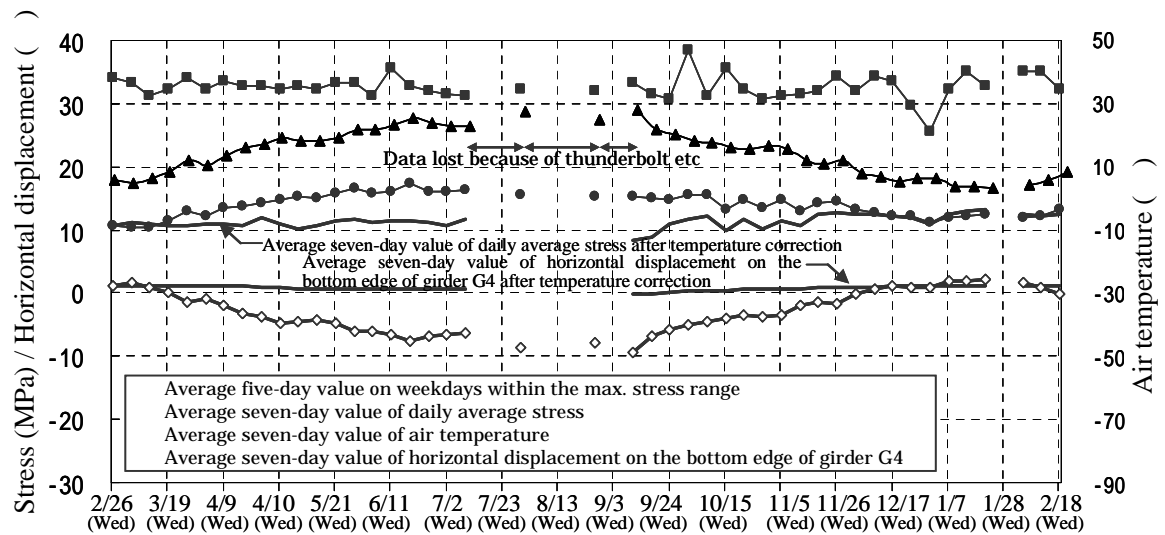
Figure 9 Seven-day Average Value of Stress of Bottom Flange in the Center of Girder G4 Span

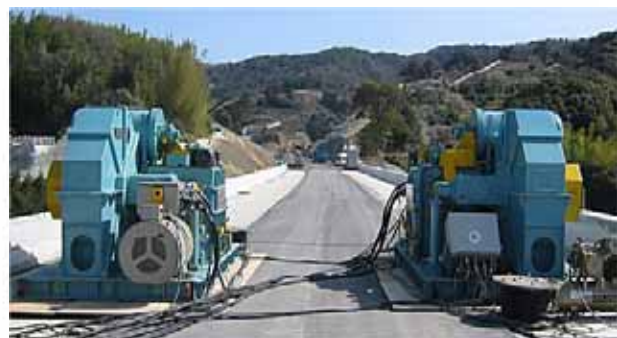
Photo 4 Installation of Exciters

The bridges were two bridges with width of 11m, half wall railings and with rubber bearings. The two bridges had relatively long maximum span lengths (Bridge A: max. span 60m, continuous 4-span 2 main girder bridge, bridge length 225m, width 11m, and Bridge B: max. span 70m, continuous 5-span 2 main girder bridge, bridge length 325m, width 11m). Two exciters (0.1 to 20Hz) owned by the PWRI (Photo 4) were used.

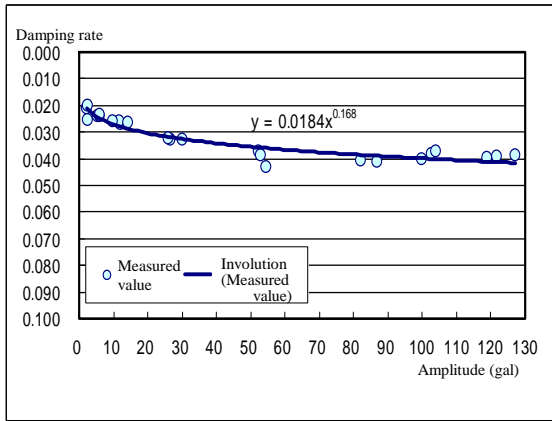
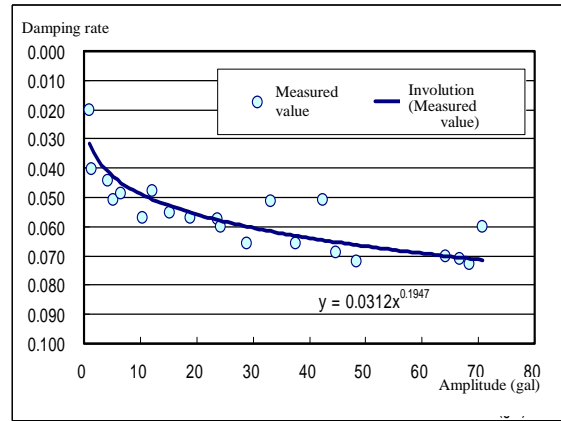
(a) Vertical deflection primary mode

(b) Oscillation primary mode

Figure 11 Amplitude and Structural Damping

The vibration characteristics of the structure tested were confirmed. As one result of the test, the vibration frequency and structural damping are found to be amplitude dependent. As an example, the amplitude dependency of structural damping in Bridge B is shown in Figure 11. From these results, it can be said that the degree of amplitude must be checked in evaluating vibration characteristics.

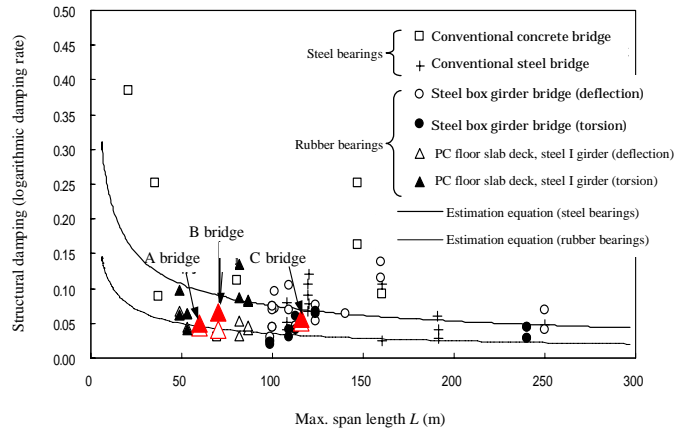
Figure 12 Structural Damping of Girder Bridges (Logarithmic Damping Rate)

And structural damping was a value that is smaller than that of a box girder bridge with conventional steel bearings. The reason for this is not clear, but an estimation equation was proposed as a criterion because structural damping is necessary to evaluation wind resistance stability (see Fig. 12).
