CYCLIC LOADING TEST OF REINFORCED CONCRETE COLUMN WITH HOLLOW SECTION AND HIGH LONGITUDIAL STEEL RATIO UNDER HIGH AXIAL LOADING

Hitoshi YATSUMOTO¹, Junichi SAKAI², Jun-ichi HOSHIKUMA³

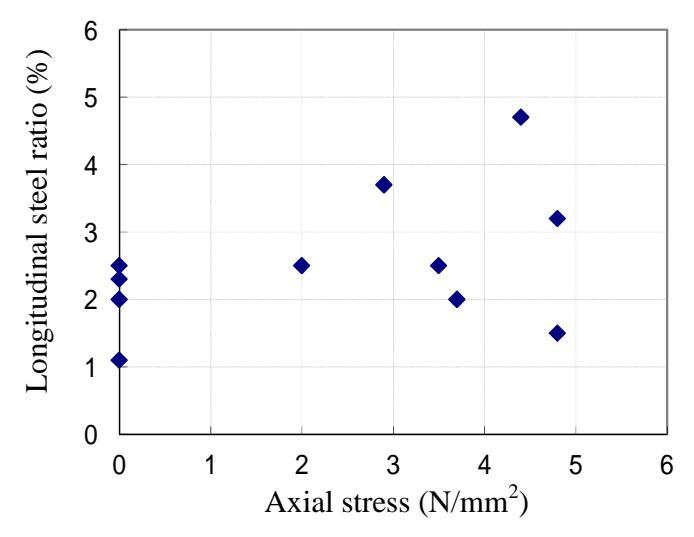
Figure 1 Structural conditions of reinforced concrete columns with hollow section tested in previous researches

Several research projects [1,2, 3, 4, 5, 6, 7] have been conducted to investigate nonlinear behavior of RC column with hollow section under cyclic loading, and design limit state and evaluation method of nonlinear ductility capacity have been determined based on the results from these experiments. Figure 1 shows the structural condition of those research tests.

Figure 1 compares structural condition of specimens between this tests and previous researches. The figure shows the specimens in this test have relatively large axial stress and

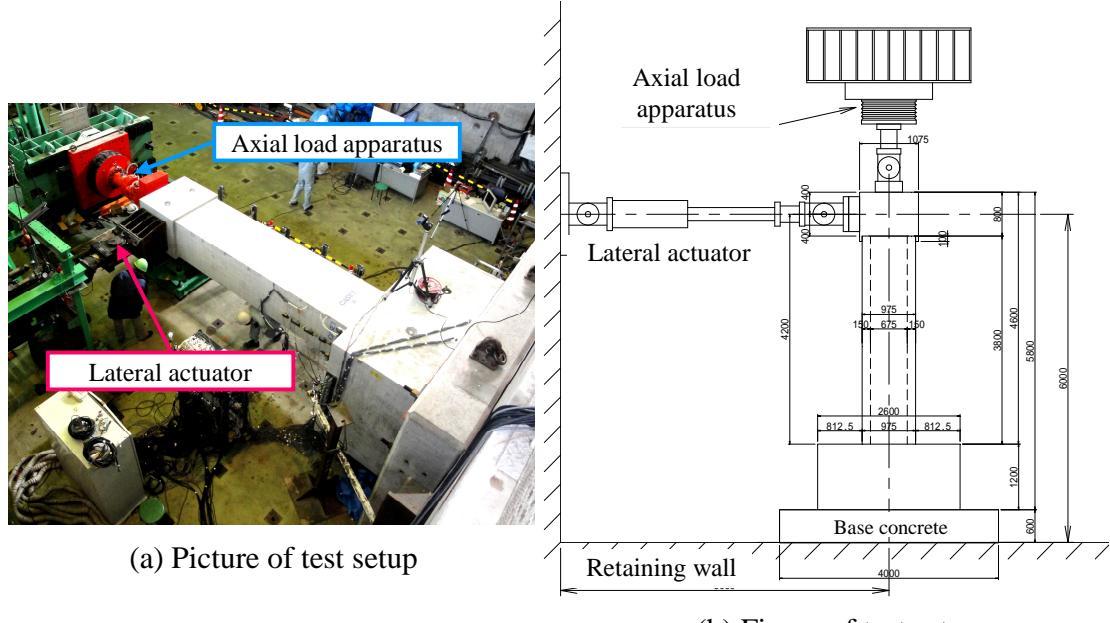
Figure 2 Test set-up

(b) Figure of test setup

Figure 2 shows the specimen tested in this study. This is a 1/7 scale model of a RC column with hollow section constructed in Japanese mountain area. The model is designed with high longitudinal steel ratio and subjected to high axial loading due to the thin wall in hollow section. As shown in Figure 2, the specimen was laid horizontally and the footing was mounted to the reaction wall through the base concrete. A lateral load was provided by a large stroke actuator at 4200 mm height from the base, resulting in an effective aspect ratio of 4.3, and a vertical load was applied at the top of the column by an axial loading apparatus.

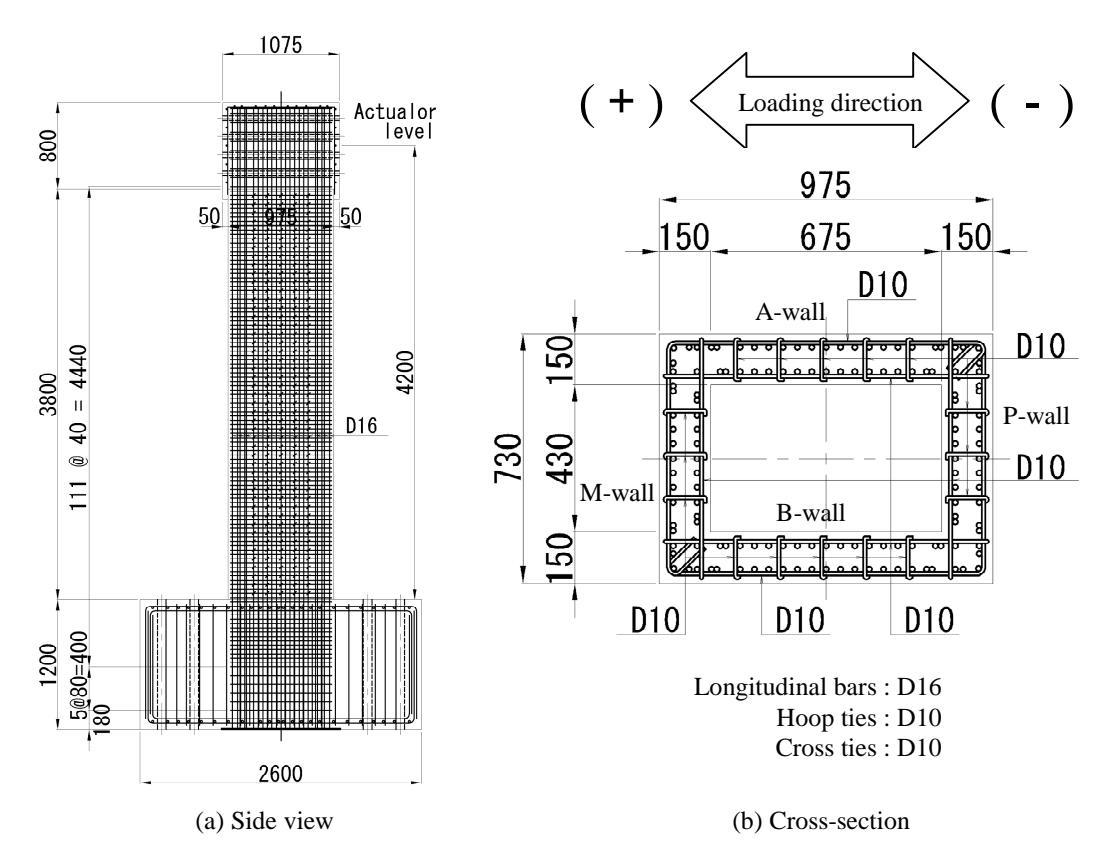
Figure 3 Reinforcement details of the specimen

Figure 3 shows the reinforcement details of the specimen and Table 1 shows the specimen details. The specimen is reinforced longitudinally with 102 of 16 mm diameter deformed bar (D16), providing a longitudinal steel ratio, ρ_1 , of 6.41%. Hoop reinforcement of 10 mm diameter deformed bar (D10) is used to confine the concrete core, spaced at 40 mm pitch and cross-tie is provided at 80 mm pitch, resulting in a volumetric reinforcement ratio, ρ_s , of 2.9%. Figure 4 shows arrangement of cross tie in flange wall. In practice of reinforcement arrangement for a hollow section, 90 degree hook is generally used at the inner face side and 135 degree hook is used at the outer face side of the wall. In this study, cross ties were arranged in the same way.

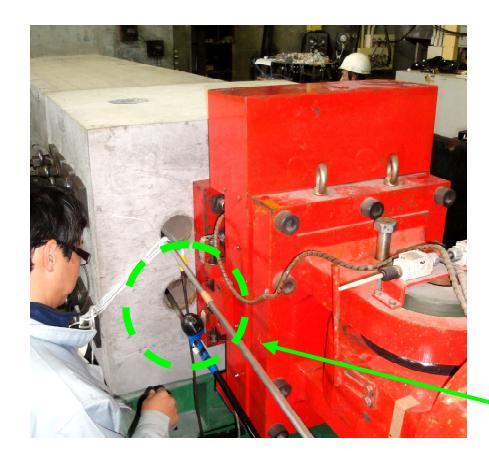
Figure 5 Small video camera set inside

Small video camera

A small video camera was inserted from the hole on the top of the column.

A small video camera was set in the hollow part to observe damage of inside faces during cyclic loading as shown in Figure 5. The video camera can capture severe damage such as spalling of cover concrete, but slight damage such as flexural cracks might be missed due to the limitation of the resolution of the video camera.

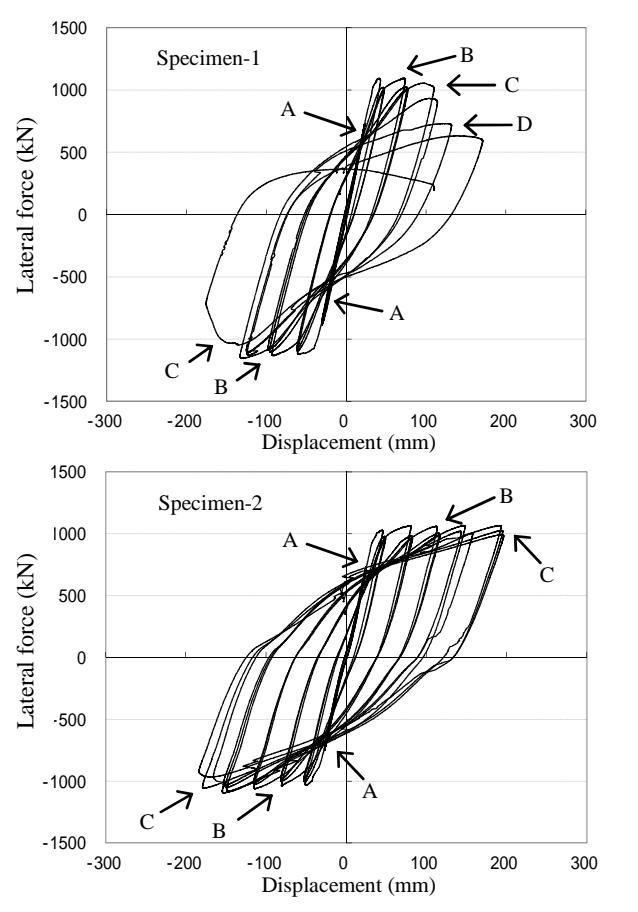
Figure 6 Lateral force vs lateral displacement

Figure 6 shows the lateral force vs. lateral displacement hysteresis and Figure 7 shows the envelop curves. Lateral displacement in Figures 6 and 7 is modified by removing the displacement caused by strain penetration of longitudinal bar into the footing.

In this research, ultimate state was defined as the stage when an extensive deterioration of lateral force was observed in the lateral force vs. lateral displacement hysteresis. Point A, Point B, Point C and Point D in Figure 6 indicate the first yield displacement, the displacement when spalling of outside cover concrete was occurred, the displacement when spalling of inside cover concrete was occurred, and the displacement when buckling of the longitudinal reinforcing bar was occurred, respectively.

- A: Yielding of long. Bar,
- B: Spalling of outside cover concrete,
- C: Spalling of inside cover concrete
- D: Fracture of long.bar

Taking the average of lateral force and lateral displacement in the push and pull direction, the maximum strength in Specimen-1 and in Specimen-2 reached 1124 kN and 1084 kN, respectively. The yield displacement of Specimen-1 and Specimen-2 were almost same but the ultimate displacement of Specimen-1 and Specimen-2 was 113 mm and 172 mm, respectively.

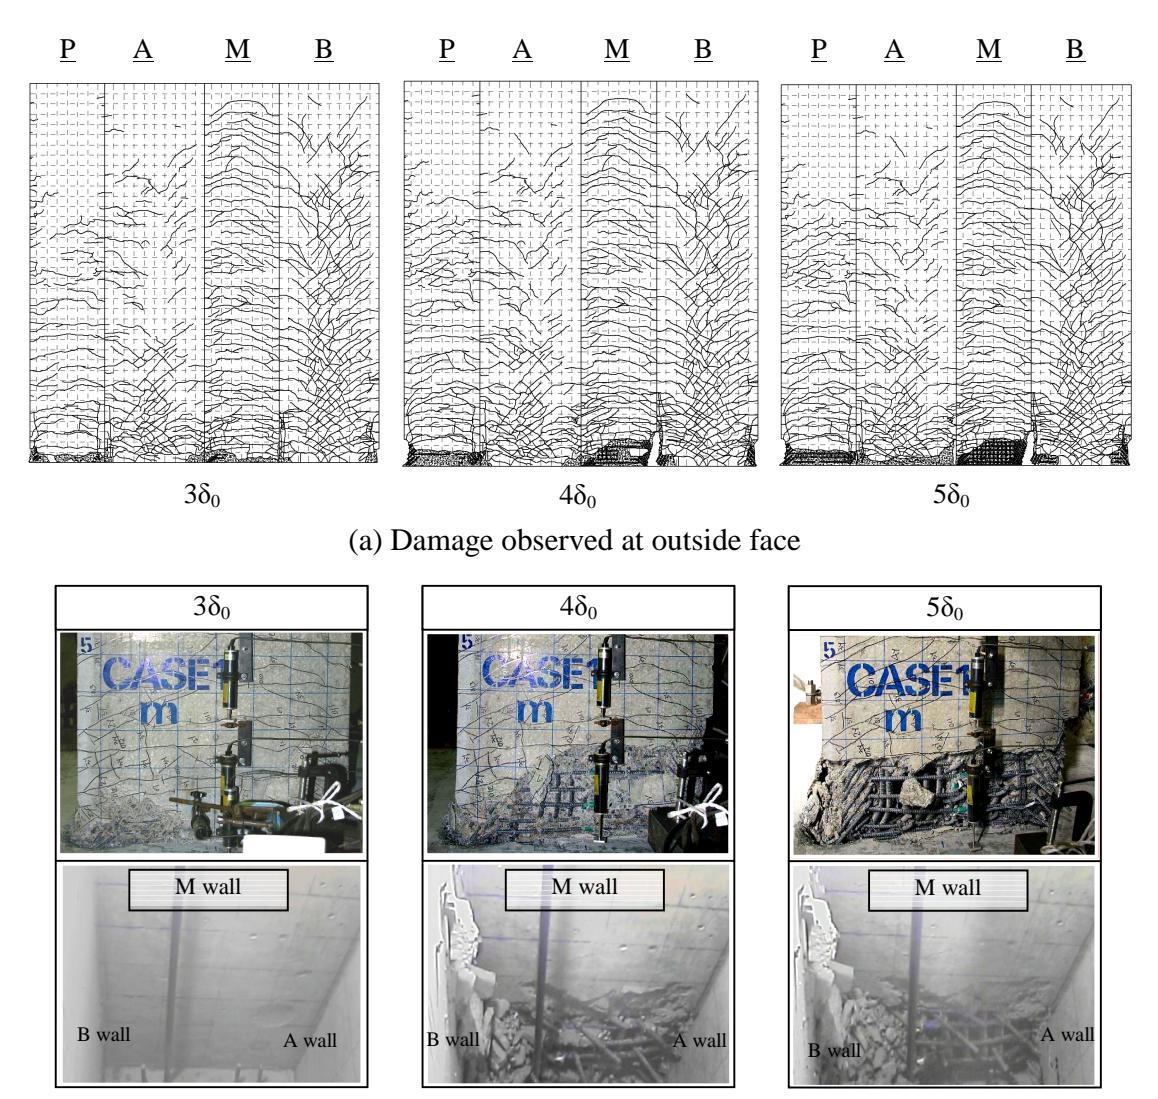
Figure 8 Damage observed in Specimen-1

As shown in Figure 8, spalling of cover concrete at the outside faces was observed but spalling of cover concrete at inside faces was not observed at 3 $_0$ in Specimen-1. At 4 $_0$, buckling of longitudinal bar arranged at the inside and outside faces of the wall was observed. At the same loading step, the 90 degree hook of the cross ties at the inner face was unhooked from the core concrete. However, the 135 degree hook at outside faces hooked well to the core concrete until the end of the test. Consequently, the damage degree at the inside faces was more severe than that at the outside faces.

(b) Damage observed at face M (upper : outside, lower : inside)

Figure 8 and 9 show the damage progress of Specimen-1 and Specimen-2, respectively.

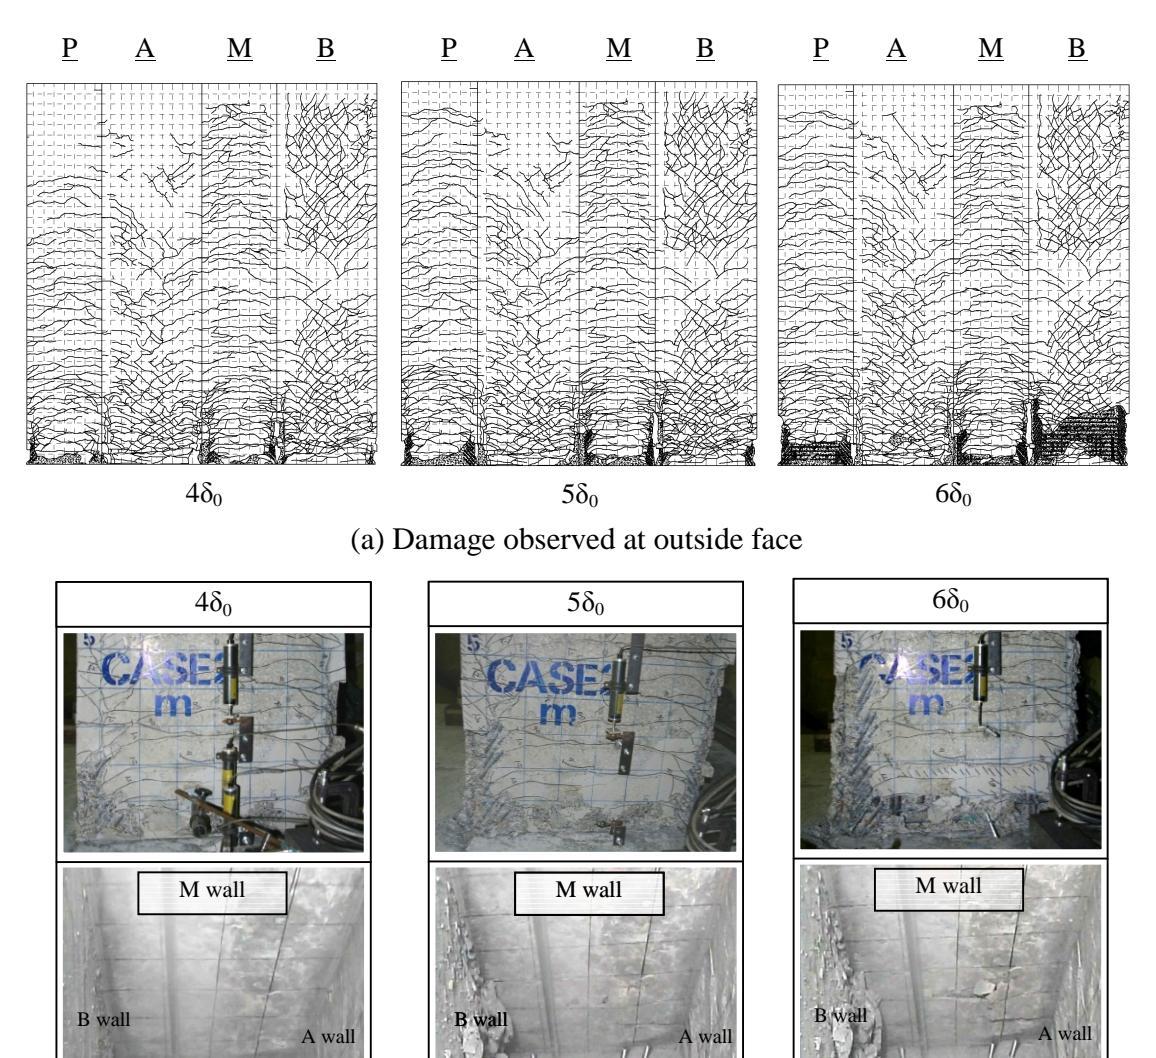
Figure 9 Damage observed in Specimen-2

As shown in Figure 9, spalling of cover concrete at the outside faces was observed but spalling of cover concrete at the inside faces was not observed at 4 $_0$ in Specimen-2. Spalling of cover concrete at the inside faces was observed at 5 $_0$. Buckling of longitudinal reinforcing bar arranged at the inside and outside faces of the wall was observed and the hook ends of the cross ties coming out from the core concrete occurred only at the inside faces at 6 $_0$ in Specimen-2. Likewise in Specimen-1, the hook ends at outside faces had not come out from the core concrete until the end of the test.

(b) Damage observed at face M (upper : outside, lower : inside)
