Seismic Retrofit of the Poplar Street Bridge

Abstract

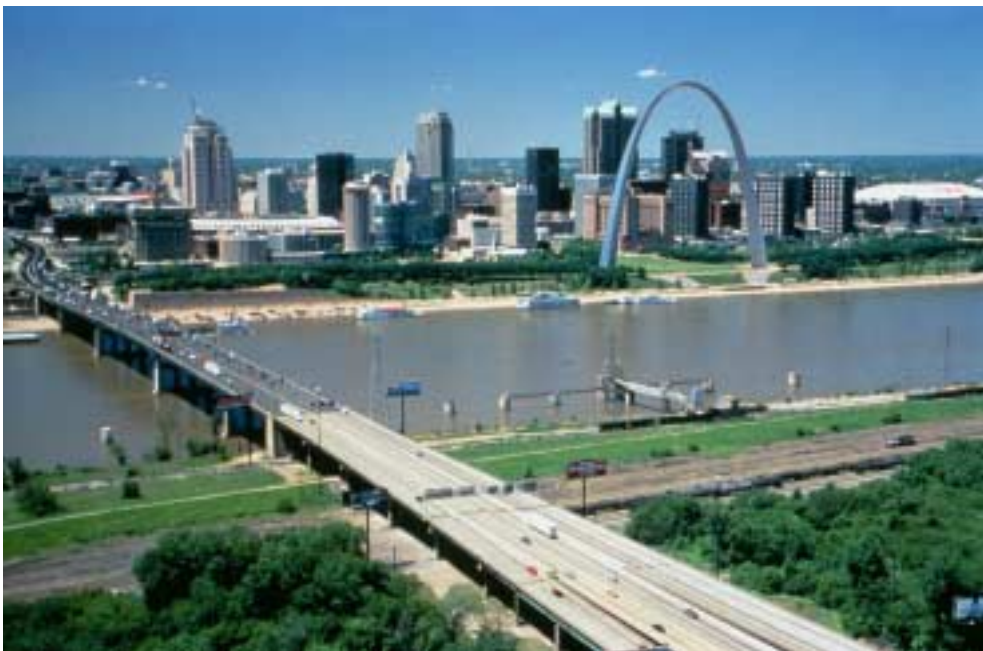
Figure 1. Poplar Street Bridge in St. Louis, Missouri

The Poplar Street Bridge carries more than 130,000 vehicles per day across the Mississippi River at St. Louis, Missouri via U.S. 40/I-64 and I-55/70, see Figure 1. The 660 meter (2,165 foot) structure consists of two parallel five span continuous roadways, each providing four lanes of traffic. Span lengths from west to east are 91, 152, 183, 152, and 81 meters (300, 500, 600, 500, and 265 feet). Two variable depth steel box girders support each roadway. The deck is of orthotropic steel plate construction consisting of a deck plate, trapezoidal longitudinal ribs and transverse floor beams. The deck plate acts as the top flange of the transverse floor beams, the trapezoidal ribs, and the main longitudinal box girders. The reinforced concrete substructure from west to east consists of a hollow shear wall type structure at Pier 1, solid shafts with rectangular columns and continuous cap beams at Piers 2, 3, 4, and 5, and a hollow shear wall structure at Pier 6. The

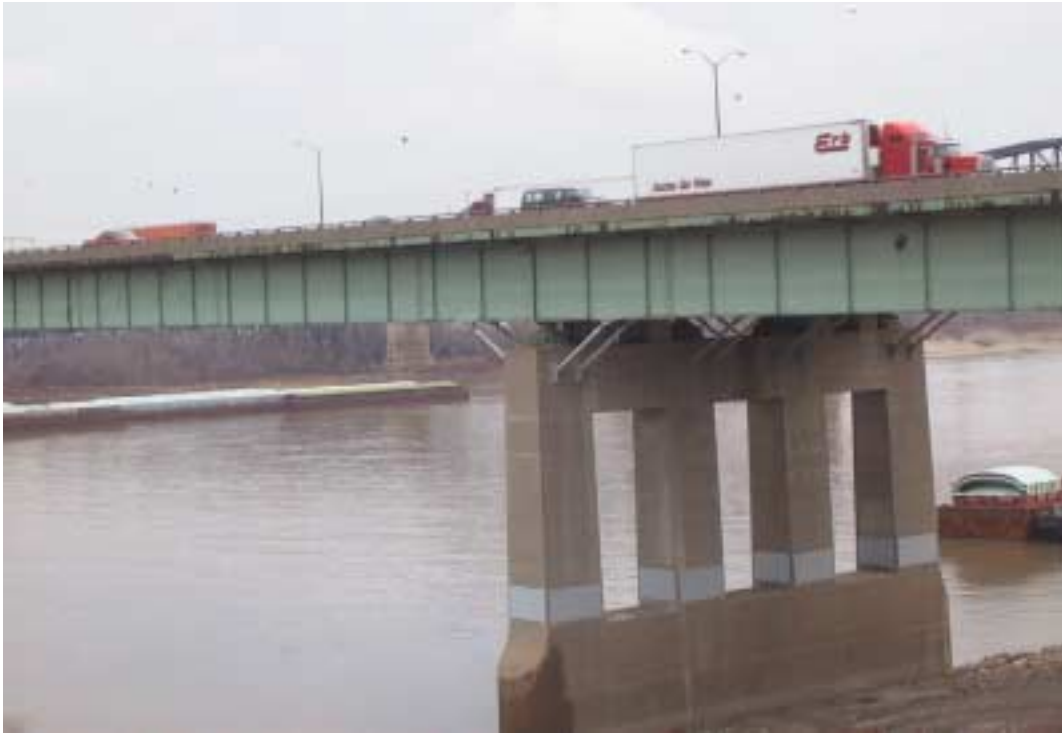
Figure 2. Pier 2 with retrofit installed

The analysis of retrofitting with longitudinal shock transmission units at all piers versus only the interior piers, showed that the former alternative provided greater longitudinal displacement control, and greater capacity for resisting seismic loading, as expected. The final longitudinal restrainer configuration provided four 1.56 mega-Newton (350 kip) shock transmission units at each of the expansion bearings at Piers 2, 4, and 5,

Confinement of the lap splices near the base of the 4 meter (13 foot) by 3.7 meter (12 foot) rectangular columns with conventional grout filled elliptical steel jackets was considered undesirable for this project because the jackets would be exposed to stream flow during flood stages, and ice flow during the winter. Investigation of composite wrap alternatives showed that this approach would not provide the required confinement near the centers of the faces of these large columns. Because of the limitations of these alternatives, confinement of the lap splice regions by steel plates with closely spaced post-tensioned steel rods was selected for the retrofit design. This approach provided minimal horizontal exposure to stream and ice forces, and tension in the rods, which were extended into the core of the column, provided the desired confining pressure.

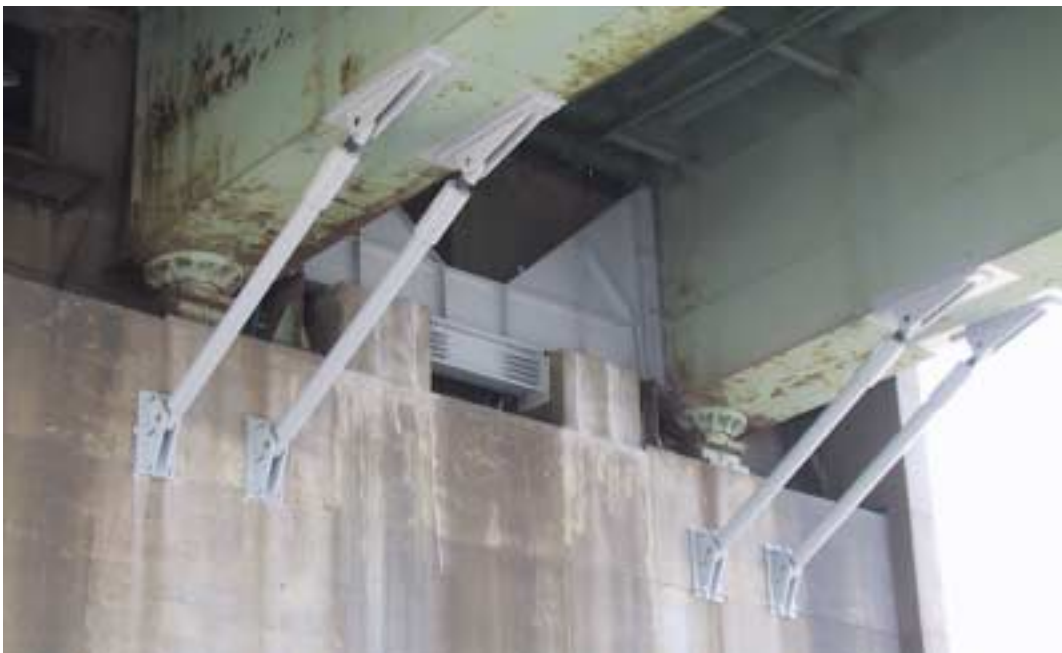
Figure 3. Pier 1 retrofits

and two 2.59 mega-Newton (500 kip) shock transmission units at each of the expansion bearings at Piers 1 and 6.

Evaluation of the longitudinal shear capacity of Piers 1 and 6 showed that these piers did not have sufficient longitudinal capacity to resist the design level restrainer forces. Consequently, the retrofit design included addition of reinforced concrete shear walls inside of Piers 1 and 6 to provide the required capacity. Also, because the depth to rock at Pier 1 was less than 8 meters (26 feet), the retrofit included adding rock anchors through the grade beams at the base of the pier, to increase overturning resistance.
