# SOME CONSIDERATIONS IN THE DESIGN OF LONG SPAN BRIDGES AGAINST PROGRESSIVE COLLAPSE

Theodore P. Zoli<sup>1</sup>, Justin Steinhouse<sup>2</sup>

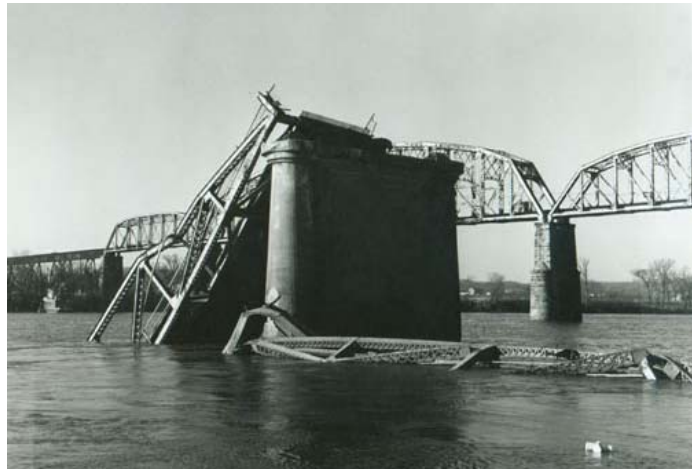
**Silver Bridge Collapse – December 15, 1967**

On December 15<sup>th</sup>, 1967, the collapse of the eyebar suspension Silver Bridge over the Ohio River during rush-hour traffic killed 46 people. The collapse was due to a fracture of the eyebar suspension chains (two eyebars per chain) associated with stress corrosion cracking and corrosion fatigue, prompting national concern

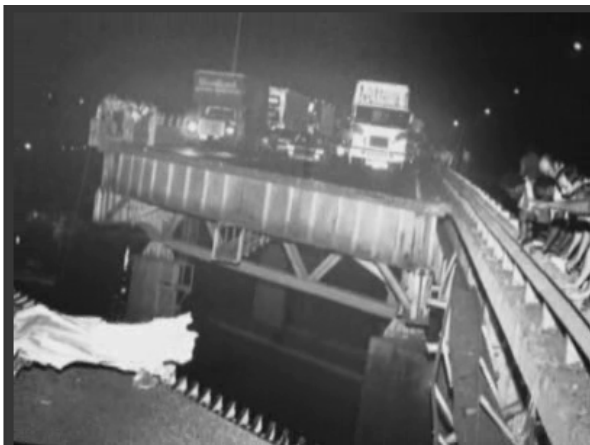
**Mianus River Bridge Collapse – June 28, 1983**

A little over 15 years later, on June 28, 1983, a section of the Mianus River Bridge catastrophically failed due to abrupt fracture of a pin and hanger detail ( a failure mode eerily similar to the Silver Bridge eyebar failure). This failure resulted in only three fatalities (fortuitously the collapse occurred at 1:30am) and disrupted commerce in the Northeastern U.S. for several months. Following this event, a significant body of research into fatigue of steel connections was undertaken and resulting in more

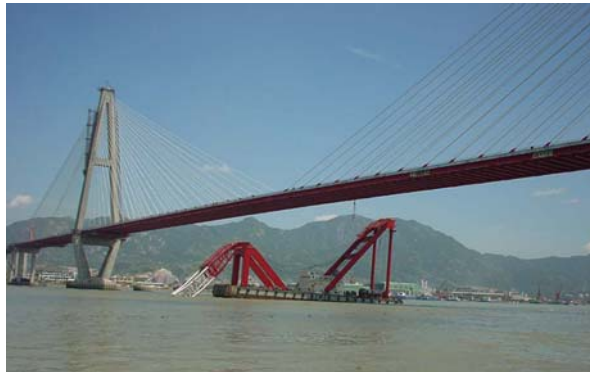
**Barge Impact to Stay Cables, Fuzhou, China**

The first example is vessel impact with a stay cable. During a hurricane in June of 2001, a runaway 1000 ton crane barge struck 3 or more stay cables of the Ching Chau Ming Jang Cable Stayed Bridge in Fuzhou, China. Only 3 strands were found to have ruptured in a single 73 strand stay [7]. The entire cable was replaced, given that the remaining strands had varying forces and the potential that these strands had been damaged could not be ruled out. It is noted that the bridge was nearing construction completion at the time of the impact; the cable was replaced with no difficulty and the bridge was opened to traffic soon after.

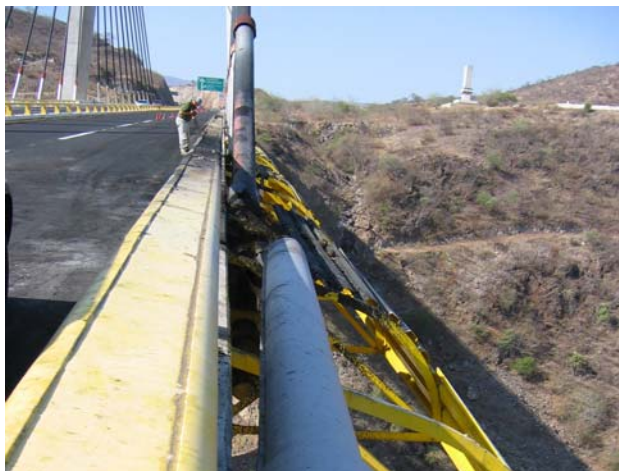
**Mezcala Bridge – Fire and Cable Failure**

On the Mezcala bridge in Mexico, a traffic incident on March 17<sup>th</sup>, 2007 involving two school busses and a truck transporting coconuts produced a fire at deck level resulting in the failure of one stay cable and limited damage to an adjacent cable. Similarly, the bridge was immediately closed to traffic and reopened to limited traffic prior to cable replacement. Here again, it seems clear that the HDPE as a corrosion protection element is poorly suited to resist fire and becomes part of the fire load, if ignited, enhancing the potential for damage. In both these instances fire produced a load that resulted in cable loss. In addition, it appears likely that multiple cables could participate in a deck level fire or a fire associated with a lightning strike. Would these bridges have survived the loss of two or three adjacent cables? A fire event that caused the failure of three adjacent stays resulting in loss of the span (or spans) is a progressive collapse event that involves multiple elements. This problem of single point vulnerability, where an extreme event results in multiple element loss is discussed in more detail below.

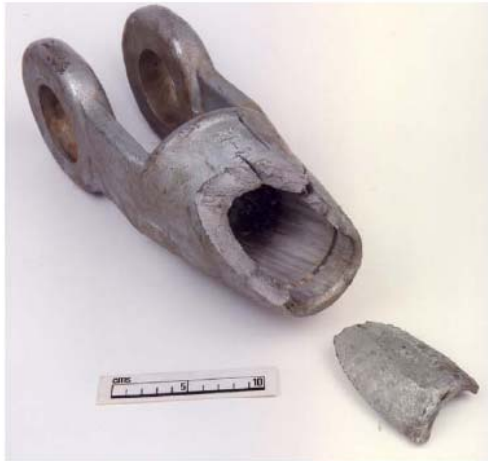
**Wire Rope Socket Premature Failure**

We have also conducted research into the behavior of cables under rapid loading near the limit state. This is of particular concern in progressive collapse design where it is vital to have an accurate assessment of the capacity of adjacent members to resist forces associated with member loss.

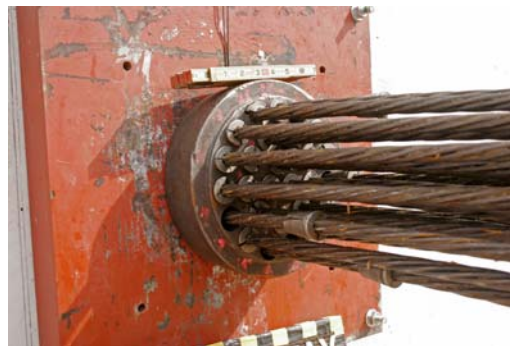
**Wedge Unseating – Explosive Tests**

As part of our explosive tests, we have also witnessed wedge unseating with 7 wire prestressing strand used in many (if not most) stay cable systems. While these tests were intended to evaluate cable behavior under explosive threats, there were clear indications that wedge unseating occurred. However, it was difficult to assess whether wedge unseating was limited to the strands that were severely damaged or not and subsequent tests are planned to evaluate the potential for wedge unseating without significant damage to the individual strands. It may be both necessary and prudent to incorporate wedge retainer plates in all stay cable anchorages to avoid this mode of failure (particularly if it results in premature cable loss).

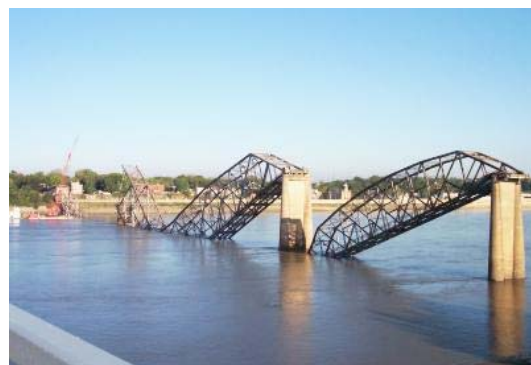
**Cape Girardeau Truss Demolition**

An important example of progressive collapse of a truss bridge during demolition appears to be a circumstance where the dynamics of member loss were improperly considered. In the early fall of 2004, the Cape Girardeau truss bridge river spans were to be demolished after completion of an adjacent cable stayed bridge.

Explosive demolition was planned to drop a span at a time to ensure that Mississippi River navigation would not be impacted. On September 9<sup>th</sup>, demolition of the side span resulted in near instantaneous failure and subsequent collapse of the main span, as well as the other side span and the adjacent approach span trusses. This accident resulted in interruption to navigation as well as substantially complicating the completion of truss demolition, which was not completed until over 1 month later.

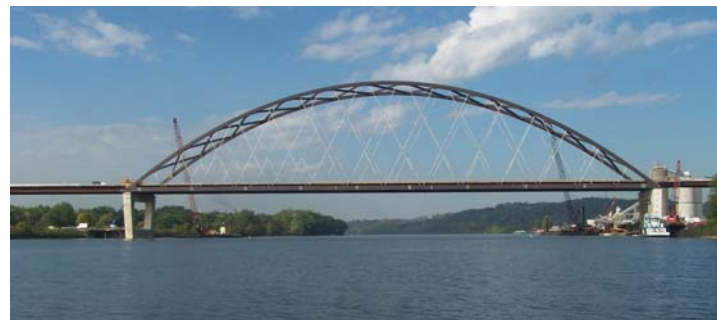
**Blennerhassett Island Network Tied Arch**

In a recent design for a 268m network tied arch in West Virginia, we together with Michael Baker, Jr. Inc conducted comprehensive analyses to evaluate cable loss and partial tie girder fracture. This project presented an ideal opportunity to assess aspects of progressive

collapse on arch bridge design with a particular emphasis on cable loss dynamics. Early on in the design process, it became clear that cable loss governed the design of the arch rib and that the tie girder redundancy strategy (the use of a built up box section, such that a crack could not propagate from flange to web or vice-versa) was highly sensitive to live load moment demands. From these evaluations, it was clear that the only viable strategy was a network configuration of hangers (i.e. inclined hangers that cross at least once). This strategy significantly reduced moment demands in the tie girder under plate loss scenarios (whereby the three remaining plates are designed to have sufficient capacity) as well as reducing moment demands and enhancing the stability of the arch rib under cable loss scenarios.

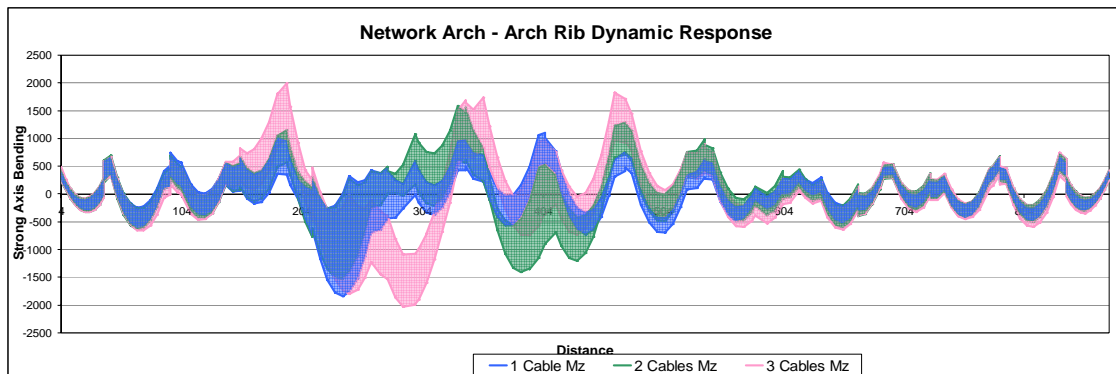
**Envelope of Dynamic Response – Abrupt Cable Loss**

This work also resulted in the development of insights into the dynamics of cable loss, particularly in terms of analysis methods and the impact of loss duration (i.e. the abruptness of the loss of an element). This work is summarized elsewhere [12] and will not be discussed herein. However additional studies of network arches under single and multiple cable loss scenarios highlight the hyperstatic nature of these forms, highlighting the ability for load redistribution throughout the structural system in the event of even multiple localized failures. It is particularly interesting to compare peak structural response associated with the loss of 1,2, and 3 adjacent cables. Notice that the peak flexural demands for the arch rib (design critical element for cable loss) do not show marked increases as the number of cables that are lost increases. Also note the flexural response of nearly the entire arch. This clearly demonstrates the ability of the

Also of interest is a comparison of the dynamic response of cable loss as compared to the pseudo-dynamic response with the technique described in the *PTI Recommendations*, whereby the lost element is applied with an impact factor of 2 with the force applied in the opposite direction of the force in the lost cable. It can be seen that the pseudo-dynamic response does capture behavior accurately, over-predicting response in some locations and under-predicting response in other locations. This is consistent with the findings of others on progressive collapse, that modeling the dynamics of loss is a necessity.

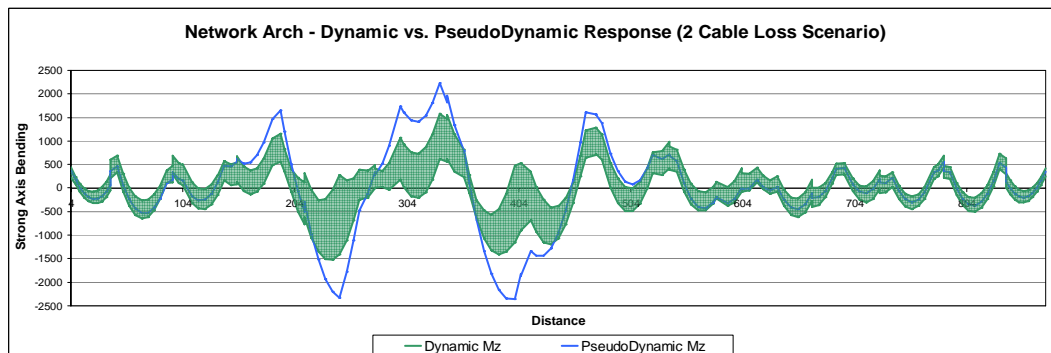
**Dynamic Envelope versus Pseudo-Dynamic Response**

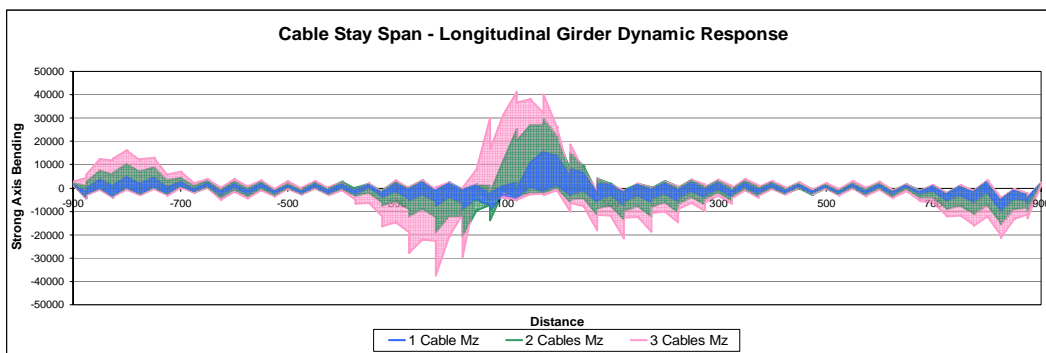
**Girder Dynamic Envelope – Multiple Cable Loss**

As part of the conceptual design of a new bridge in the northeast United States, a comprehensive evaluation of multi-cable loss was undertaken to assess the structure's resistance to progressive collapse. It is noted that this conceptual design is of an unusual configuration with parallel roadways supported by 4 planes of cables supported by a tower that has a high degree of lateral and torsional stiffness. These features were implemented to enhance overall resistance to progressive collapse.

It is clear from the longitudinal girder dynamic envelopes shown in the above figure that a significant increase in flexural demand (and similarly the likelihood of

buckling) is associated with each additional cable lost. It is clear from these studies that multiple cable loss, whether a dynamic event (impact, terrorist attack) or a quasi-static event (fire) the potential for progressive collapse exists, and that superstructure depth (as a function of cable spacing) is the primary means of enhancing resistance to progressive collapse.

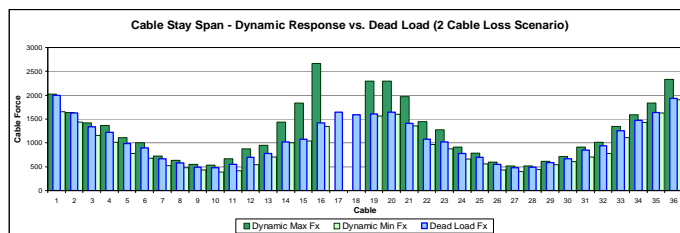
**Dynamic Cable Loss – Cable Force Envelopes**

Similar insights can be derived from evaluating the dynamic force envelopes associated with multiple cable loss scenarios. Depending upon the stiffness of the superstructure, cable force increases are localized adjacent to the lost cables resulting in the potential for unzipping. As will be discussed below in the response of suspension bridges, stiff superstructures tend to maximize the force demands at the adjacent cable.

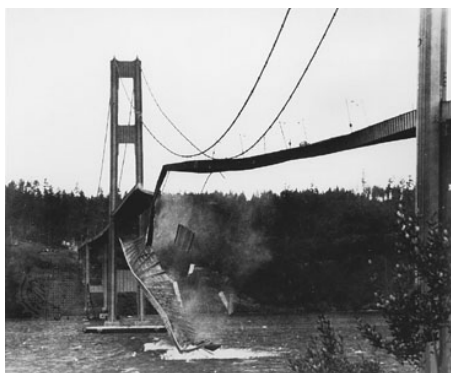
**Tacoma Narrows – Suspender Unzipping**

We have also completed progressive collapse evaluations associated with adjacent suspender loss with a focus on the potential for unzipping. Suspension bridges, particularly bridges with deep stiffening trusses, do not efficiently redistribute localized loading associated with member loss throughout the structure. The potential for unzipping becomes a concern when sufficient consecutive suspenders are lost and the redistributed force results in overload of the adjacent suspenders that remain. It is often the case that the superstructure has less strength than the ultimate strength of the suspender group, given that the factor of safety for the suspenders is much higher than for the design of the stiffening truss or girder. While damage to the superstructure may be anticipated with the loss of fewer adjacent suspenders, we would caution against the conclusion that the superstructure acts as a fuse to protect adjacent suspenders, rendering suspenders safe from the perspective of initiating progressive collapse, particularly in circumstances where abrupt cable loss is anticipated. The ability of the superstructure to transfer large loads prior to failure cannot be ruled out, particularly given the potential for membrane action at the flexural failure limit state. The video documentary of the failure of the Tacoma Narrows Bridge supports the potential for unzipping type failure, where wind induced damage to the superstructure resulted in the loss of nearly the entire main span.
